## CASE STUDY

OISD/CS/2017-18/P&E/02

Title: **Coker Unit Incident during un-heading operation (semiautomatic) at one Indian Refinery**

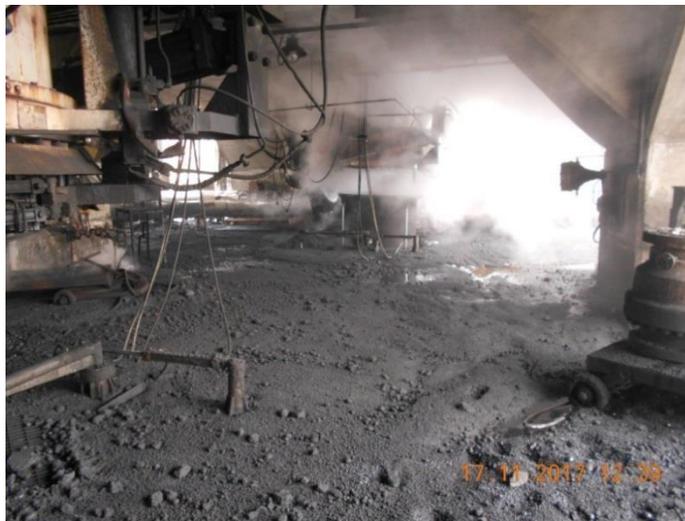
- Just in the beginning of next sequence during un-heading i.e. bottom cover swing operation, the shot coke and hot water suddenly gushed out and spread out in the switch deck platform. Some of the shot coke and water spilled over to the ground level near the staircase area adjacent to the lift.

- Two persons at switch deck platform sustained superficial burn injuries and two persons at ground level sustained approx. 65% burn injuries.
- Based on the observations of operating team, there was excessive shot coke in the coke drum as compared to their previous experience, which may affect smooth draining operation due to clogging of coke drum inlet distributor. To reduce the shot coke generation, there is no mechanism to review the asphaltene content in the coker feed blend, which is one of the contributors in excessive shot coke generation along with other operating parameters like coke drum pressure, heater coil outlet temperature and recycle ratio. However, lab results show that the asphaltene content is checked only on monthly basis.

**Shot Coke and water spilled on the Switch Deck Platform**

- The spillage could not be contained at the switch deck platform at 20M elevation due to inadequate barriers and got spilled over to the ground floor

- Area barricading of the coke drum area at ground floor level with proper warning sign board is to be ensured during every un-heading activity in Delayed Coker Unit.
- The coke drum area at ground floor level should be covered under CCTV surveillance.
- The containment of coke spillage during un-heading is to be ensured by providing necessary removable type metal barriers around the chute so that any coke and hot water spillage is directed towards the coke pit.
- A provision of Pressure Indication (PT) is to be made along with Temperature Indication (TI) in coke drum feed line after coke drum feed isolation valve which may assist in proper assessment of completion of water draining.

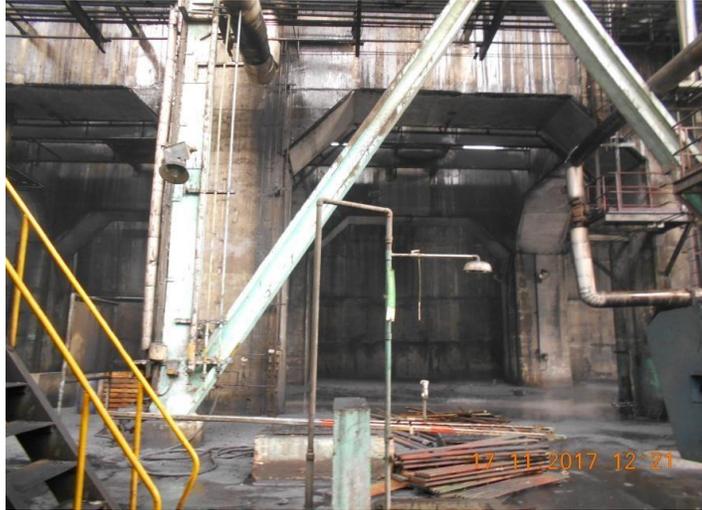
- The safety shower at the ground level was not available at strategic location.

**Safety shower location**
