Major Fire Incident in an Indian Refinery

- V.J.Rao / Tarsem Singh / M.Gupta

The Incident:

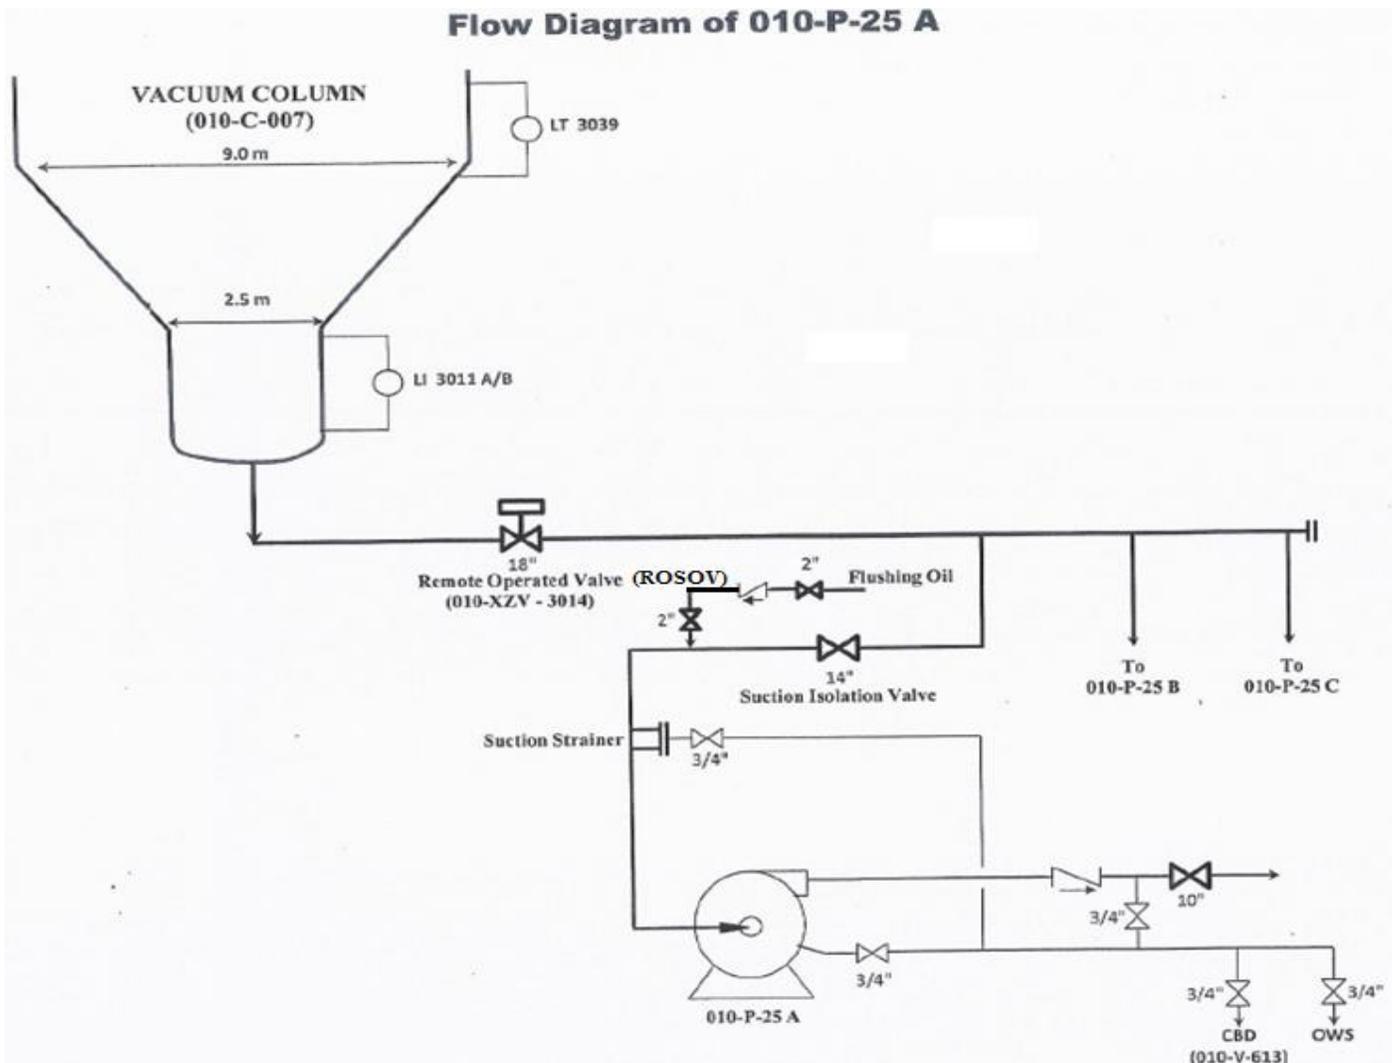
- The general arrangement view of the VDU column bottom to pumps suction is given in Sketch below.

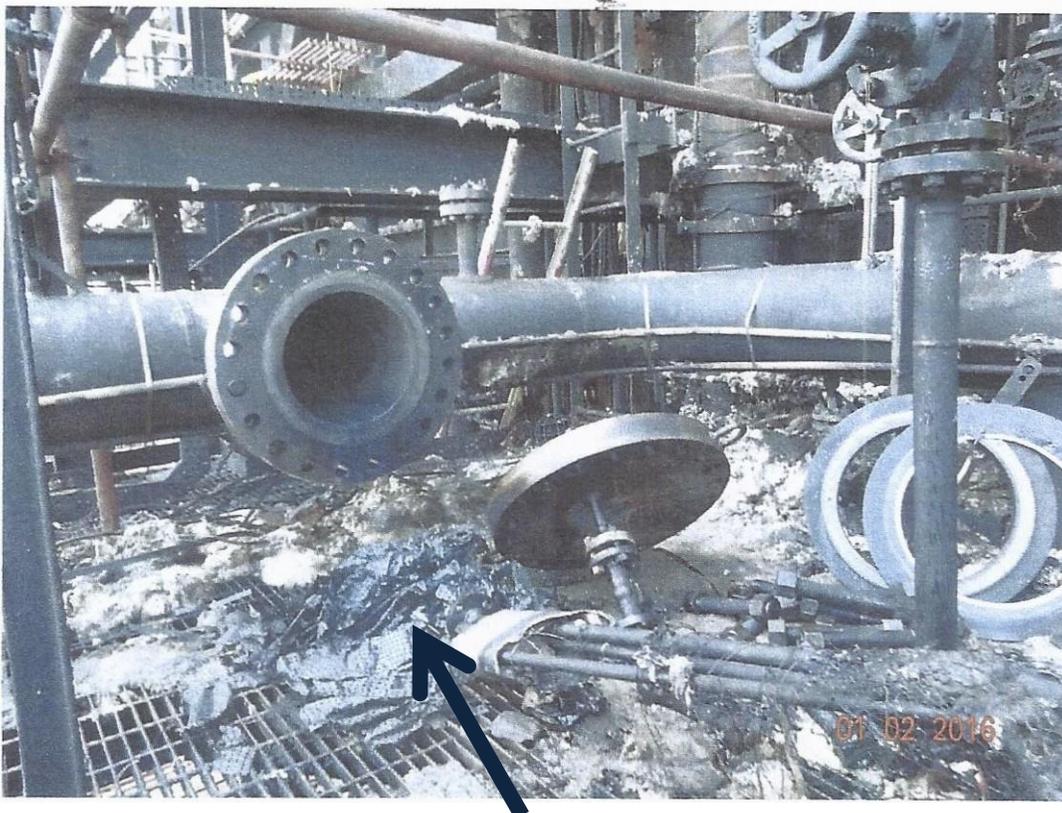
- When the contractor workmen started creating space between the two opened flanges and disturbed the strainer inside, small amount of vapour came out indicating that the strainer disturbance created a path for the liquid to flow.
- It was found that lot of structured packing material from inside the column was found in the strainer and the same was removed when the strainer was opened after the fire incident.

Strenuous material in P 025A suction strainer

- The strainer area of each of the VR pumps to be checked with standards (for congealing /choking VR service) and accordingly modified, if required.
- Before every start-up of the unit the ROV/SOV has to undergo functionality test and recorded.

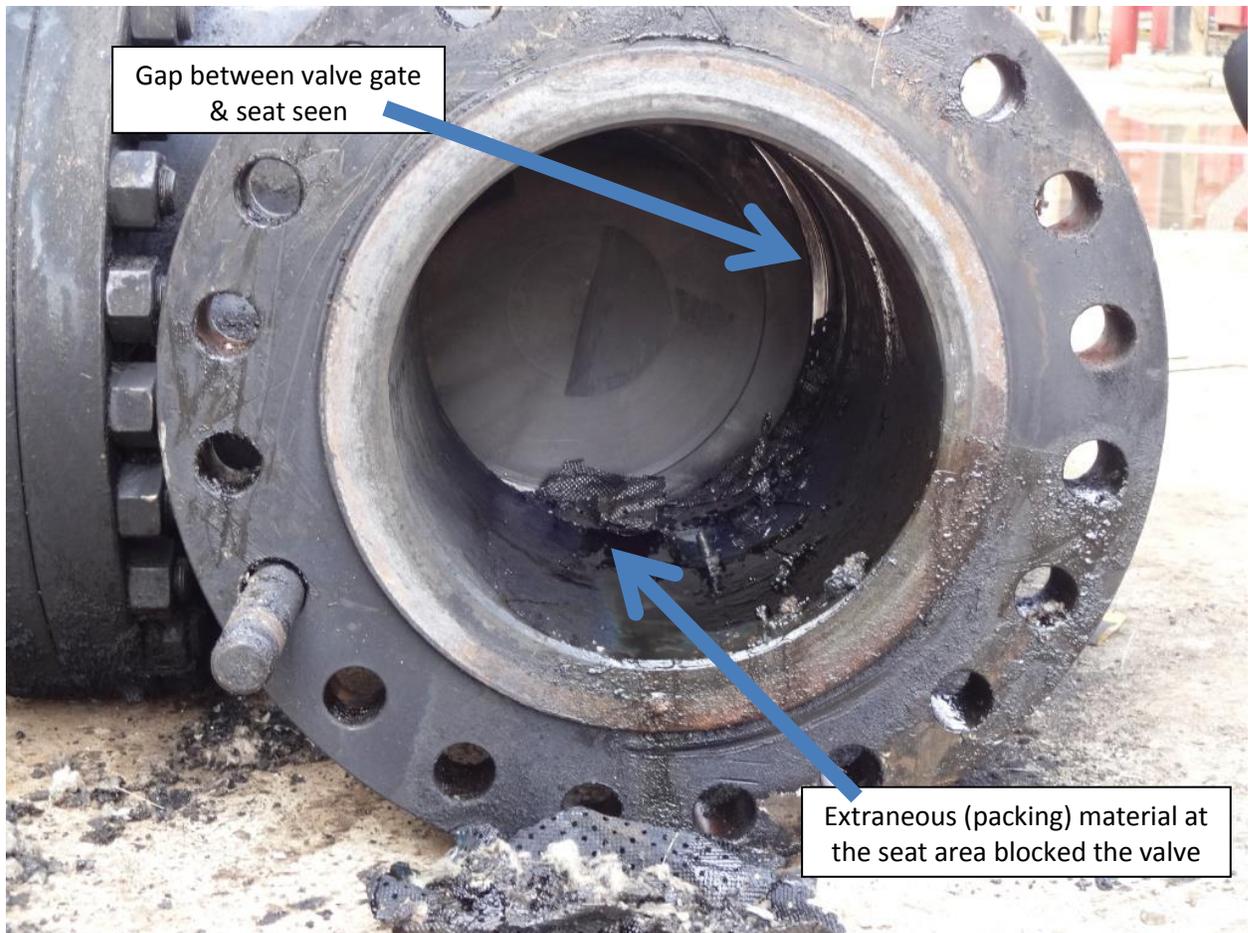
- The isolation valve of P-25A (which was lying outside) was also observed with structured packing between the valve gate and the valve seat restricting the full closure of the valve. It was observed that about 5-8% of the valve remained open due to this structured packing.

- The isolation valve of the pump was not fully closed as could be seen from the spindle and from the gap in valve gate & seat when the valve was opened. A fool-proof mechanical arrangement to be made (like it is made in all gear operated valves) to ensure that the operator is guided to understand the valve is fully closed or not.

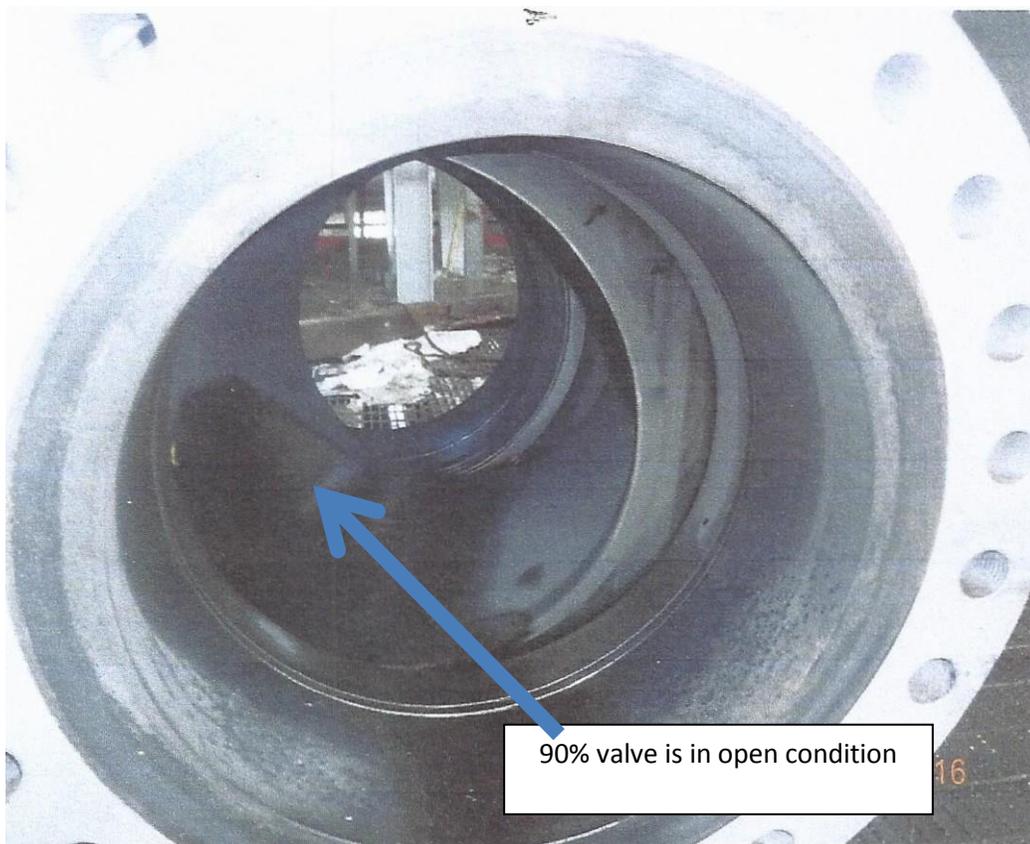
XZV 3014 (Shut off valve)

- When the strainer was disturbed by the contractor workmen, the liquid pressure due to the passing suction valve found a way to come out from the open strainer flange.
- VR started coming out first as vapour and then in large amounts when the congealed VR started de-congealing at the temperature of about 300 deg C and finally the liquid VR came out and started falling down.
- VR temperature being higher than auto ignition temperature (220 deg C), it caught fire immediately.
- Although the common remotely operated isolation valve (XZV-3014) on the line was shut by remote PB as well as local push button but it did not function. It was observed (when the valve was opened up after the fire) that the ball valve was stuck at 90% open and hence the complete liquid hold up volume in the column fed to the fire which lasted for more than 3 hours.
