CASE STUDY

OISD/CS/2020-21/P&E/03.

Dt.: 18.04.2020

- Title:** Fire incident in a river due to crude oil leakage from feeding pipeline.
- Location:** In a river near crude oil storage location.
- Activity:** Crude transfer.
- Result / Outcome:** Leakage of crude oil from feeding pipeline, flowing into river through a drain & its subsequent fire.

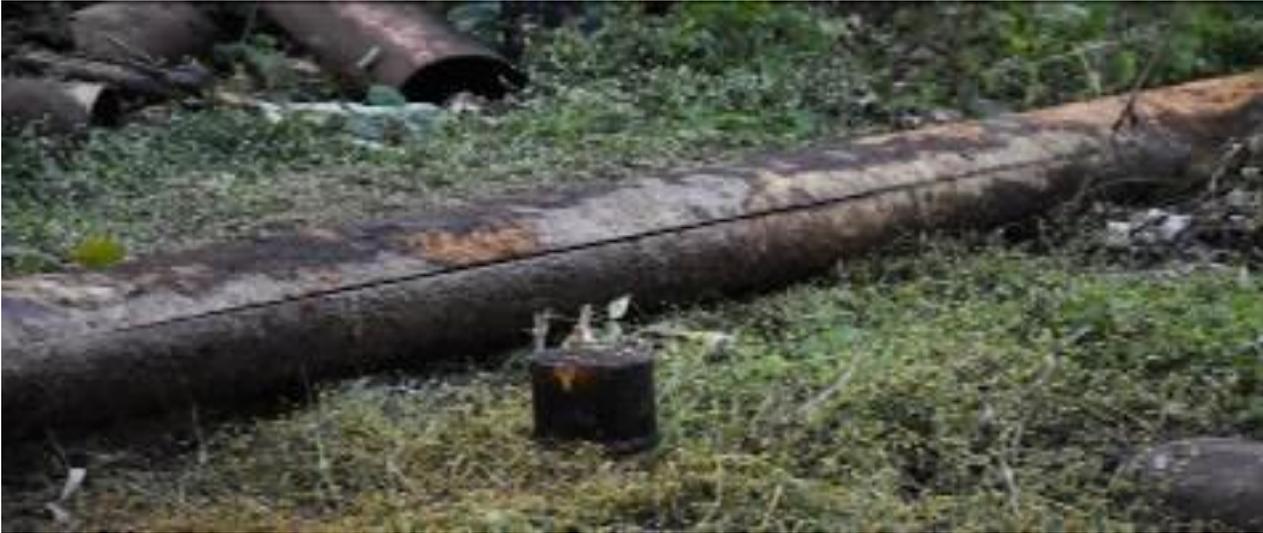
Accidental activation of Emergency Shutdown Switch (ESD) of Tanks, apparently while carrying out instrumentation job in the Main Control Room racks resulted in sudden closure of ROSOVs and MOVs of the inlet and outlet of all the storage tanks of location, which resulted in surge pressure build up within the location and feeding pipeline and development of leakage thereof inside and outside the location.

- Coating and wrapping is not provided on buried piping inside the location which resulted into severe pitting/corrosion on the failed pipes.
- Supervisory Control and Data Acquisition (SCADA) system is not available for monitoring and control of all pumping and receipt operations. As on date there are about 17 pumping locations which is difficult to manage without online data availability.

Ruputured seam pipe at the CTF location

- Surge analysis study to be carried out considering the design parameters. Necessary recommendations of this study shall be implemented in crude receiving location, crude feeding installation and pipelines connecting these locations.

- Pressure control and protection mechanism to be incorporated in the existing system for maintaining pressure within normal operating range and activate automatic shutoff of pumps in case of any pressure excursion beyond acceptable limits.

- Wrapping & coating shall be done for all underground piping and its inspection to be done in line with OISD-STD-130.
- Monitoring mechanism for all pipeline parameters to be developed for ensuring safe and sustained operations. Mechanism to be developed for identification of any leak based on pipeline parameters such as flow and pressure.

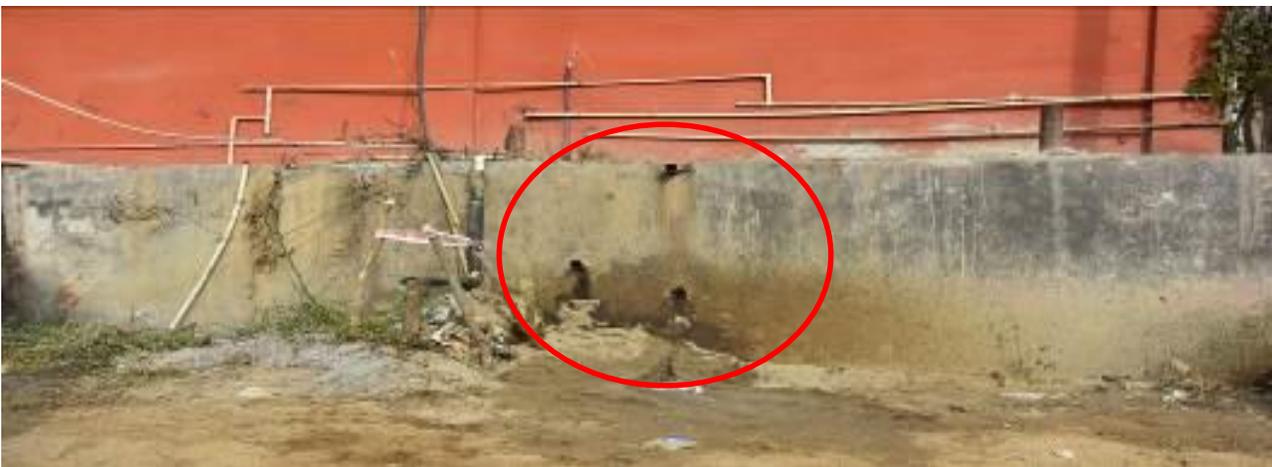
Overflow pipe of septic tank of house through which crude oil released after leak

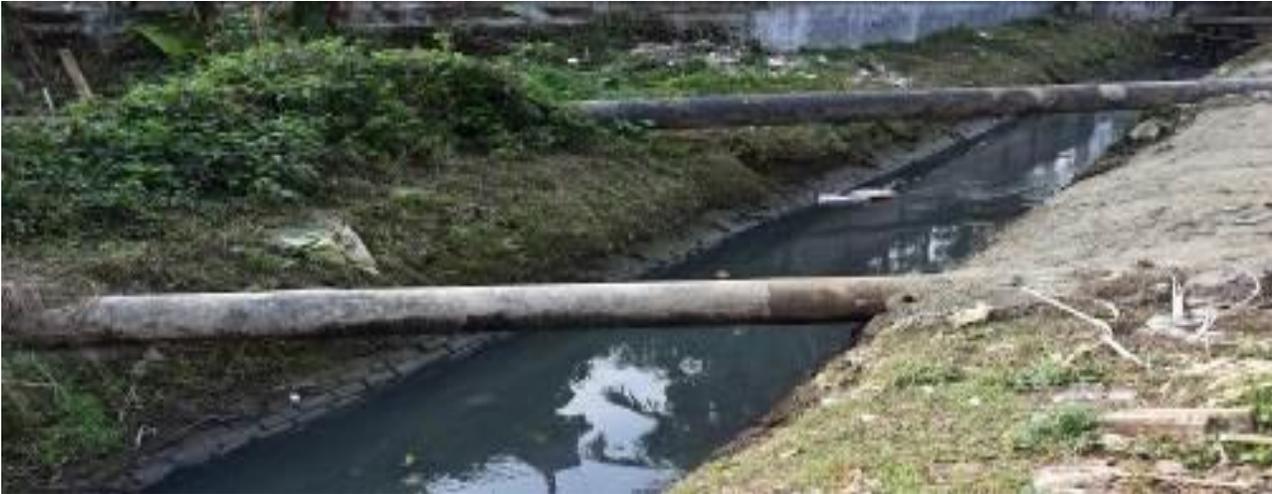
- Arrangements were made to arrest crude oil spillage inside and outside the location using booms, sorbent pillows, bunds and spilled crude oil was collected in drums. However, substantial quantity of leaked crude oil just outside the location boundary got mixed in nearby civil water drain and flowed into the river. The leaked crude in the river was set on fire by some miscreants which got media coverage locally and nationally.

Drain where leaked crude oil travelled before flowing into river

- Emergency response system should include survey of the adjoining water body and river considering worst possible scenario and deployment of booms in the flowing stream of any drain/canal/river for collecting all the spilled quantities.

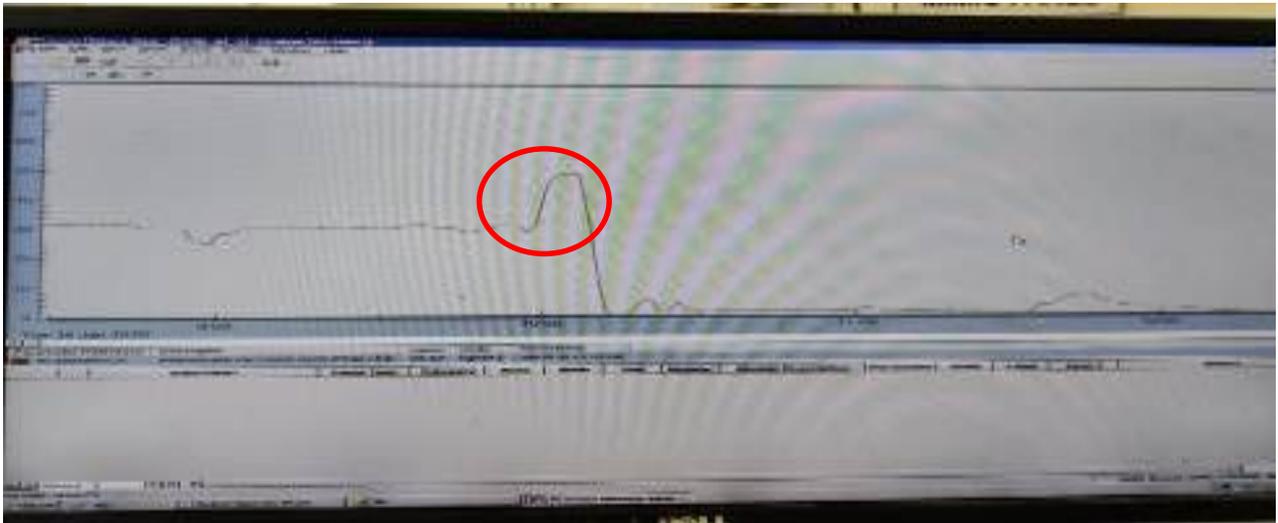
- High pressure protection system is not installed neither at the storage location nor at the feeding locations for automatic shutoff of pumps, closing of station inlet valves in case of abnormal pressure rise. Pipeline operations are not conceptualized keeping in mind the abnormal scenarios like surge creation due to closing of ROSOV/ MOVs or any other reasons.

Pressure increase recorded in one of the crude delivery installation
