## CASE STUDY

OISD/CS/2020-21/P&E/01

Title: Fire incident in Effluent treatment plant (ETP) at one of the Indian Refinery

Location: Inlet sump of ETP

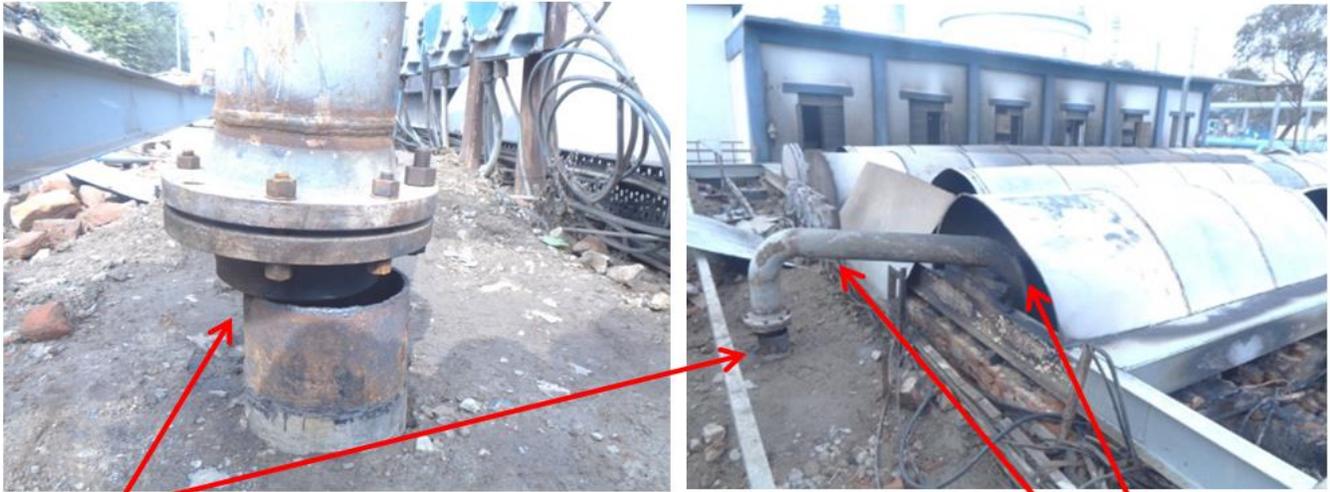
Elbow was cut ; Pre-fabricated line section (with flange fitting) was placed over the cut cross section for proper placement before final welding ;  
Open Side cover of IS VOC chamber.

- It was observed through the opened side cover that there was accumulation of an oil layer over the oily effluent liquid hold up in the IS and smell of hydrocarbon could be felt there.

- It is concluded that Hydrocarbon vapor had escaped from the inlet sump through the side cover opening and accumulated in the adjacent work site to form a flammable HC-Air mixture.

- Possible source of ignition for the fire incident: -
  - For execution of the fit up job, a metal pipe was used to lift the spool piece and the flanged end was adjusted on top of the rough edge of the cut out pipeline. So, it is possible that spark could have been generated from the metal to metal contact/ friction: -

- During any hot work, the risk should be reassessed after deviation from the existing conditions.
- Detailed Job Safety Analysis (JSA)/ Risk Assessment involving multidisciplinary sections (including the plant shift in charge) should be carried out for non-routine jobs during operation/ maintenance/ modification.

- Tool box talk/ pre job safety meeting shall be held for the specific job involving all the crew assigned for that job and record maintained.
- While carrying out hot job in areas where presence of HC gas/ oil is likely to prevail, continuous monitoring of flammable substances should be arranged.

- Wearing of Fire retardant/ cotton coverall is to be made mandatory in the operational area.
- Fire tender to be kept as standby during hot job where presence of hydrocarbon is anticipated. This requirement should be assessed in JSA and work permit.

- Proper planning should be done for lifting of heavy material and such material shall be handled through crane/ fork lift or other suitable means.
- Competency of working crew needs to be ensured.
