CASE STUDY

OISD/CS/2020-21/POL/01

Title: Fire Incident due to leakage of MS from insulating flange joint.

Location: POL Terminal

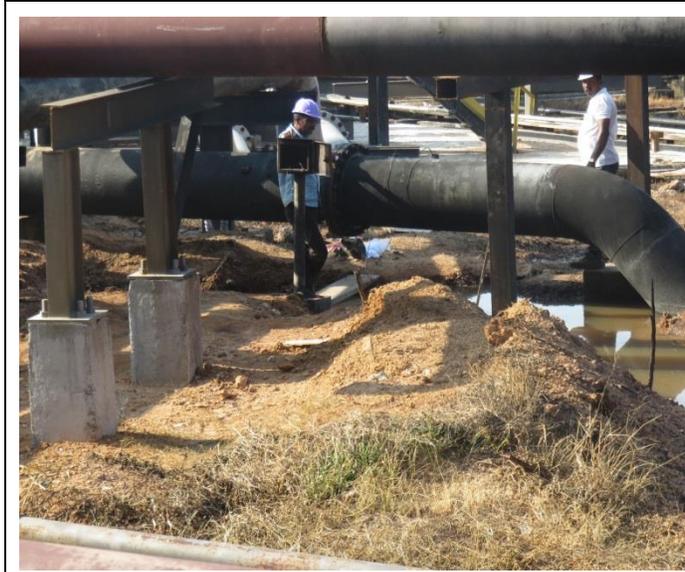
Flange, the point of leakage

1. Insulating flange gasket was used in the pipeline instead of monolithic insulating joint. Insulating flange gasket and insulating sleeve on studs are susceptible to weathering and deterioration
2. Refinery is the owner of pipelines supplying products to Terminal and further to Jetty area through the installation. The integrity assessment through hydrotest, CIPL / DCVG surveys and PSP readings measurement & monitoring was being done by Refinery.

Profuse leakage of MS from insulating flange gasket, most likely due to ageing of sleeves leading to failure of grip at flange joint, and generation of spark due to release of accumulated charge with MS resulted in immediate fire

1. Insulating type flange joint shall be replaced by monolithic insulating joint.
2. Earthing of the pipeline and piping system shall be ensured at insulating type flange joints to avoid charge build up in case of PLT operation. The earthing is really important at all the potential leak points to avoid generation of spark due to static charge dissipation. Further, surge protection device shall be provided across insulating joint.

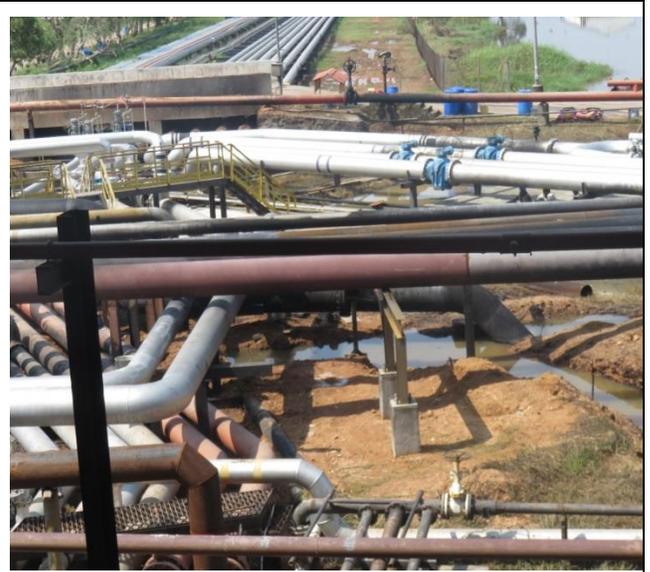
Piping inside the terminal
