OISD/CS/2020-21/P&E/02...

Title: **Fire incident on Maintenance Vessel used for SPM maintenance.**

Location: **During MBC replacement job carried out on the Maintenance Vessel.**

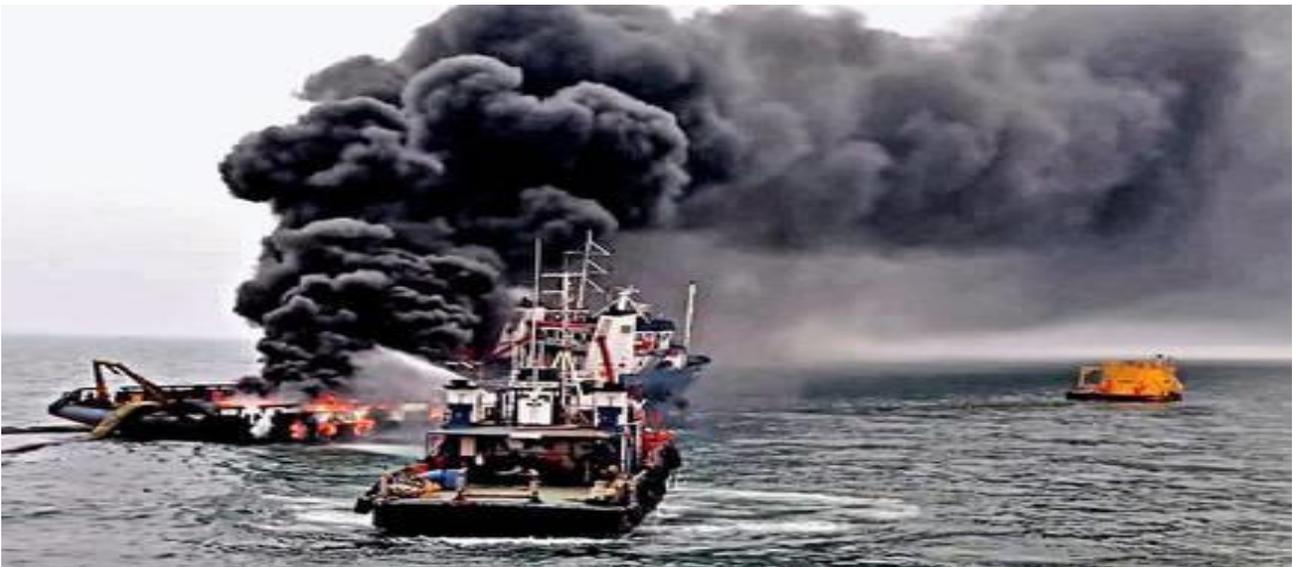
- Later on, the main Maintenance Vessel - A was physically inspected. It was ascertained that the entire engine room seemed to have been engulfed in fire. Main area of the flame appeared to be the starboard side near the emergency exit of the engine room. The electrical panels of the main engine and one of the MSB on the starboard side near the emergency exit were fully burnt and deformed. Some amount of fire melt areas were also seen on the starboard side including some parts of the starboard Main Engine.

- The fire appeared to have started from an ignition point in the engine room near the MSB panel or from generator which was in operation at that time. The most probable reason for explosion appears to be presence of highly flammable gases in the engine room due to which fire spread quickly to the entire oil spill (including vapor) on the main deck.

- Main Maintenance Vessel - A was taken to SPM without having valid certificate/ clearances for sailing. As per Port Trust report, hot work was pending and vessel had gaps on the deck. Through these gaps, crude oil seeped into the engine room and caught fire. Although, O&M contractor has taken the vessel in the larger interest of mitigating environmental disaster but had not anticipated the rough weather resulting in overspill of crude oil from floating hoses onto deck of main Maintenance Vessel - A.

Maintenance Vessel on fire

- Whenever, Maintenance Vessel is taken for periodic survey/ dry dock, it shall be ensured that alternate vessel being deployed is having same facilities (e.g. A-frame, enough deck space) for maintenance activities.

- Maintenance Vessels with statutory certificates/ clearances shall only be deployed for SPM related activities.
- In line with rule-25 of Petroleum and Natural Gas (Safety in Offshore Operations) Rules, 2008, detailed Risk Analysis on direction of oil movement and its impact on environment are to be carried out. Availability of sufficient resource persons either with O&M contractor or owner for estimating the quantity of oil in such cases that is exposed to risk of oil spillage is to be ensured.
