CASE STUDY

Title: Fire incident in a Charter Hired Workover Rig

Location: Onshore Asset

Loss/ Outcome: Fire resulting in six fatalities

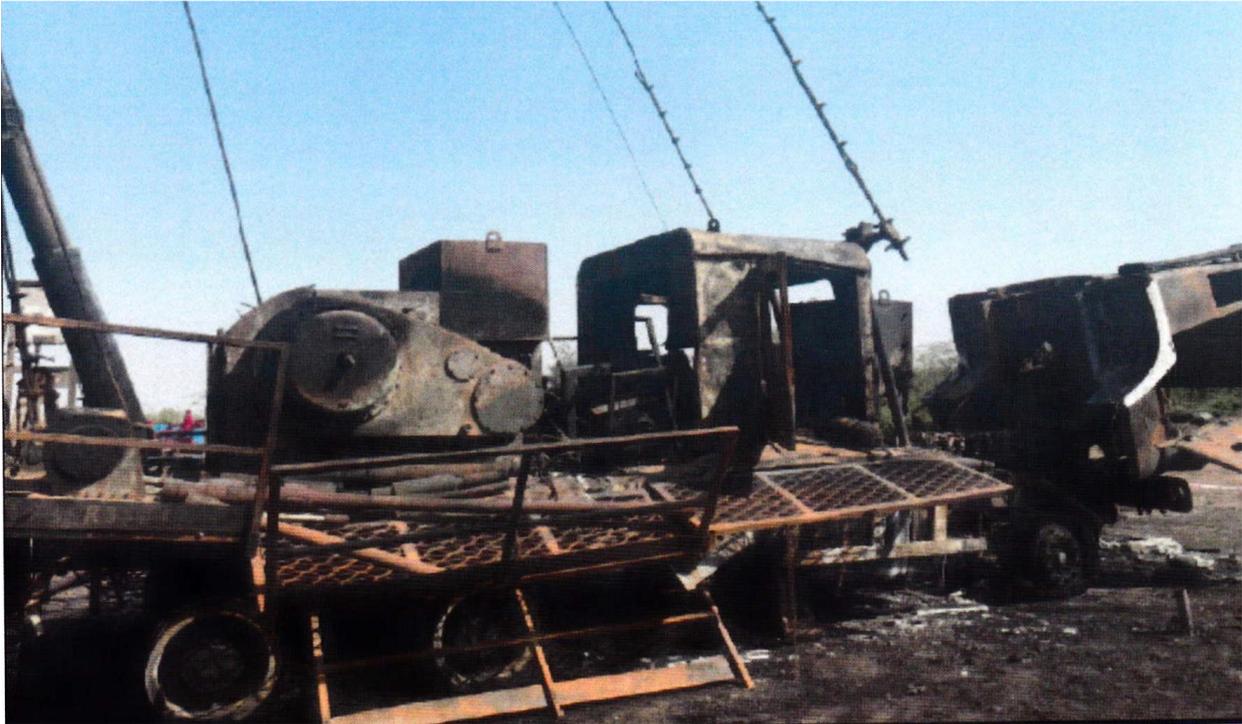
- ❖ Fire resulted in extensive damage to activation tank, rig carrier and surrounding bushes. No damage was observed on BOP. However, hydraulic hoses were found damaged. From the damage, it can be concluded that gas had travelled from activation tank towards rig carrier during circulation. The gas cloud thus formed, got ignited due to presence of an ignition source.

View of the Burnt Rig Carrier

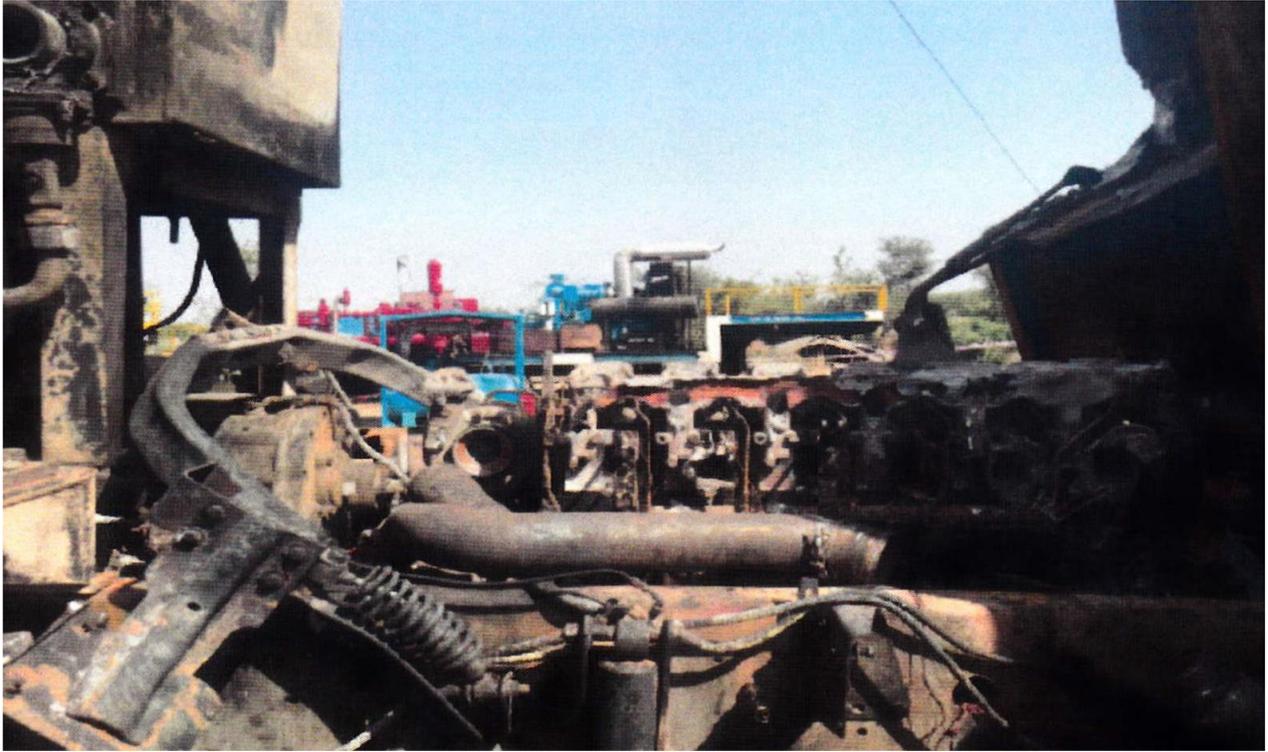
- ❖ Spark generated from rig engine.

View of the Burnt Carrier Engine

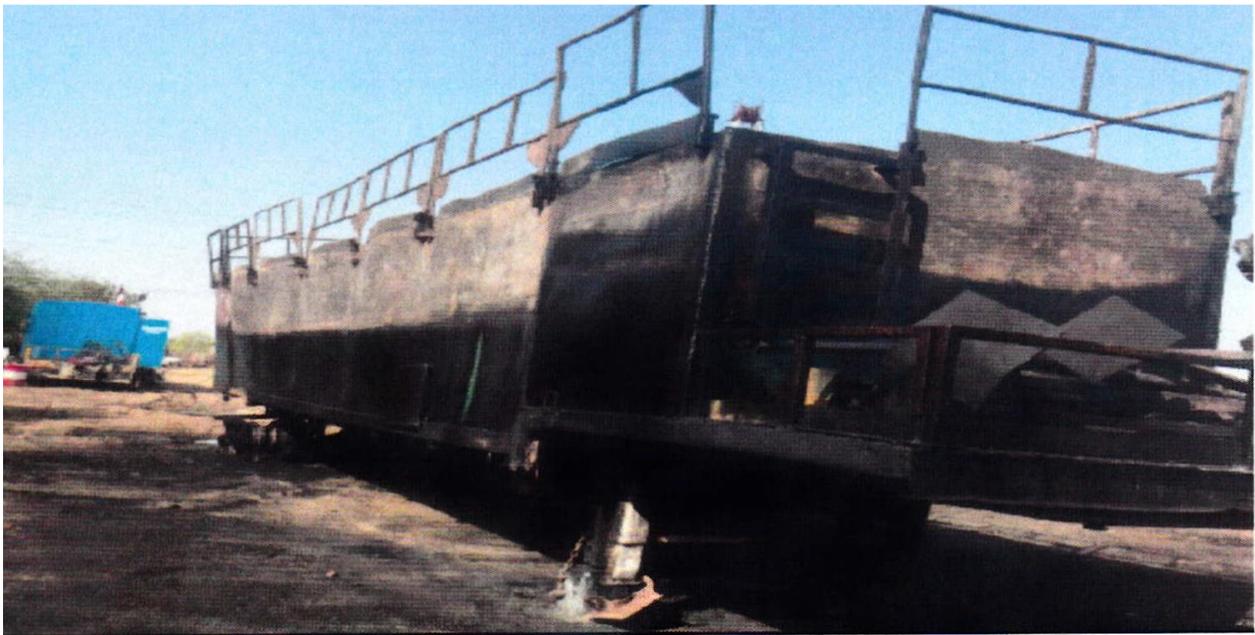
- ❖ Deficient SOP for subduing the well w.r.t. process followed for taking well fluid in the activation tank.
- ❖ Non usage of oil / gas separator unit/ GGS flow line during subduing activity.
- ❖ A gas cloud was formed surrounding the activation tank in the absence of oil / gas separator.
- ❖ Lack of supervision by the Contractor.
- ❖ Lack of supervision by the Operator during critical jobs such as well subduing.
- ❖ Lack of periodic monitoring of LEL.
- ❖ Inadequate lighting near activation tank area.

View of the Burnt Activation Tank

- ❖ The SOP for subduing the well should be modified. It should include the steps to be followed to ensure separation of associated gas from oil and its discharge at a safe distance from the rig. This should include a flare line also.
- ❖ In the Daily Progress Report, break up of time of every operation should be recorded separately.
- ❖ Carrying of mobile phones inside the operational area shall be prohibited and signboards displayed at prominent locations.
- ❖ Only non-sparking tools should be used where there is any chance of presence of hydrocarbon.
- ❖ Persons working in hydrocarbon environment should wear overalls made of fire retardant cloth.
- ❖ Adequate lighting shall be provided in the drill site area.
