CASE STUDY

OISD/CS/2020-21/E&P/02

Title: Accidental Removal of Structure Pins Caused Fall of the Dog House.

Location: On-land Drilling Location

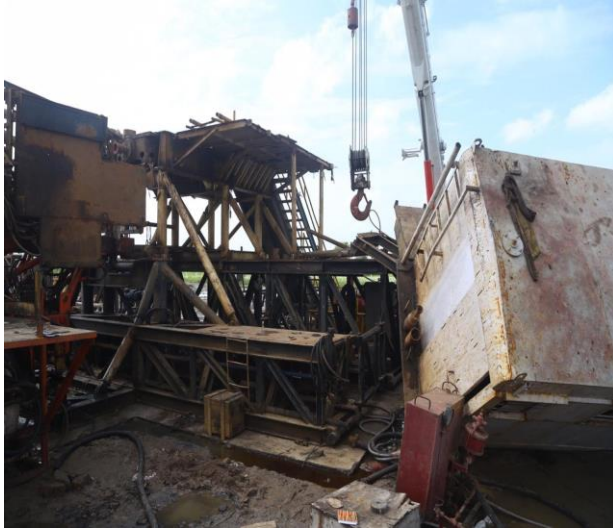
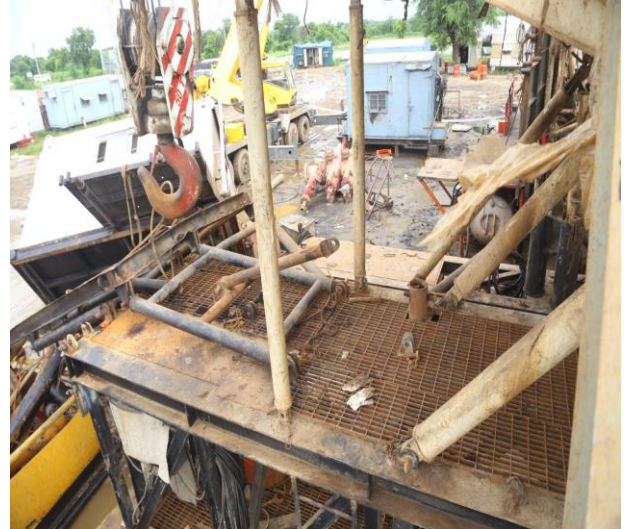
After the accident

Shift in charge conducted Tool Box Talk at start of the morning shift and crew started dismantling work for inter location movement of the rig. The doghouse structure with doghouse positioned on it was alongside the rig floor structure in erected position and its two diagonal supporting beams were pinned with base structure. Injured Person 1 climbed the base structure and released the pins of two diagonal beams, which were holding doghouse structure in its place. As a result, the doghouse structure got destabilized and started drifting away from rig floor and fell down. The skid on which doghouse was placed fell and rested in slanting position on base structure while the dog house tumbled sideways and rested on the ground. IP1, who was on the base structure, was caught in between the falling beam of doghouse structure and base structure. Another IP, who was on the rig floor, close to doghouse also fell with doghouse and sustained injuries. He along with IP2 shifted to the nearest hospital in site ambulance.

- Without removing dog house from its structure and holding of dog house structure, pins of the diagonal beams were removed which were holding dog house understructure in vertical position.
- Adequate supervision was not available for such critical/ hazardous job like dismantling of an elevated structure.
- Lack of knowledge of hazards on the part of the injured persons and other crew members who were involved in the assigned activity.

- Before removing pins of an elevated structure, it should be held by the crane to control the stability and movement.
- Every crew member involved in the job should have clear knowledge about his role and responsibility.

- Lateral stability of doghouse structure needs to be examined. Adequate arrangement to arrest swing of the dog house structure in case of accidental removal of pins of diagonal beams should be done. OEM should be consulted in this regard.
