CASE STUDY

OISD/CS/2020-21/E&P/03

Title: Blast and Subsequent Fire in Storage Tank

Location: Onland Production Installation

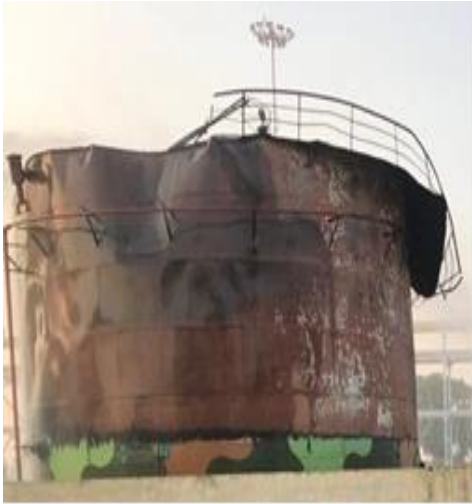
Tank no.3 was found to be with roof shifted and tilted into the tank. Paint of the top of tank and roof had peeled off but paint on the bottom was found to be intact. There was water level of about half the height inside the tank till which level paint was found to be intact from outside. Staircase had also tilted at the top but was serviceable and climbing to the top was possible.

Photographs of Storage tank no. 3 after incident (a) Overall view (b) Backside of tank (c) Roof of tank (d) & (e) Foam pourer feed pipe end

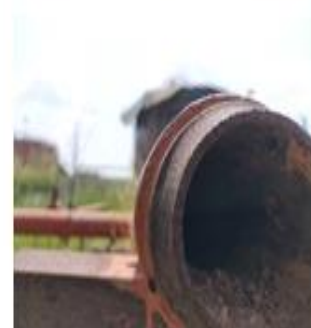
(e)

- Foam pourer lines below the foam chamber on the south side of the tank were removed by cutting. The incident did not happen while cutting on this side of the foam pourer lines as HC mixture was not combustible (concentration of HC was above upper explosive limit).
- Paint/ HC vapours inside the tank & foam pourer lines on north side formed a combustible mixture due to opening of flanges below the foam chamber on the south side.

- e) Hot job on any pipeline connected to the tank should be undertaken only after positive isolation of the tank and pipeline.
- f) Hot work on the pipeline should only be performed after the pipeline is made gas free and suitable testing is done to ensure such operation.
