## CASE STUDY

OISD/CS/2021-22/E&P/02

Dt.: 30.09.2021

Title: Fall of The Telescopic Mast  
Location: On-land Drilling Location  
Loss/ Outcome: Major Loss of Asset

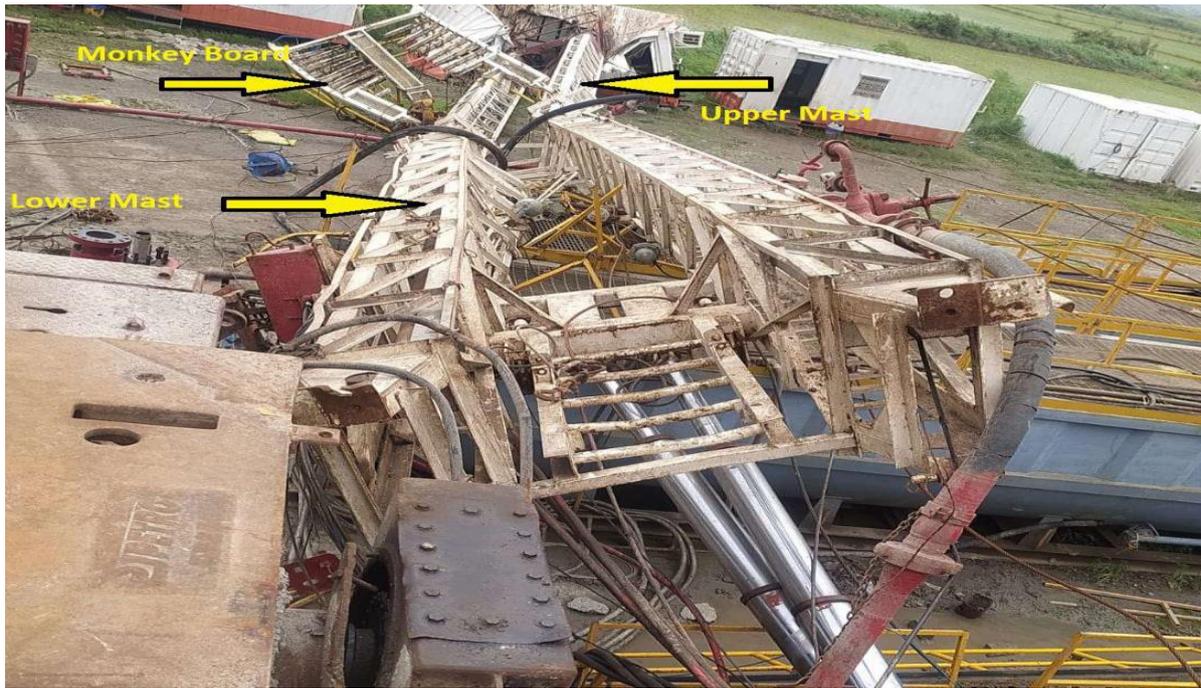
After conducting Pre Job Safety Meeting, shift crew started rig mast down process. Mechanical l/c operated lever meant for raising telescopic mast 3 to 4" up, so that mechanical lock can be removed and telescopic mast may slide down. Subsequently, driller on derrick floor observed some vibrations in the mast and after few seconds a loud metallic sound was heard by everyone. All crew escaped and no injury occurred; complete mast fell down towards left of the rig damaging the Shift in charge/ Store bunk house completely.

### After the incident

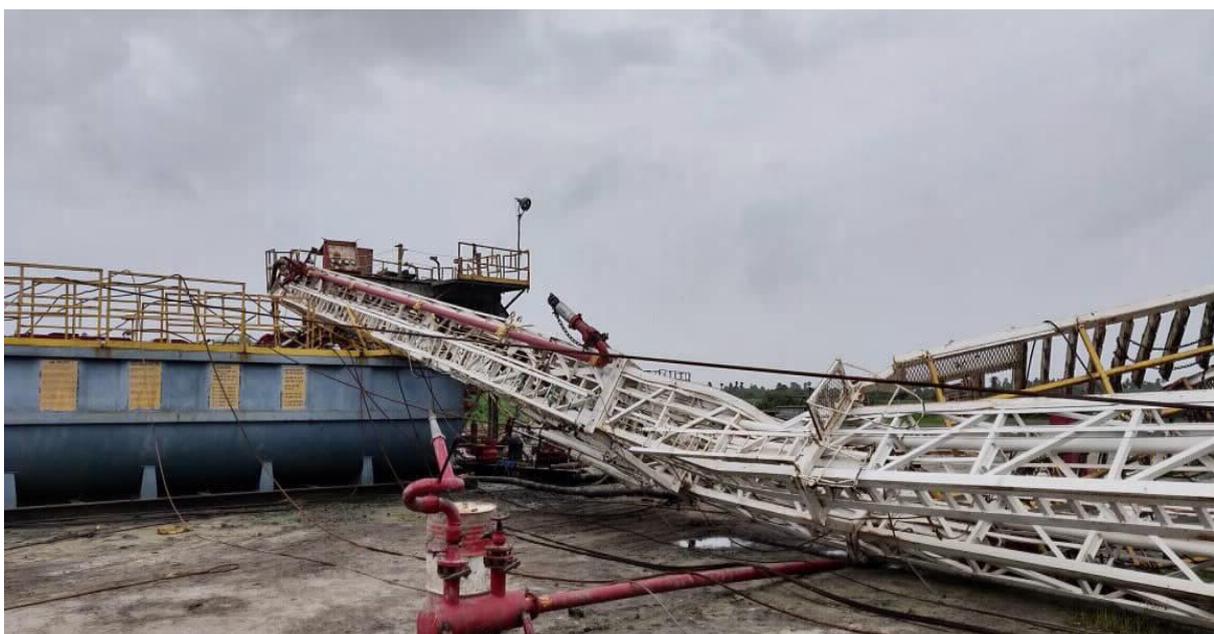
As the telescopic ram (right side) couldn't move up, stress generated in the right side of the structure got transferred to the weakest joint (in this case, it was the joint between lower part of the mast and 'Y' frame). This resulted in snapping of bolt and hinge I-pad fitted at the top of 'Y' frame (right side); subsequently damaged left side of the 'Y' frame joint too and rig mast toppled to left side of the carrier.

View of fallen mast from bunk house side

- Audits shall be conducted during rig building/ rig dismantling period.
- Bunk houses at site should be placed at such a distance which is more than the height of total mast. If this is not feasible, in such case during mast raising/ lowering, no one should stay inside the bunk house. This should be included in SOP too.
