CASE STUDY

OISD/CS/2021-22/P&E/03

Title: Fire incident in Crude Distillation Unit due to SR line leak.

Location: Refinery

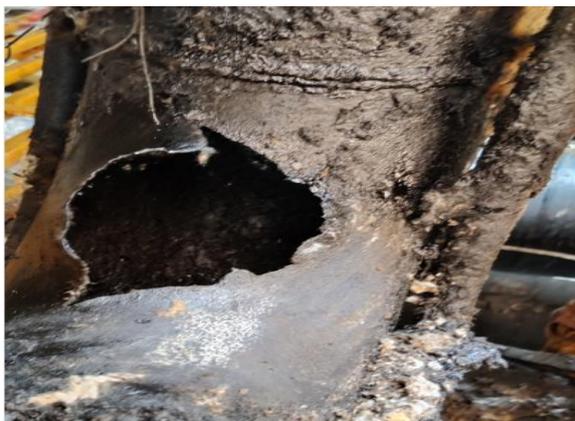
6" SR line ruptured hole in elbow - seen after removal of insulation

- Thickness of the failed elbow on SR circuit was found in the range of 1.8 mm (near hole) to 4.6 mm. Significant thickness loss was noted w.r.t. the previous thickness (6.0 to 7.8 mm) measured in last unit M&I (Four years earlier). Metallurgy of the elbow as per Positive material identification (PMI) was noted as Carbon Steel (CS).

- The API-RP-571 (Corrosion and Materials) indicates that vacuum distillation plants/ circuits in a refinery are vulnerable to naphthenic acid corrosion (NAC) and sulphidic corrosion (SC) due to high Total Acid Number (TAN) and high operating temperature in the produced fractions. NAC is mostly localised corrosion predominantly in location of change in flow direction or high turbulence. Keeping these aspects under consideration, alloy steel (P5) metallurgy was recommended for the SR circuit.
- Due to presence of CS metallurgy, accelerated localised corrosion/ erosion must have occurred resulting in thinning and failure of the subject CS elbow.

- From the above analysis, it is concluded that the immediate cause of the fire was due to the SR leaking out from the failed CS elbow, which resulted in instantaneous fire due to the fluid temperature being above its auto ignition temperature.

- Industry needs to review and strengthen the system of PMI checks at the project execution stage itself to eliminate lapses of metallurgical mismatch.
- A robust system shall be implemented for quality checks at different stages of job planning & execution during normal as well as TA activities related to piping works to prevent error in marking of drawing (in Maintenance/ Inspection work list) offered to executing agencies. PMI shall be done to re-confirm before and after site execution

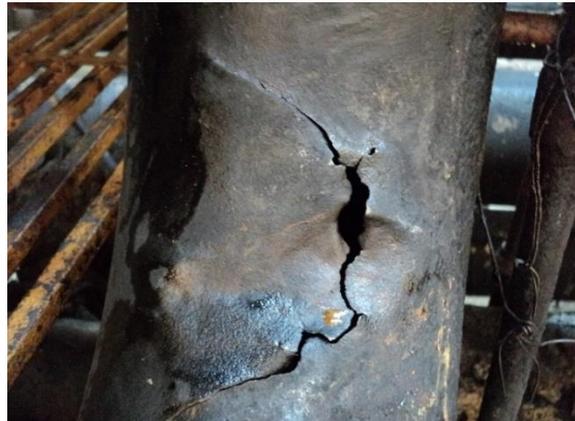
Ruptured hole after adjustment to facilitate temporary clamping and line purging

- The leaky section in the SR line was clamped to facilitate flushing out the bottom circuit of VDU column and subsequent shutdown activities prior to Maintenance & Inspection.
