CASE STUDY

OISD/CS/2021-22/E&P/07

Title: Fall of The Travelling Block
Location: On-land Drilling Location
Loss/ Outcome: Loss of life and equipment damage

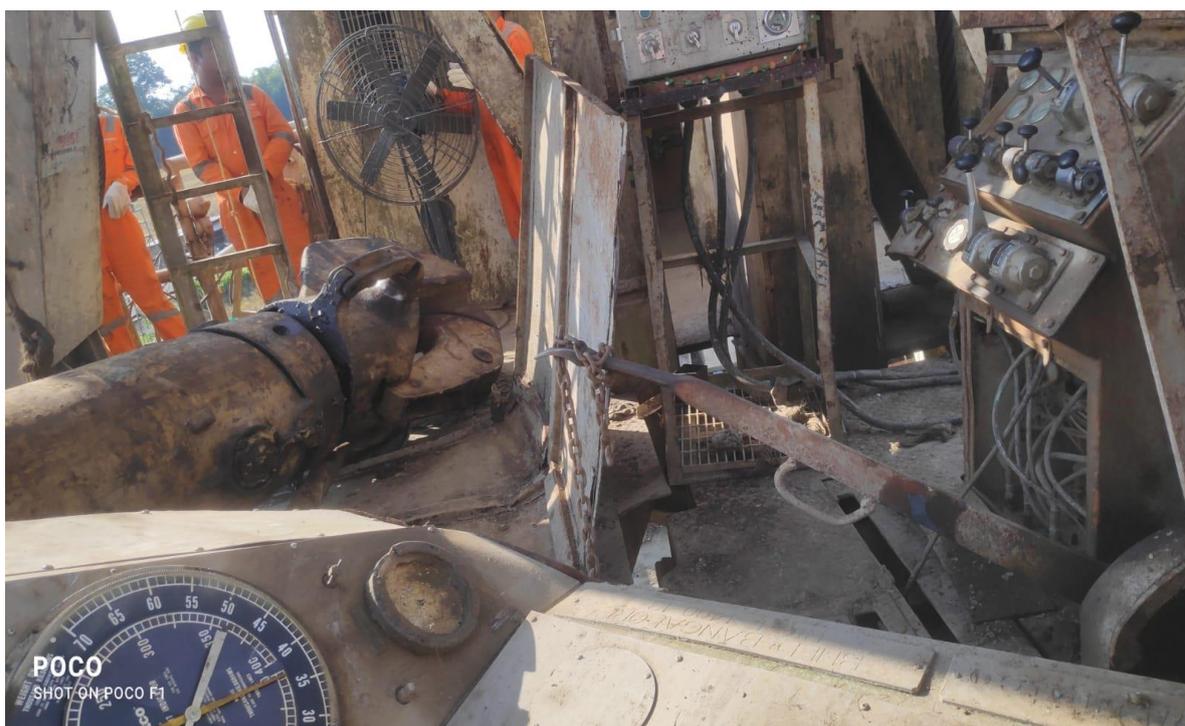
View of place of accident

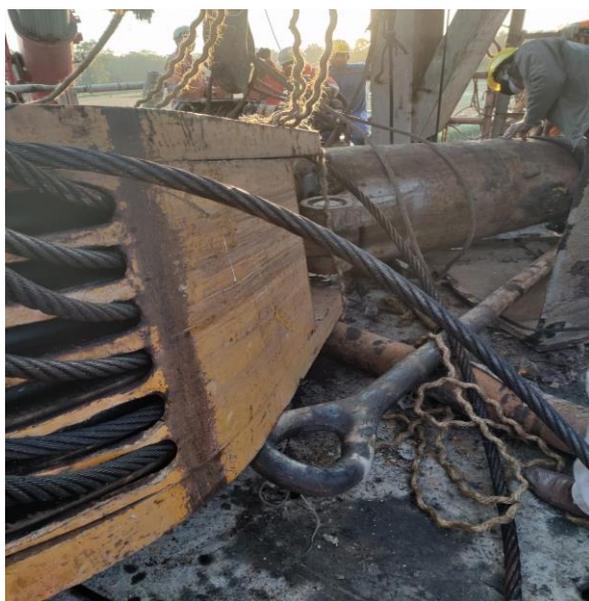
Travelling Block came towards Driller

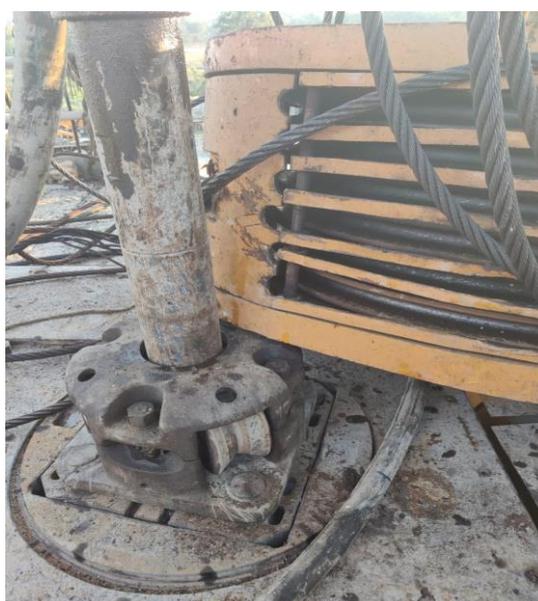
Final position of Travelling Block
