CASE STUDY

OISD/CS/2022-23/PL/02

Title: Leakage incident in cross country crude oil pipeline.
Location: Pipeline ROU near to township location.
Loss/ Outcome: 1200 KL crude oil leaked in incident and shutdown of pipeline for 5 days.

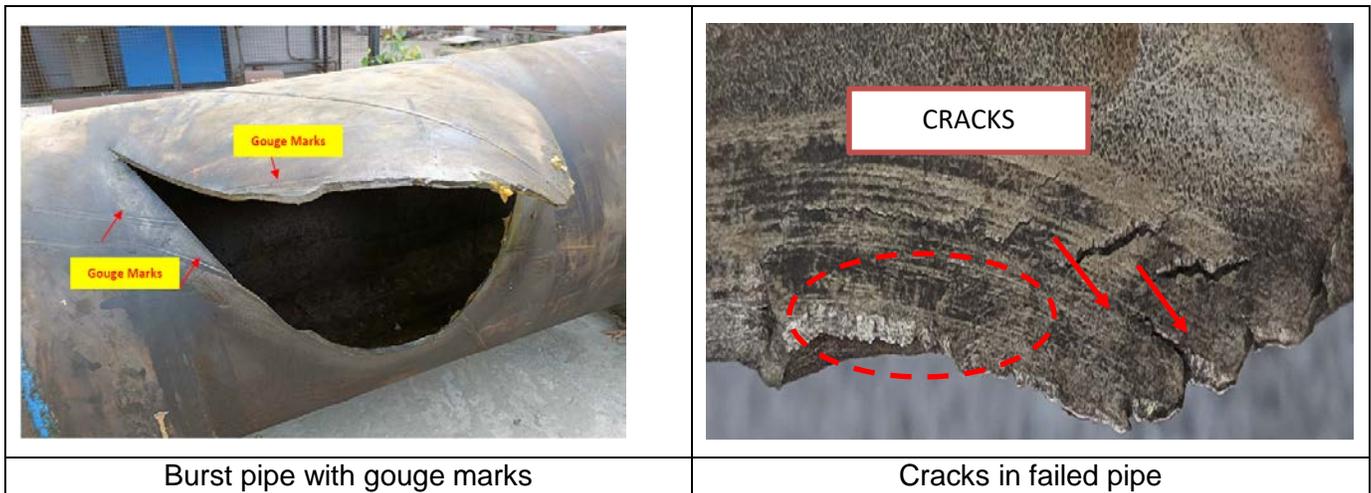
The leakage happened due to burst in pipeline, operating at 59 kg/cm² with flow rate of 2450 KL/Hr. This caused tripping of mainline pumps due to low suction. Within five minutes, information received from DGR line-patrolman who was patrolling in that area about crude oil leakage. Immediately shutdown was taken for the complete pipeline and the affected section was isolated to minimize leaking volume and manpower, Mobile Oil Spill Recovery Unit (MOSRU) and fire tender were mobilized to the location to cordon off the area and recovery of the oil.

2. Pipeline was repaired by sleeving in very close to the burst point. During site visit, 3 heavy (mechanical) scratch marks / Gouging marks were visible on pipeline near to burst point, which were going upward. Scratch mark was not visible on sleeve, which indicates their scratch/Gouge occurrence happened before sleeving job. Gouge mark due to mechanical damage was not reported by the contractor during pipeline repair work. Pipeline was burst at point where scratch was deepest.

10. Failed pipe sample Fractographic scanning indicated presence of microscopic cracks in midsection, propagation from outer to inner side indicating generation of crack from impact of external force.
