CASE STUDY

OISD/CS/2022-23/E&P/03

Title: Fall of stopper pipe on victim.

Location: On-land Drilling Location.

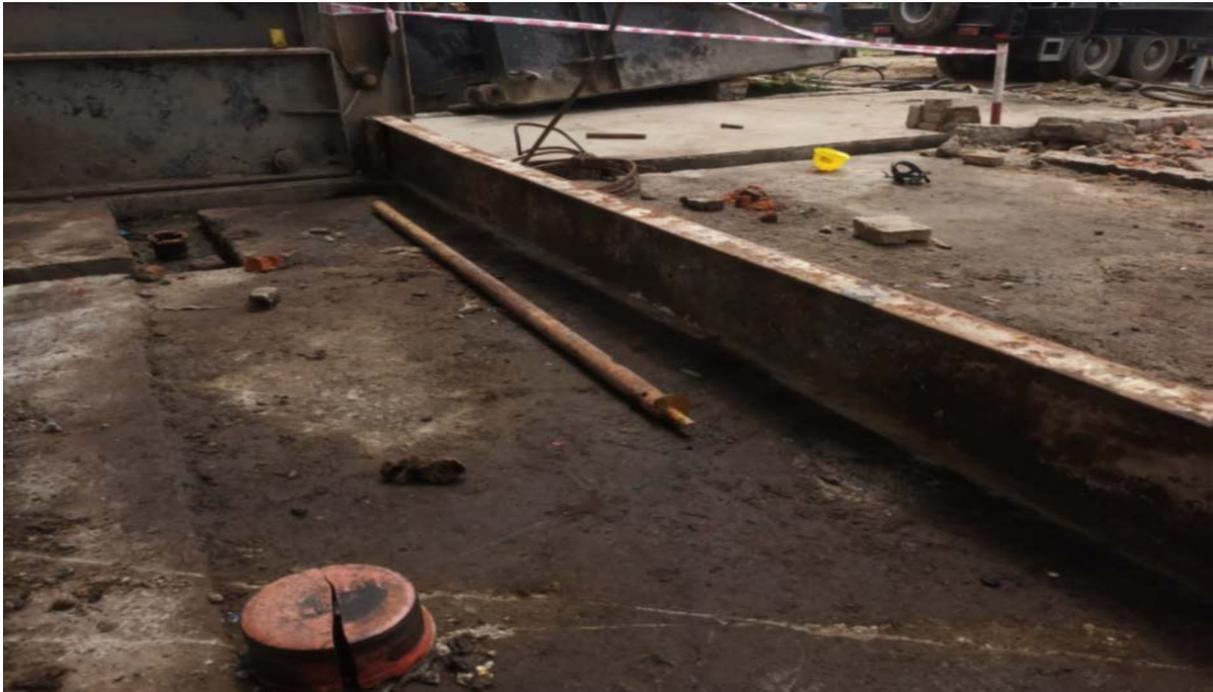
- Two nos. of stopper pipes locally fabricated (2 7/8" OD of 6.5 ppf having 3.04M approx. length) were fitted on railing instead of using conventional chain barrier in order to prevent any person from falling through the V door. This modification was carried out without following MOC procedure as per OISD-GDN-178.

- Loose part and tool of the rig were not securely fastened, in this case the stopper pipe was not properly secured on derrick floor.
- Crane operator failed to see persons working under crane boom.

- The railing adjacent to the V door (off driller side) was welded with its adjacent railing (conjoined) as the socket for inserting the lower foot pipe was in damaged condition on derrick floor which caused sticking of railing and subsequent swinging due to improper slinging procedure for that kind of bulky & lengthy railing (30 kgs/3.04 M) during the removal.

The stopper pipe that hit the IP.

- Pipe stopper should be discontinued, and earlier chain barrier system or proper engineering solution (Risk assessment) should be used for the intended purpose as per OISD- GDN- 206.
