FATAL INCIDENT AT AN INTERMEDIATE PIGGING STATION OF AN LPG CROSS-COUNTRY PIPELINE

Narration: S/Shri Hirak Dutta, ED, OISD, Rajesh Uprety, Additional Director (Pipelines), OISD & YVN Sharma, DGM, HPCL, Vizag

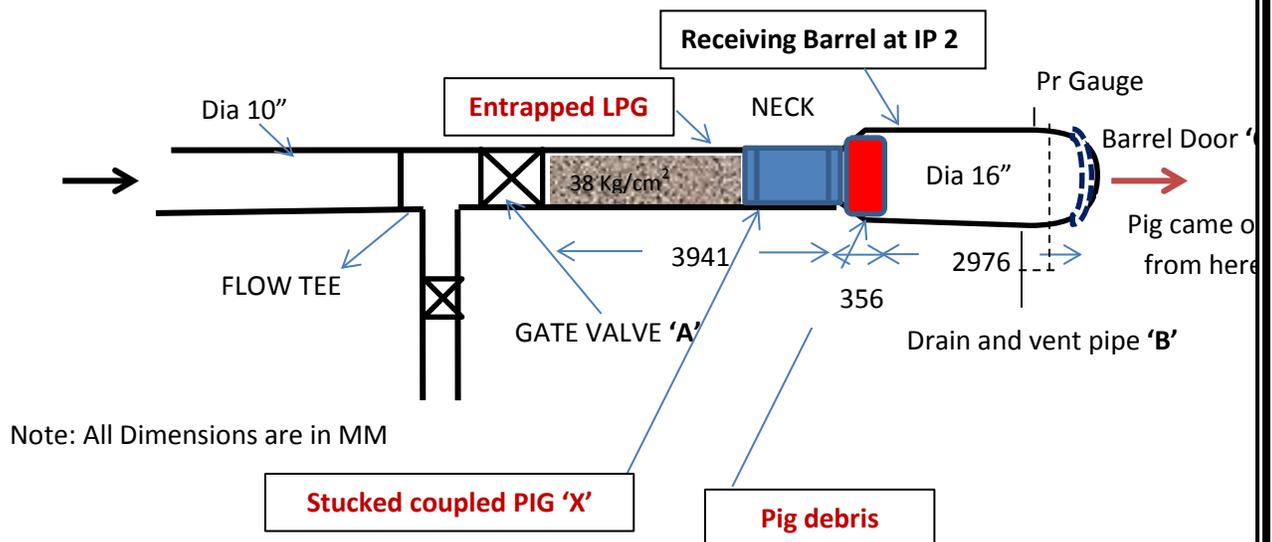
SCHEMATIC DIAGRAM OF SCRAPER RECEIVING STATION (IPS)

- The Scrapper Receiving Barrel was isolated by closing the barrel body valve at A (API-6D Gate Valve) and depressurization was carried out from the vent at B.
- The barrel door at C was opened and it was observed that the pig was stuck inside the barrel and there was lot of pig residue present in front of the pig. The debris was removed by water flushing.
- After water flushing the pig was being pulled out. During this operation, the coupled pig (three pigs were tied together) came out with a great force and hit the persons standing in front of the barrel.
- The impact of the force was such that it broke the compound wall and the metal structure of the pedestal of the pig trolley.
- Due to the impact of the pig, there were two fatalities. In addition, three other persons suffered injuries - one of them suffered major injury.

As may be seen, from the schematic diagram, that LPG was trapped between the valve A and the pig at X, due to the presence of magnetic pig and the high iron content the residue got solidified which acted as sealant, thus not allowing LPG to escape from the open barrel door. Thus, actually, only the portion between the pig and the barrel door was depressurized, while the portion between the valve and the pig remained pressurized with LPG at a pressure of 38 Kg/cm². Further during the day as the temperature soared, it might have further increased the pressure of the entrapped LPG in the rear portion of the barrel. As soon as the pig residue was manually cleaned, the entrapped LPG, which was at a high pressure of > 38 Kg/cm², propelled the coupled pig out of the open barrel door with a huge force.

1. Pyrophoric iron in contact with air liberated heat which resulted in explosion of LPG-air mixture inside the barrel resulting in propulsion of pig at a very high force/ speed. The persons standing in front of the open door of the barrel were hit by the pig which resulted in fatality & injury.
2. Sudden release of entrapped LPG at high pressure (38 Kg/cm²) might have propelled the pigs out of the barrel. The rise in temperature during the day might have further increased the pressure of entrapped LPG.
3. Draining of entrapped LPG inside the barrel between barrel valve & pig could not be done due to absence of drain or vent in that location (in the neck portion of the barrel).

3. An additional vent & drain point with pressure gauge shall be provided in the neck portion of the barrel to drain the Hydrocarbon.
4. Pig train must not be used with all pigs in tied condition. This is not a standard practice.

7. SOPs must be properly explained to all the operating crew.
8. While receiving the pigs, it shall be ensured that proper venting has been carried out between barrel body valve and the pig so that the barrel is free from any Hydrocarbon.

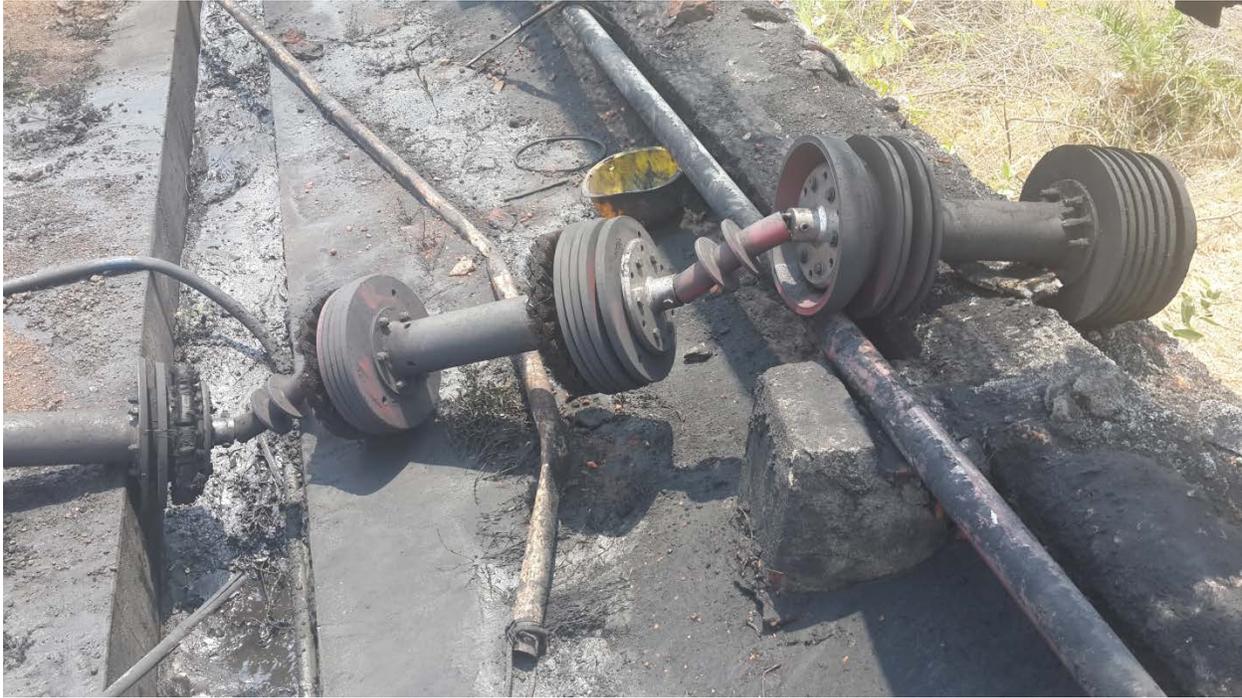
**VIEW OF COUPLED PIG THROWN OUT OF THE RECEIVER
BARREL**
