## Case Study: Major Fire at Industry Tank Wagon Siding

### *The Incident*

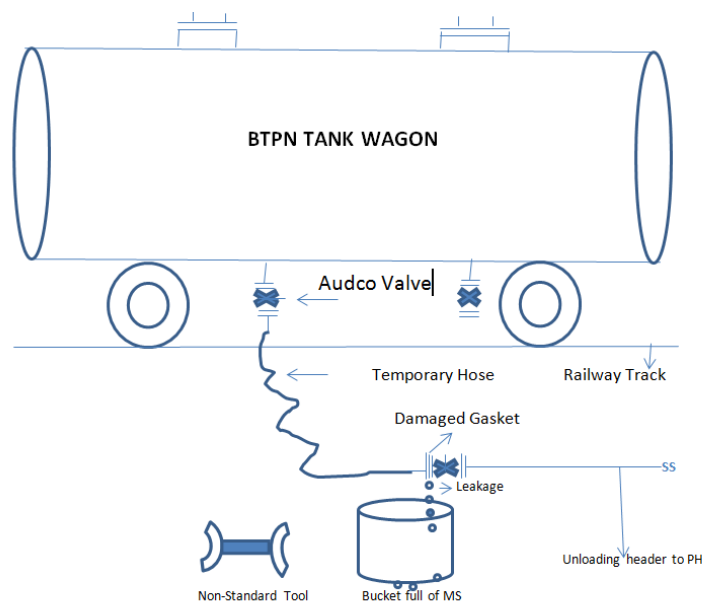
**Schematic Line Diagram**

- On completion of hose connections of the 02 TWs, contract workmen opened the master valve of TW, bottom valve and unloading header valve and MS unloading operations from these 02 wagons started.

- While unloading was in progress, contractor workmen noticed that MS was leaking from the flange joint connecting tank wagon unloading header and unloading hose of one of the MS tank wagon. The spilled MS was being collected in a bucket.

- Without closing the bottom valve and master valve of the MS tank wagon, contract worker tried to tighten the bolt of the flange joint with a spanner to arrest the leakage. While tightening, the gasket between the unloading header & the hose got ruptured, which resulted in heavy leakage of MS & vapour cloud.

- During the process of tightening, the spanner slipped & fell down resulting in generation of spark. The MS vapors immediately caught fire due to the spark and subsequently the MS tank wagon was engulfed by the fire.
