FATAL ACCIDENT AT WORKOVER RIG DUE TO FAILURE OF CASING LINE

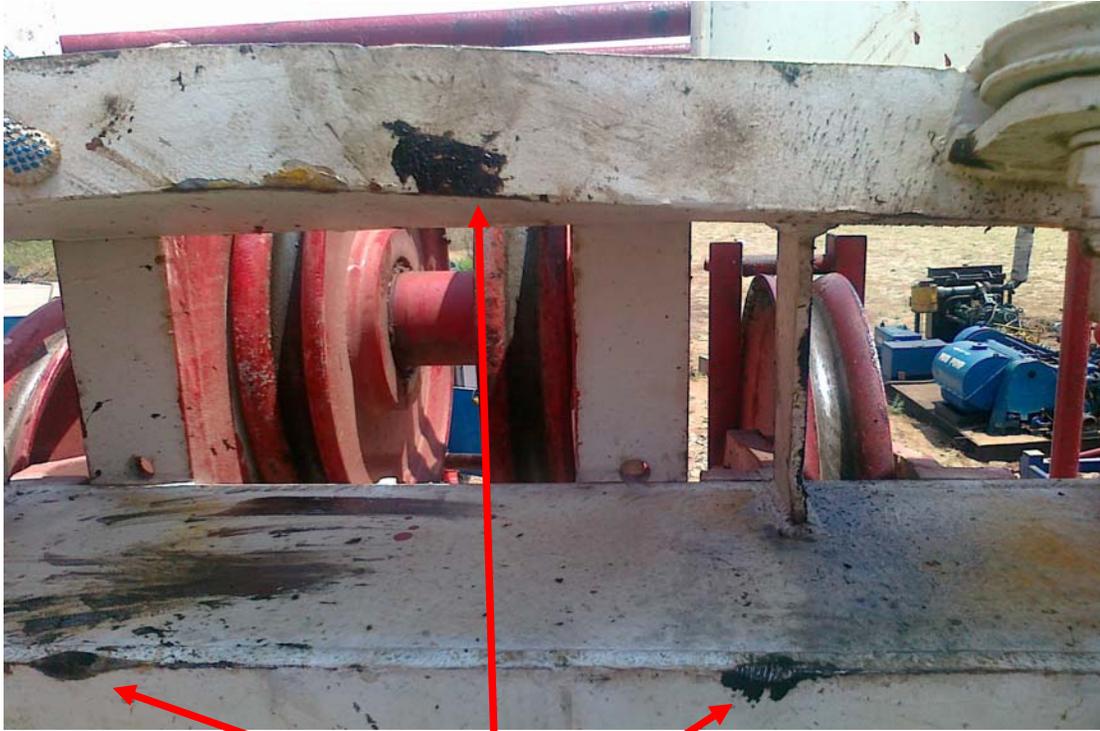
- iii) Damage observed on the crown block members, monkey board, travelling block and derrick floor area.
- iv) Derrick floor was very congested with number of equipment lying there.

Damage on crown block members

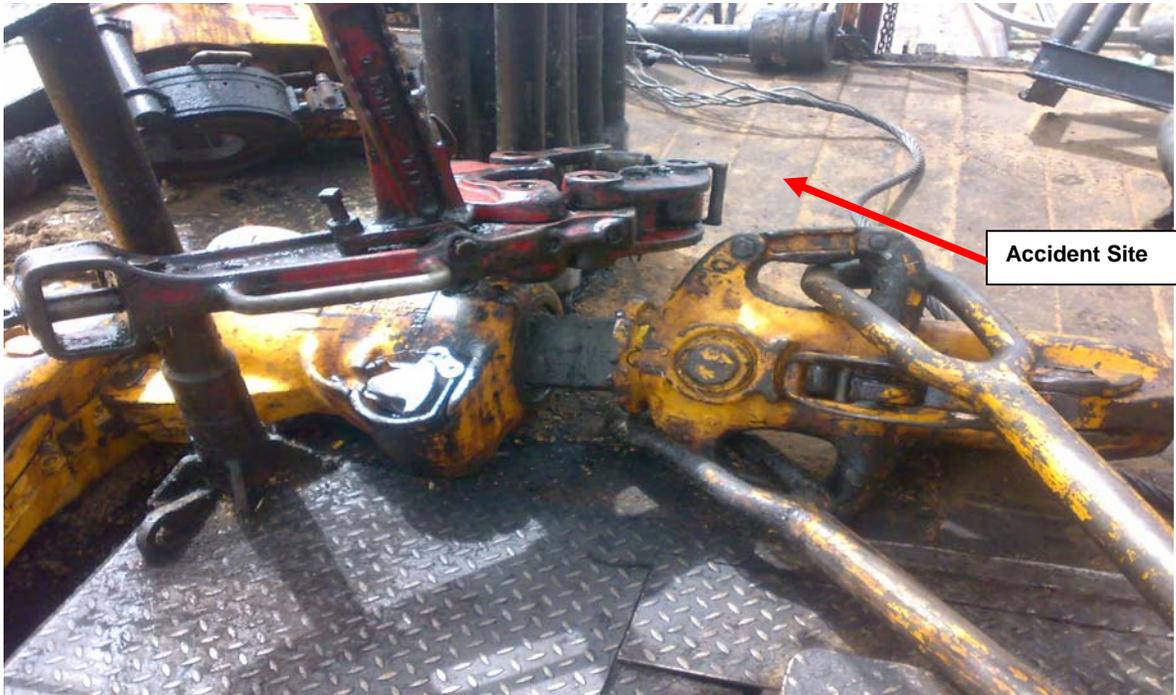
Derrick floor after the incident

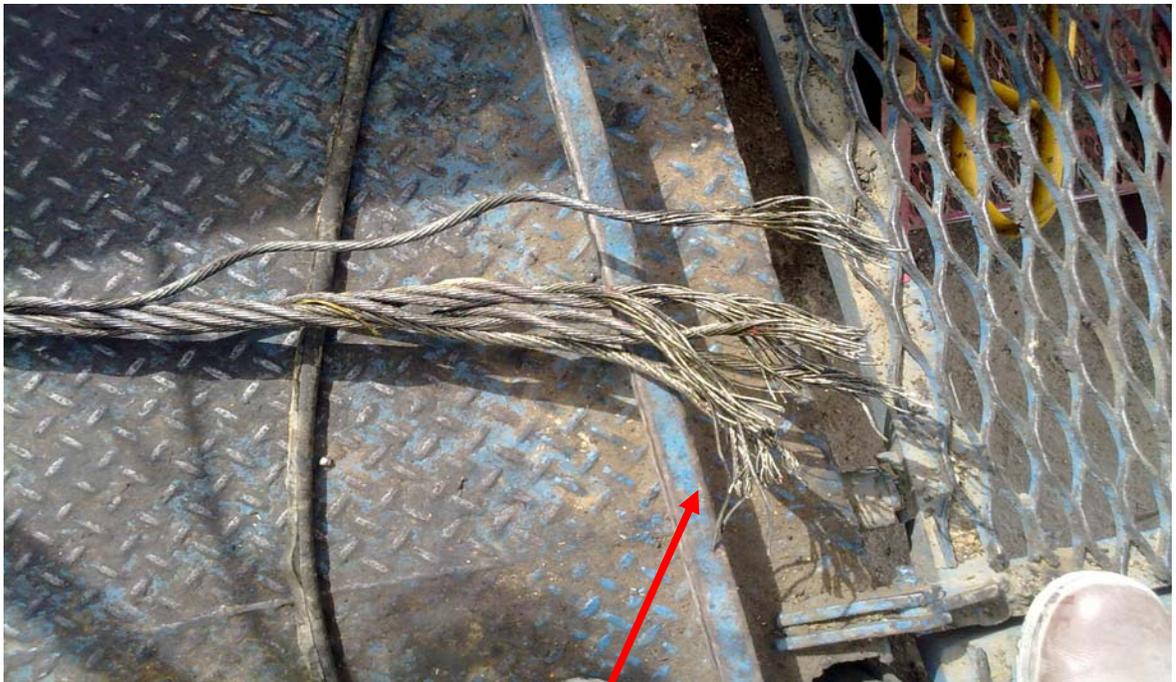
- i) Assistant shift incharge who was operating the brake at the time of incident was doing extra duty from 1900 hrs to 0700 hrs. His actual duty period was from 0700 hrs to 1900 hrs. on the previous day. Retaining him on extra duty was without the knowledge of the rig coordinator.
- ii) Apparently crown-o-matic device (a safety device meant to control the movement of travelling block) did not function; as a result travelling block moved up and hit the crown block, where the casing line (wire rope) got entrapped between crown block and travelling block that resulted in the breaking of casing line.

The immediate cause of accident was breaking of casing line and subsequent falling of travelling block on derrick floor that resulted in the accident (Fatality).

Damaged casing line after the incident

1. Crown-o-matic and floor-o-matic device should always be operational and inline to prevent unsafe movement of the travelling block.
2. SOPs for the job undertaken by the rig should be available, and followed by the crew.
3. Sufficient rest should be provided to the rig crew.
4. Bridging documents between company and workover rig contractor for interface management should be available.
5. Contractor employees' safety should be emphasized (refer OISD-STDs-206 & 207).

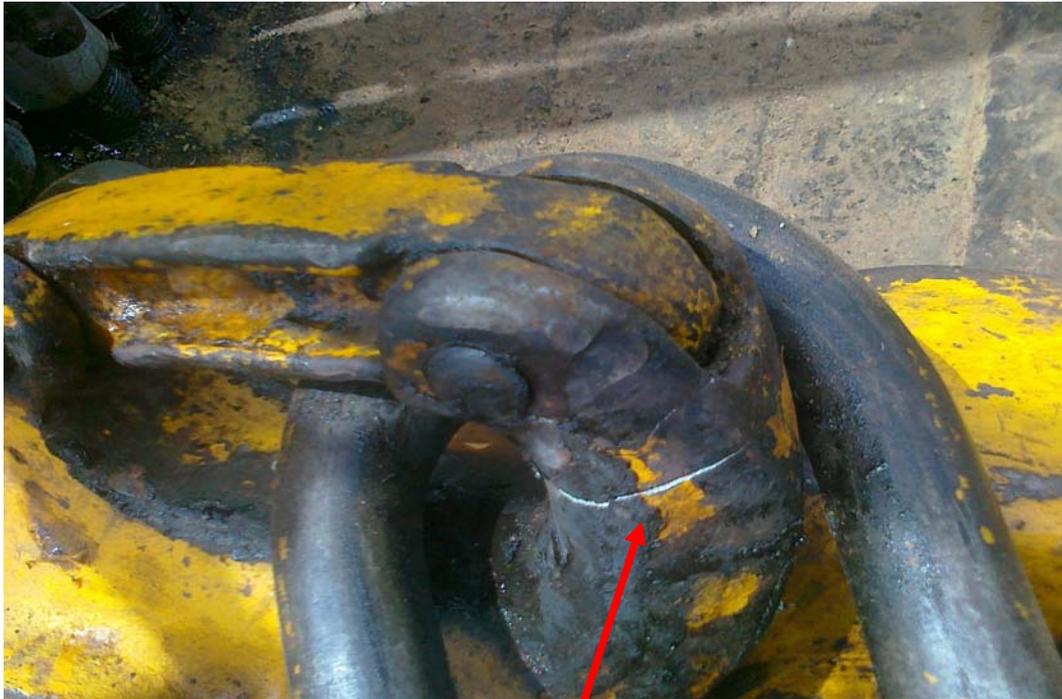
Damage on travelling block
