## Fire incident in Heater Treater unit in a GGS

### Introduction:

A major fire incident took place at Heater Treater unit of a GGS at around 2120 hrs. on 28/09/2012. It has resulted into damage to the three numbers of heater treaters & associated equipment, and production loss due to stoppage of operations.

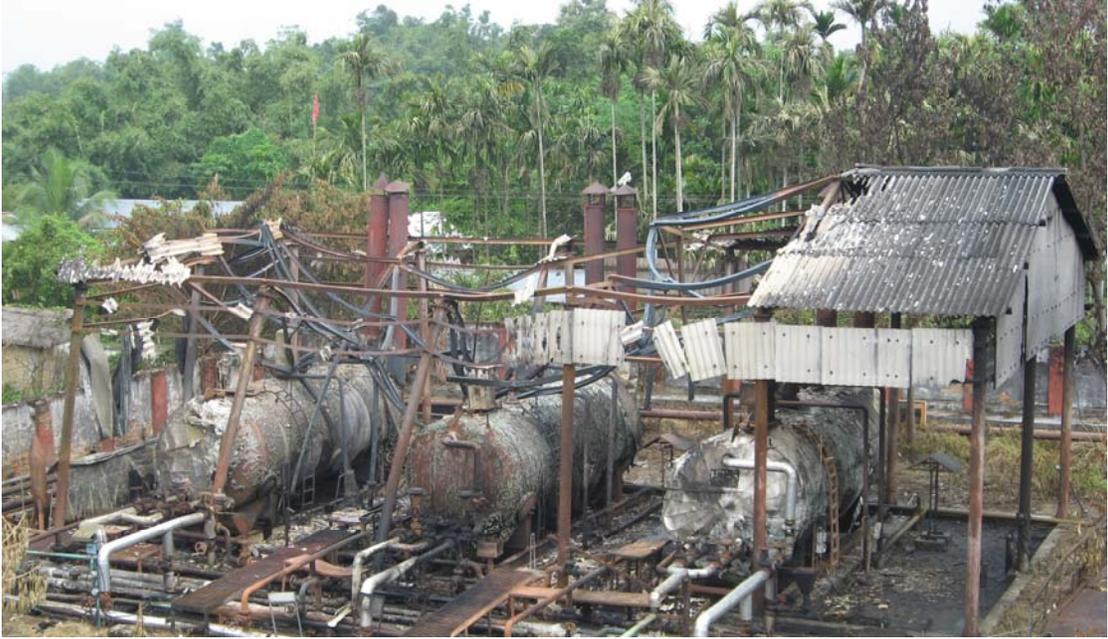
**Heater treater Area**

- I. Heater treaters were located very close to the boundary wall of the installation. Inter-distance requirement as per OISD-STD-118 was not being met and this was pointed out by OISD audit team which visited the installation earlier in July, 2010. Also, there was a lot of crude oil spilled in the area
- II. Storm water channel was full of oil which caused the fire to spread. Audit team had observed the same in July 2010 also and the company had informed in January 2011 that the audit observation has been complied with, and drain channel cleaning is being done at regular interval.
- III. Plant is more than 30 years old and equipment maintenance was found to be poor during the site visit.

Though the exact source of ignition could not be ascertained, as the area of fire ignition was very close to the boundary wall, the possibility of source of ignition being external (from outside the boundary wall) cannot be ruled out. [Incidentally, based on forensic analysis, concerned state authority have ruled out the use of explosives, as per the information received later on] There was sign of considerable amount of crude oil spillage near the heater treater area which fuelled the fire, and crude oil in storm water channel caused the fire to spread from one corner of GGS to another.

- I. The process equipment should be relocated to safe area, maintaining the inter-distance requirements as per OISD-STD-118 on 'Layouts for Oil and Gas Installations'. Alternately, additional control measures should be put in place, based on quantitative risk assessment.
- II. Engineering and procedural control measures should be taken to avoid the abnormal spillage/leakage of crude oil.
- III. Crude oil in storm water channel is unacceptable. Immediate measures to be taken to stop spillage of crude oil in the storm water channel.
- IV. Housekeeping in the plant should be improved.

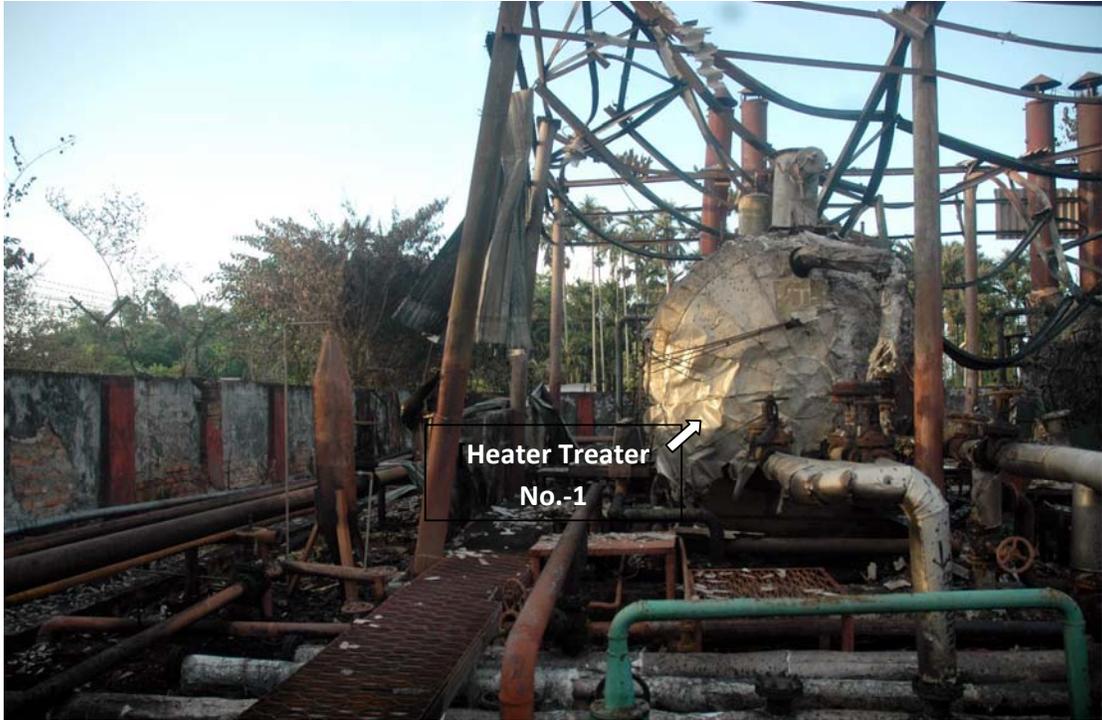
- IV. Housekeeping was very poor with lot of vegetation and crude oil spillage at many places.
