# Major fire incident at FCCU: Flare KOD draining to OWS

## 1. THE INCIDENT:

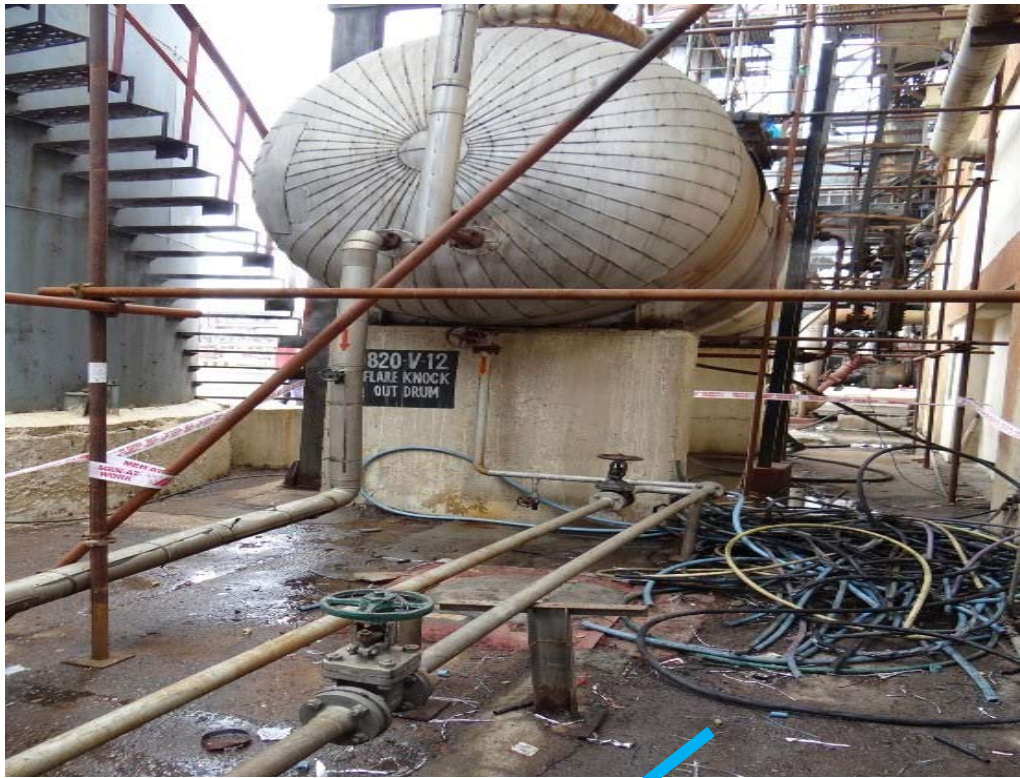
**2" Dia drain Valve** Page 5 of 6

- As per the design provision KOD contents are to be routed to CBD but since lines to CBD for the last many years were defunct, liquid was drained to OWS; an unsafe act and not acceptable as per norms. Currently, provision exists to drain the accumulated liquid only to OWS instead of draining to CBD (Closed Blow Down system) as it is not maintained / defunct.

- At around 10:45 PM, the night shift field operator started draining from the KOD. Draining was kept continued, as liquid was coming continuously. The liquid drained from KOD comprise low boiling lean gas, LPG and unstabilised naphtha component etc., it started evaporating and formed vapour cloud around the area.

1. Liquids from KOD should be routed to the Closed Blowdown system (CBD) as per OISD STD 106 and never to open drain / OWS.
2. Hazop study / MOC should be carried out for all Modification / critical Operations & implement the safety measures to prevent recurrence.

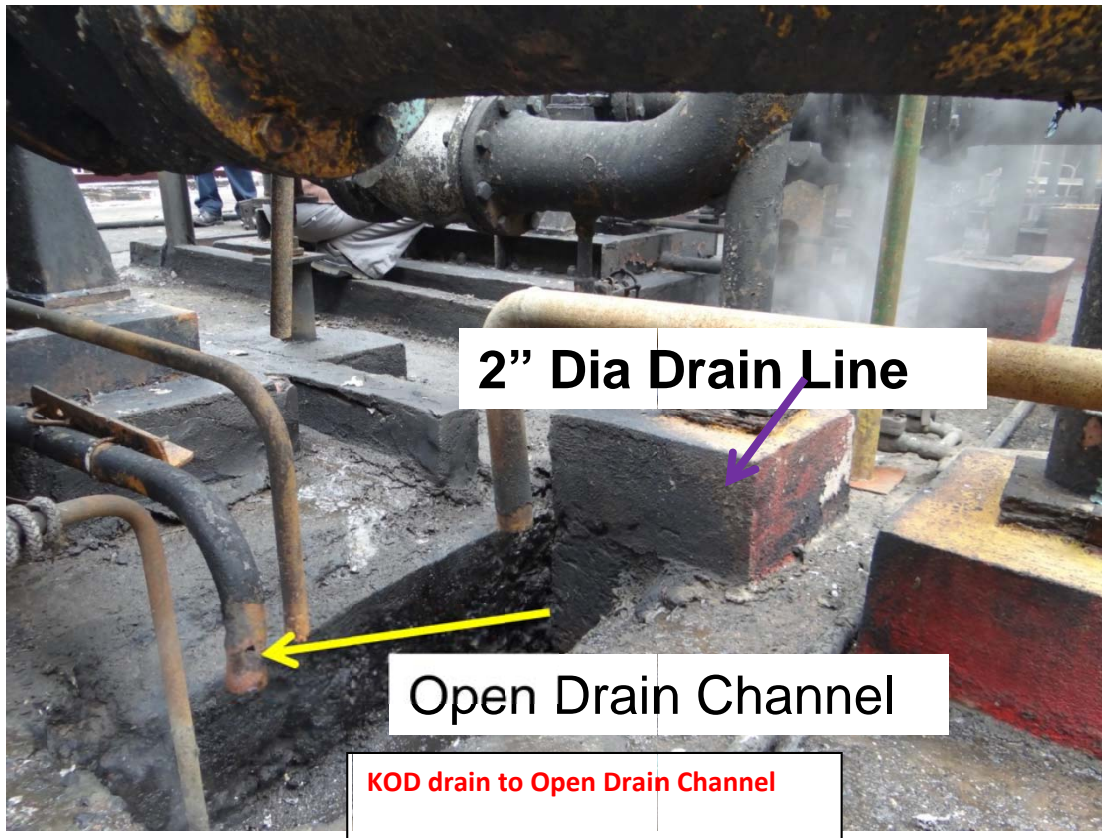
- Draining of low boiling liquid containing LPG and naphtha component in the open drain connected with OWS manhole is the main cause of fire. The vapour cloud which formed from the drained liquid migrated towards the nearby Feed Preheater and caused fire. The liquid collected in the KOD should always be routed to closed blowdown system or slop system and not to open drain.
- The dedicated transfer pump, was having occasional starting problem particularly during change over schedule. The problem of any critical pumps/system should be analysed and corrective action taken promptly to prevent any unexpected failure of the system. In the extant case failure of pump led to high level in HP separator and consequential popping of PSV that led to high level in KOD.

**2" Dia Drain Line**

**Open Drain Channel**

**KOD drain to Open Drain Channel**

5. Immediate restoration of CBD facility must be taken up.
