Investigation report on GGS fire incident

A major fire incident took place at Heater Treater unit of a GGS at around 2120 hrs.

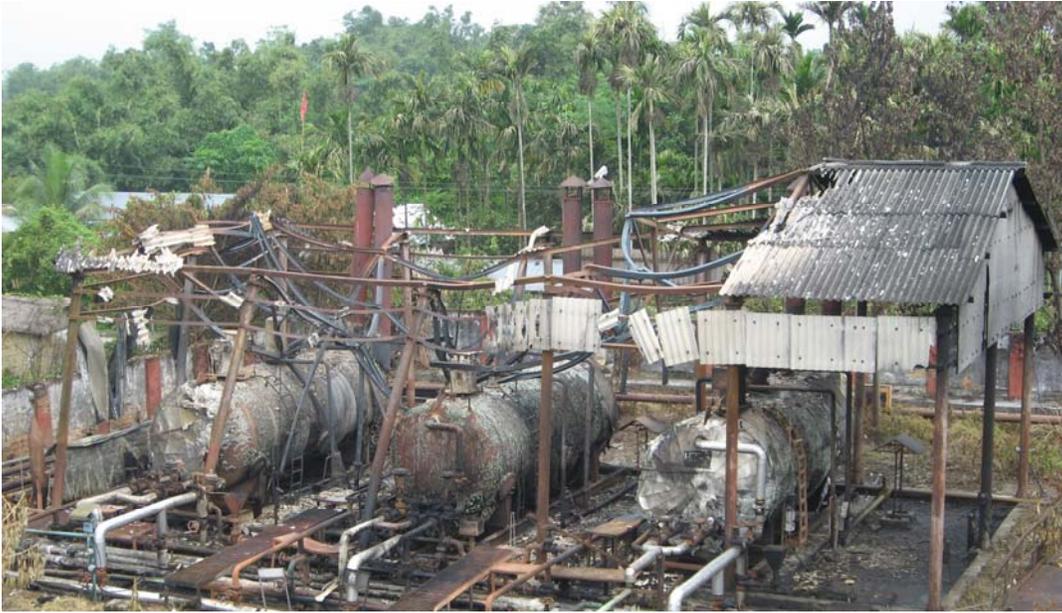
Heater treater Area

- i. Heater treaters are located very close to the boundary wall of the installation. Inter-distance requirement as per OISD-STD-118 is not being met and this was pointed out by OISD audit team which visited

the installation in July, 2010. Also, there was a lot of crude oil spilled in the area

Though the exact source of ignition could not be ascertained, as the area of fire ignition is very close to the boundary wall, the possibility of source of ignition being external (from outside the boundary wall) cannot be ruled out. [Incidentally, based on forensic analysis, concerned state authority have ruled out the use of explosives, as per the information received later on] There was sign of considerable amount of crude oil spillage near the heater treater area which fuelled the fire, and crude oil in storm water channel caused the fire to spread from one corner of GGS to another.

- I. The process equipment should be relocated to safe area, maintaining the inter-distance requirements as per OISD-STD-118 on 'Layouts for Oil and Gas Installations'. Alternately, additional control measures should be put in place, based on quantitative risk assessment.
- II. Engineering and procedural control measures should be taken to avoid the abnormal spillage/leakage of crude oil.
- III. Crude oil in storm water channel is unacceptable. Immediate measures to be taken to stop spillage of crude oil in the storm water channel.
- IV. Housekeeping in the plant need lot of improvement.

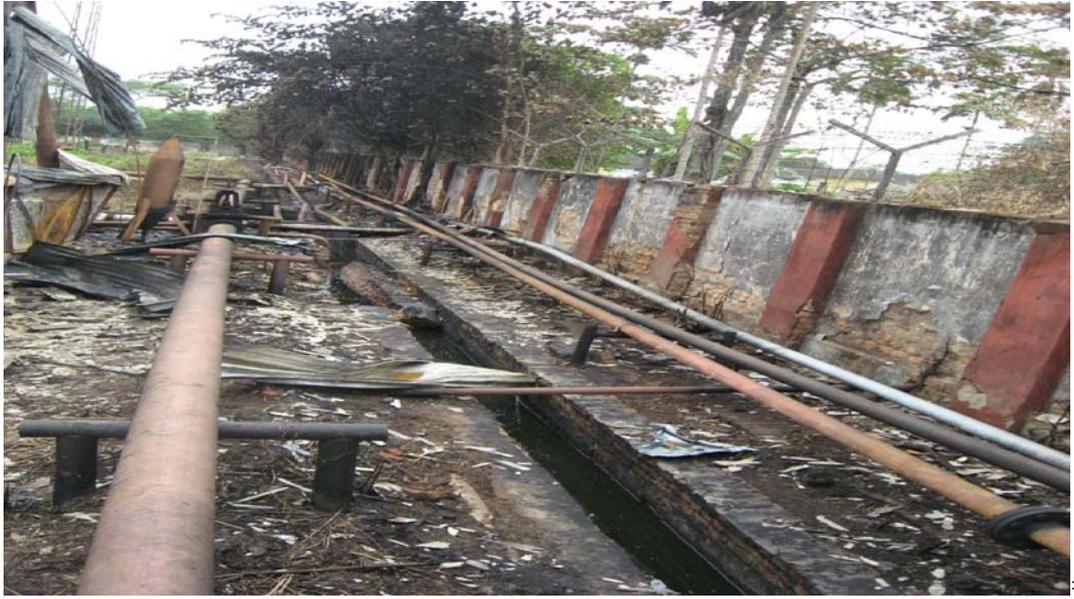
Storm Water Channel

- ii. Storm water channel was full of oil which caused the fire to spread. Audit team had observed the same in July 2010 also and the company had informed in January 2011 that the audit observation has been complied with, and drain channel cleaning is being done at regular interval.
- iii. Plant is more than 30 years old and equipment maintenance was found to be poor during the site visit.
- iv. Housekeeping was very poor with lot of vegetation and crude oil spillage at many places.
