LPG Leakage from bulk TT during unloading

S K Bagchi, AD (Process)
S Majumdar, Dir(MO)

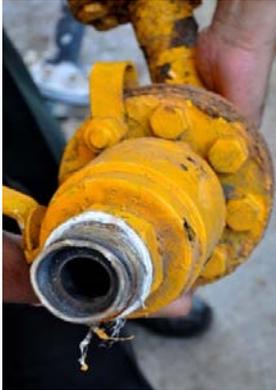
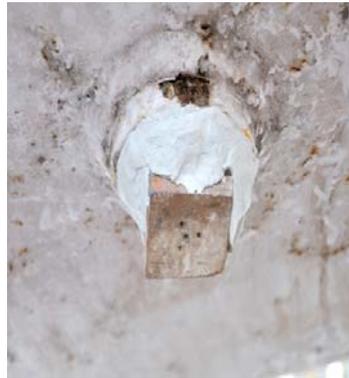
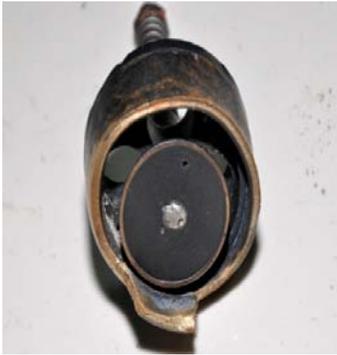
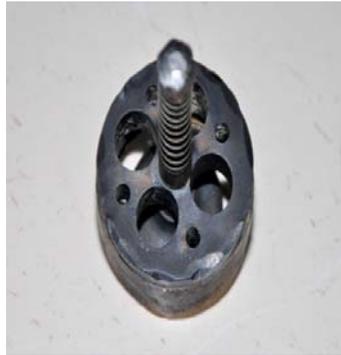
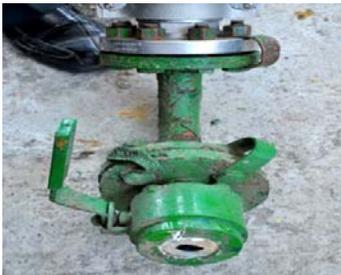
- 7.7 It was observed that the excess flow check valve of liquid line connected to the TT had sheared off from the shell of the Bullet. The broken excess flow check valve along with the 90 deg C elbow pipe, isolation valve and flange of the TT were found to be connected with the unloading arm. This resulted in loss of primary containment. It was further observed that the excess flow check valve of the vapour line of the bullet ruptured at a point where the excess flow check valve is connected to 90 deg elbow pipe. In this case the EFCV remains attached to the TT. Use of brass as MoC for the threaded joint of EFCV with the rest of the components having MS as MoC does not add to structural strength of this vital interconnection.

- 8.1.7 Absence of any break away coupling in the unloading line (in contravention of # 6.3(iii) of OISD STD 144) ensured entire break away thrust of the moving TT on the TT manifold and as a result the weakest links i.e. threaded EFCV housings of brass construction gave away in shear.

- 8.1.8 Due to this failure, the EFCV of the liquid line got completely detached leaving a hole in the bullet (the EFCV of vapour line, however, held on to its housing stopping any vapour leakage in spite of the shear) through which the entire liquid content of the TT leaked to the atmosphere.

Pics showing EFCV condition after shear-off

- 9.7 As per the requirement of OISD STD-144, the unloading arm shall be provided with breakaway couplings (clause no. 6.3iii) which are not the case in this location.

- 9.8 The design of bulk LPG TTs needs to be revisited with respect to material of construction / protection / placement of the excess flow check valve to prevent loss of containment in case of any mechanical damage due to any impact / force on the manifold connections.

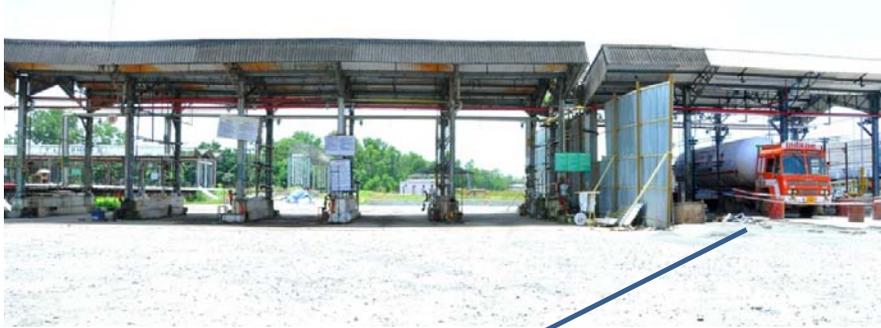
- 8.1.1 The LPG Bulk TT was allowed to be parked in Bay 15 of TLD 1 – which was reportedly not yet operational but still under construction – without any supervisory intervention indicating systemic failure.

- 8.1.2 This was further compounded by absence of physical barrier in this bay. The absence of any such practice is corroborated by absence of any such barrier in any of the four such bays in the plant.

The errant TT in Bay 15 of TLD 1 under construction

- 9.1.2 Facilities yet to be commissioned but under construction must be positively barricaded from inadvertent entry attempts.
 - 9.1.3 Drivers of bulk TTs are not allowed to line up their vehicles with loading / unloading arm at all. This job should be done by OMC workmen under direct supervision of officer responsible for TLD operations.

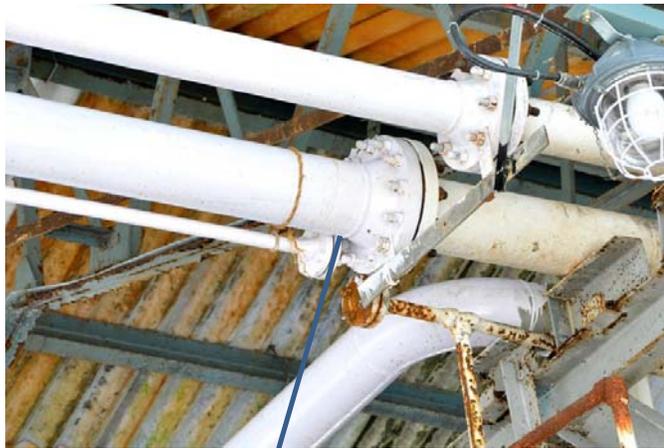
- 7.8 It was observed that the physical construction of additional bays (bay no15 & 16) was complete. It was further observed that the LPG headers were connected to the existing TLD-1 header and were charged with LPG. No physical barriers were set up to pro-actively debarring entry of bulk TT even by mistake. This simple step would have averted this incident.

- 7.10.4 The Liquid LPG header of TLD 1 remaining charged in bay 15 & 16 even when the bays were yet to be commissioned.
- 7.11 The overall upkeep of the facility around the TLD-1 needs improvement in so far as housekeeping, painting, civil maintenance and drainage are concerned. The peripheral drain level with respect to ground level was uneven and the drain was clogged & overflowing. LPG vapour accumulation in TLD 1 was expected to flow through this drain discharging to canal outside the perimeter wall but the drain was not having any vapour seal.

The extended header connected with and charged thru the existing header even before the bay is declared ready for operation

- 9.1.4 Addition of new facilities in an existing plant must also be offered to OISD for PCSA after its due clearance by Internal MDT. Till this clearance, gas-in by any means should not be done and if necessary positively segregated by blinding inter-connecting joints / ends.
