## Explosion at OWS sump near Sour Water Stripper Unit

-**Shashi Vardhan, Additional Director**

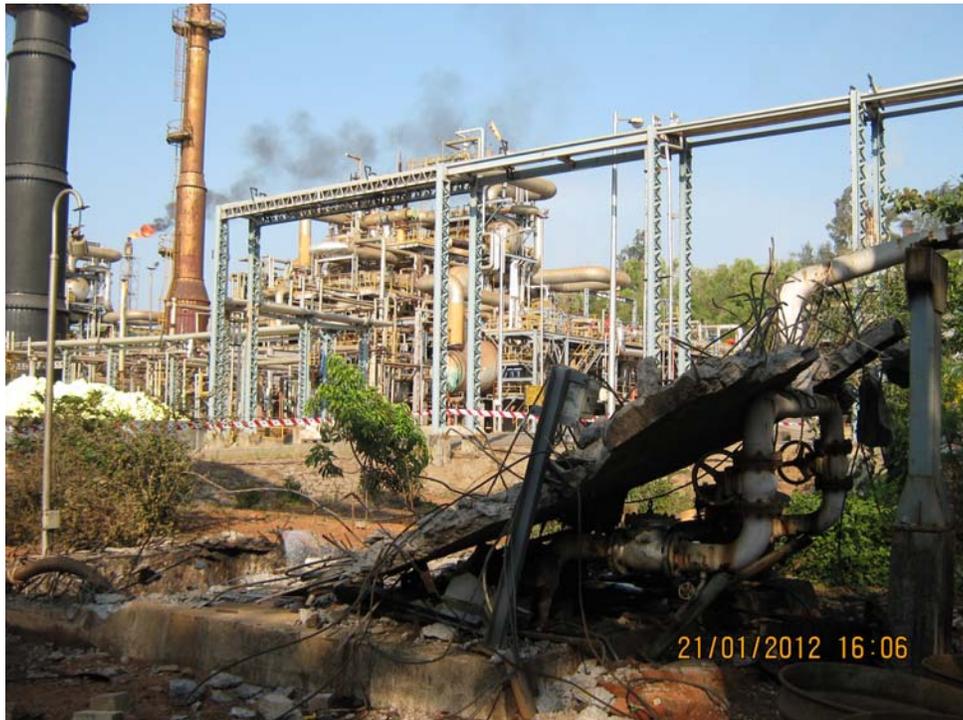
- g) The pump was installed on the support plate and the stitch welding of the old and new plates was completed at three locations (Two in the East side and one on the South Side). The explosion happened when tack weld at the fourth location (west side) was attempted at around 11:15 am.

**Explosion in OWS manhole- the pump foundation totally shattered**

- The liquid content remaining inside the sump is more likely to be either sludge (H<sub>2</sub>S rich or oily) or oil. The ambient temperature was low at the time the gas test was done as it was early morning (7.30 AM). Subsequently, by 11:00 am, when the ambient temperature rose, vapors started emanating from the sludge. These vapors could either be H<sub>2</sub>S gas or hydrocarbon vapors. H<sub>2</sub>S is flammable at 4 % to 43%.

- The explosive mixture inside the pit could be formed with hydrocarbon vapors or H<sub>2</sub>S gas or the combination of these two. Since LEL level was zero at 7.30 AM as mentioned in work permit, it indicates presence of H<sub>2</sub>S gas inside the pit in range of flammable concentration.

- During initial tack welding spark from the welding torch could not have reached inside the pit and when tack welding was attempted on the other side the spark might have made contact with explosive mixture present inside the pit.

- The concentration of Hydrocarbon vapors was less in the morning since the ambient temperature at 7.30 am was low.
- At 11.00 am atmospheric temperature increased; the concentration of HC / H<sub>2</sub>S vapors must have reached LEL level but at that time reading was not taken.
- SRU/SWS unit OWS pit will normally have presence of oil & H<sub>2</sub>S vapors. Since the material received in the pit had presence of H<sub>2</sub>S, the explosive mixture could be formed by H<sub>2</sub>S vapors which was not detected since the test was not carried out. The requirement of carrying out testing for the presence of toxic H<sub>2</sub>S prior to carrying out the hot job was not mentioned in the permit.
- Job safety analysis (JSA) for carrying out the job was not done otherwise it would have clearly indicated the presence of H<sub>2</sub>S.

- The presence of explosive mixture must be measured just before the start of hot job such as welding, cutting etc.
- The measurement of H<sub>2</sub>S must also be taken besides hydrocarbon vapors wherever presence of H<sub>2</sub>S is expected.
- Work permit system needs to be strengthened and permit should be issued for specific job and not for multiple jobs.
- The reference of electrical isolation should be given on hot work permit to ensure electrical isolation of the equipment.
- Job safety analysis should be carried out before taking up any job.

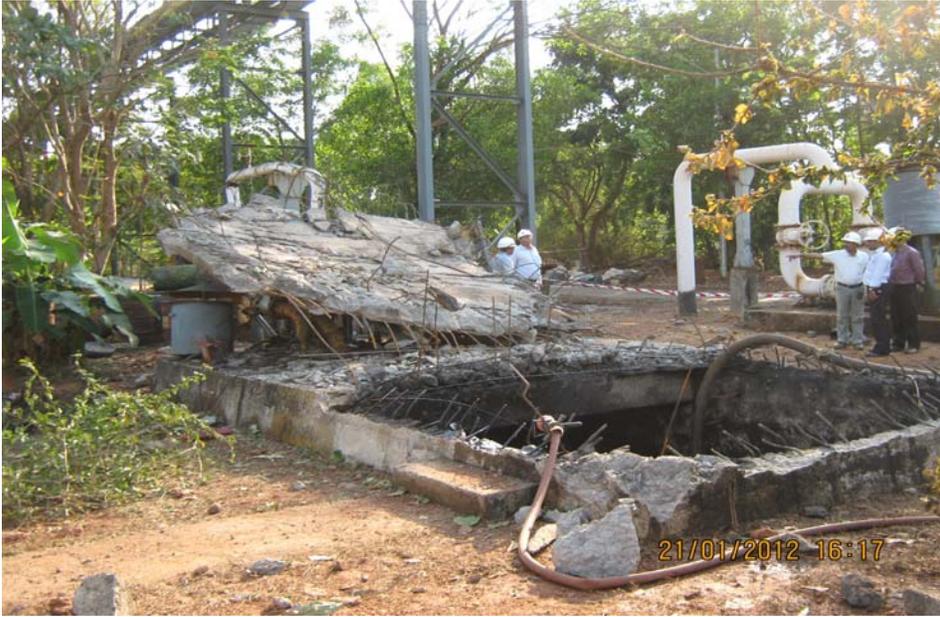
**Explosion in OWS: The manhole cover blown up**
