# CASE STUDY

## Electrocution due to violation of Work Permit System

- R.D. Danny & Parmod Kumar

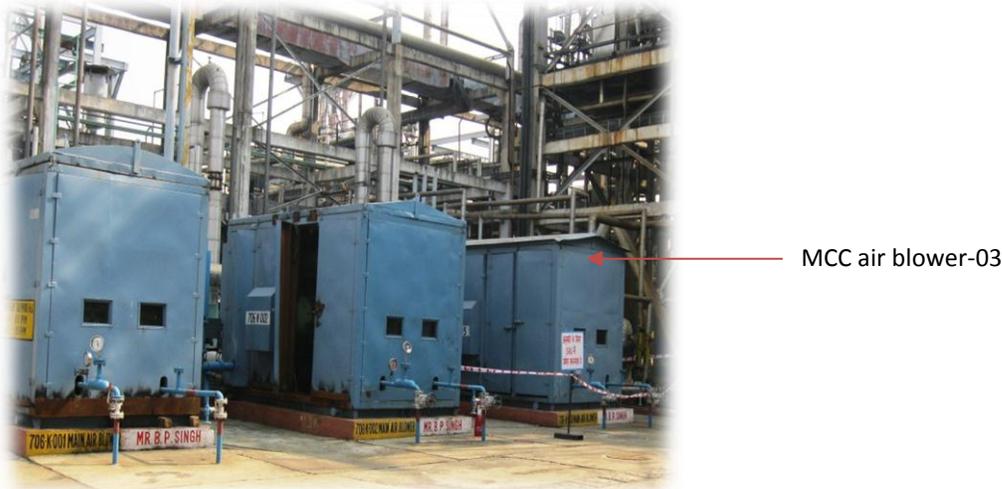
**Fig1: Photograph showing MCC air blower-01/02/03**

Main Combustion Chamber (MCC) air blowers-01/02/03 in SRU supplies air to the main burner to burn as much H<sub>2</sub>S as required to obtain 0.5 - 0.7 vol. % H<sub>2</sub>S at the outlet of the 3rd reactor stage.

On the date of incident at around 01:30 AM, SRU shift engineer observed that MCC air blower-03 was not developing the required flow. Immediately, MCC blower-02 was started & taken in line to meet the process requirement. However, field operator couldn't stop MCC blower-03 from field. SRU shift engineer referred this problem to sub-station electrical operator, who in turn switched 'OFF' the MCC blower-03 breaker from 6.6KV HT switchboard.

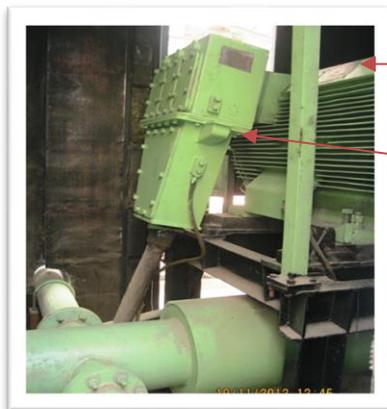
**Fig: MCC air blower -03 HT motor & cable terminal box.**

Electrical testing along with contractor employees reached incident site at around 12:30 PM for diagnostic testing on MCC blower-03. Deceased person approached the MCC blower-03 to note down the name plate details, and got electrocuted after coming in contact with charged power cables.

- MCC blower-03 6.6KV feeder from HT switchgear was tripped on earth fault protection.
- The incident site was found little cramped. It appeared that while noting down the name plate details of MCC blower-03, contractor employee stood on blower discharge pipe & took support of motor terminal box. In the process, he got electrocuted after touching the exposed power cable accidentally charged to 6.6KV voltage.

Motor name plate located adjacent to cable terminal box.

Motor cable terminal box - open at the time of Incident.

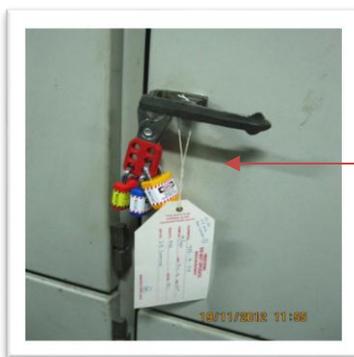
**Fig: MCC air blower-03 breaker in 6.6KV HT switchboard**

that while doing so they accidentally 'Closed' the MCC blower-03 motor breaker from sub-station. With breaker closing, the power cable of MCC blower-03 got charged to 6.6 KV upto the motor terminal box.

- From the incident it was clear that when Electrical maintenance disconnected the power cables of MCC blower-03, the 6.6KV breaker at sub-station end was still in 'OFF' condition otherwise he would have been first to get electrical shock. It is only while attending the field TNC (Trip-Neutral-Close) switch that the breaker switched 'ON' from sub-station, and power cable got charged up to the motor terminal box. This possibly happened while E/M was tightening the control wirings & shorted the TNC 'close' contact, or while checking the freeness of TNC switch & moving it towards 'close' position.

LOTO activity started after the incident

5. LOTO (lock out tag out) must be implemented wherein production & maintenance groups shall provide individual locking & tagging to ensure avoiding untoward incident & exercise control over the hazardous situations.
