CASE STUDY- CRUDE OIL PIPELINE FAILURE

INTRODUCTION:

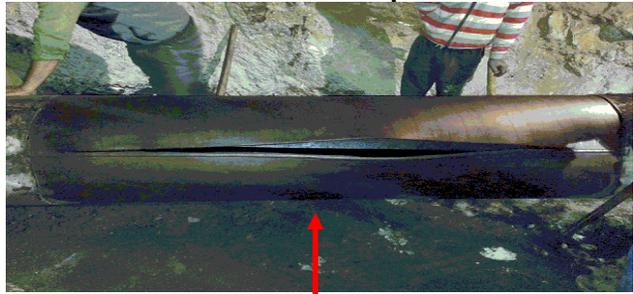
<p>(i) Crude oil sprayed due to rupture of pipeline. The leak position was at about 10' O clock position at HAZ of pipe seam. The pipe is LSAW, API 5L-X-65 grade coating is 3 LPE coating.</p>	<p style="text-align: center;">Leak at 10'O clock position</p>

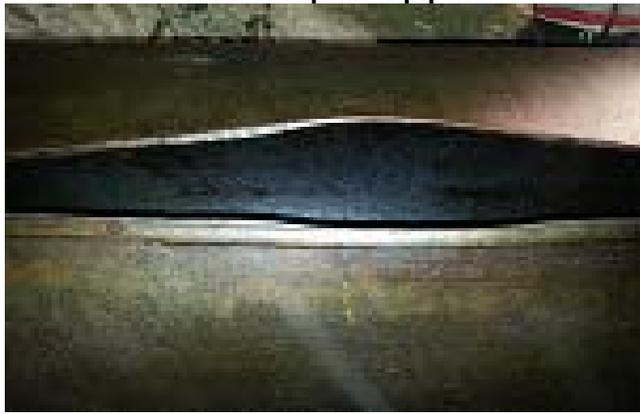
<p>(i) Dimensions of pipe rupture are L= 1525 mm and maximum opening in the middle of rupture is 100 mm.</p> <p>(ii) The failure initiated from HAZ (Heat Affected Zone) near the weld seam and extended parallel to the seam and finally took a fish-mouth opening shape.</p> <p>(iii) Bulging was observed at the ruptured location.</p>	<p style="text-align: center;">View of ruptured pipe</p>

- (3) During visual observation of the pipeline at rupture location, it was observed that the failure had initiated from HAZ (Heat Affected Zone) near the weld seam and extended parallel to the seam and finally took a fish-mouth opening shape. The pattern of present failure is same to the earlier three failures. It indicates that the reason of failure may be similar.

- (4) Repetitive failure of the pipe of similar nature at weld seam establishes that there might be some inherent problem of the pipe related to welding quality at the manufacturing stage and might have been grown during subsequent operations mainly due to cyclic loading in stressed condition.

- (1) Some inherent problem of the pipe related to weld seam at the manufacturing stage and might have been grown during subsequent operations mainly due to cyclic loading.
- (2) Corrosion or other failure mechanism of the pipe due to change of service from product to crude oil.
- (3) A combination of the above.

- (2) Repetitive failure of pipe at weld seam in some of the sections indicates that the health condition of the pipeline is not reliable for sustained and safe operation and calls for replacement of the pipes of the affected sections to avoid recurrence.

- (3) Alternatively, these sections of the pipeline need to be pressure tested at 1.25 times the maximum operating pressure. Test shall be held for 24 hours as per OISD-STD-141 (clause 17.5 b) to assess integrity of pipeline in line with our earlier recommendation of incident report.

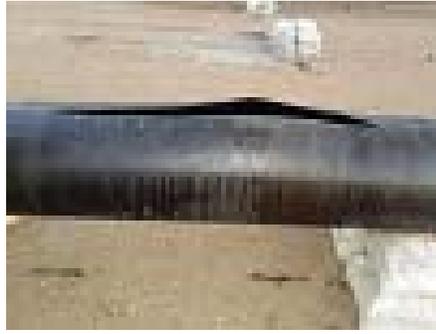
Ruptured pipe removed from M/L

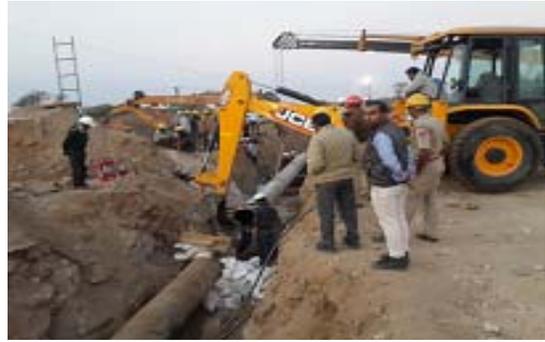
View of pipeline repairing job
