**Underground Blowout Control  
at Well NHK# 285  
OIL, Assam.**

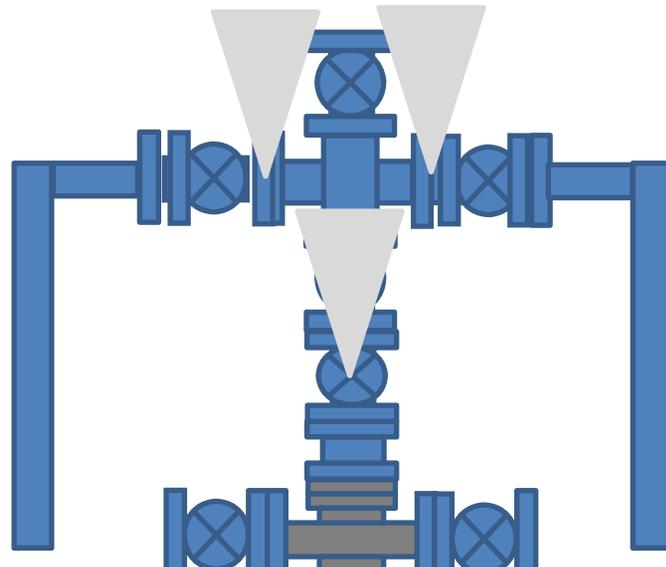
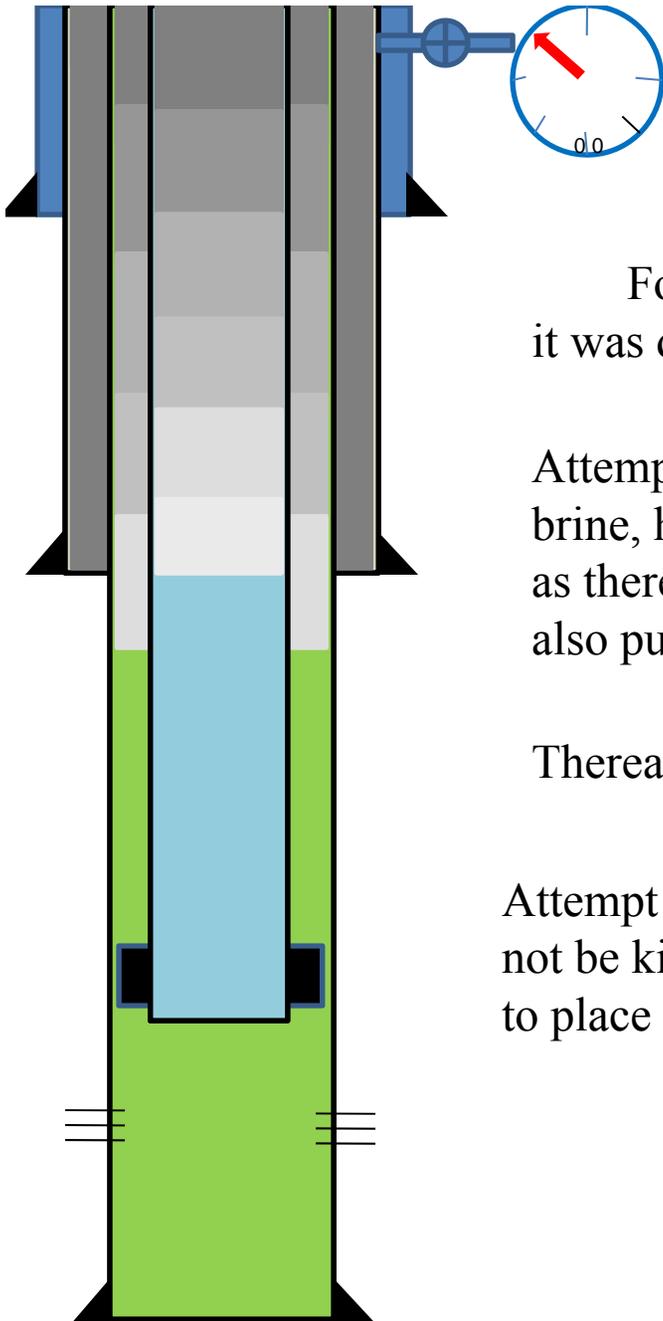
On 14<sup>th</sup> July, 2011 at around 1 A.M, it was reported about a high intensity sound from the well NHK 285.

It was found that there was leakage from the wellhead fittings above the master valve. Subsequently the master valve of the wellhead was closed.

Following the gas leakage at several places of the wellhead it was decided to kill the well and repair the wellhead.

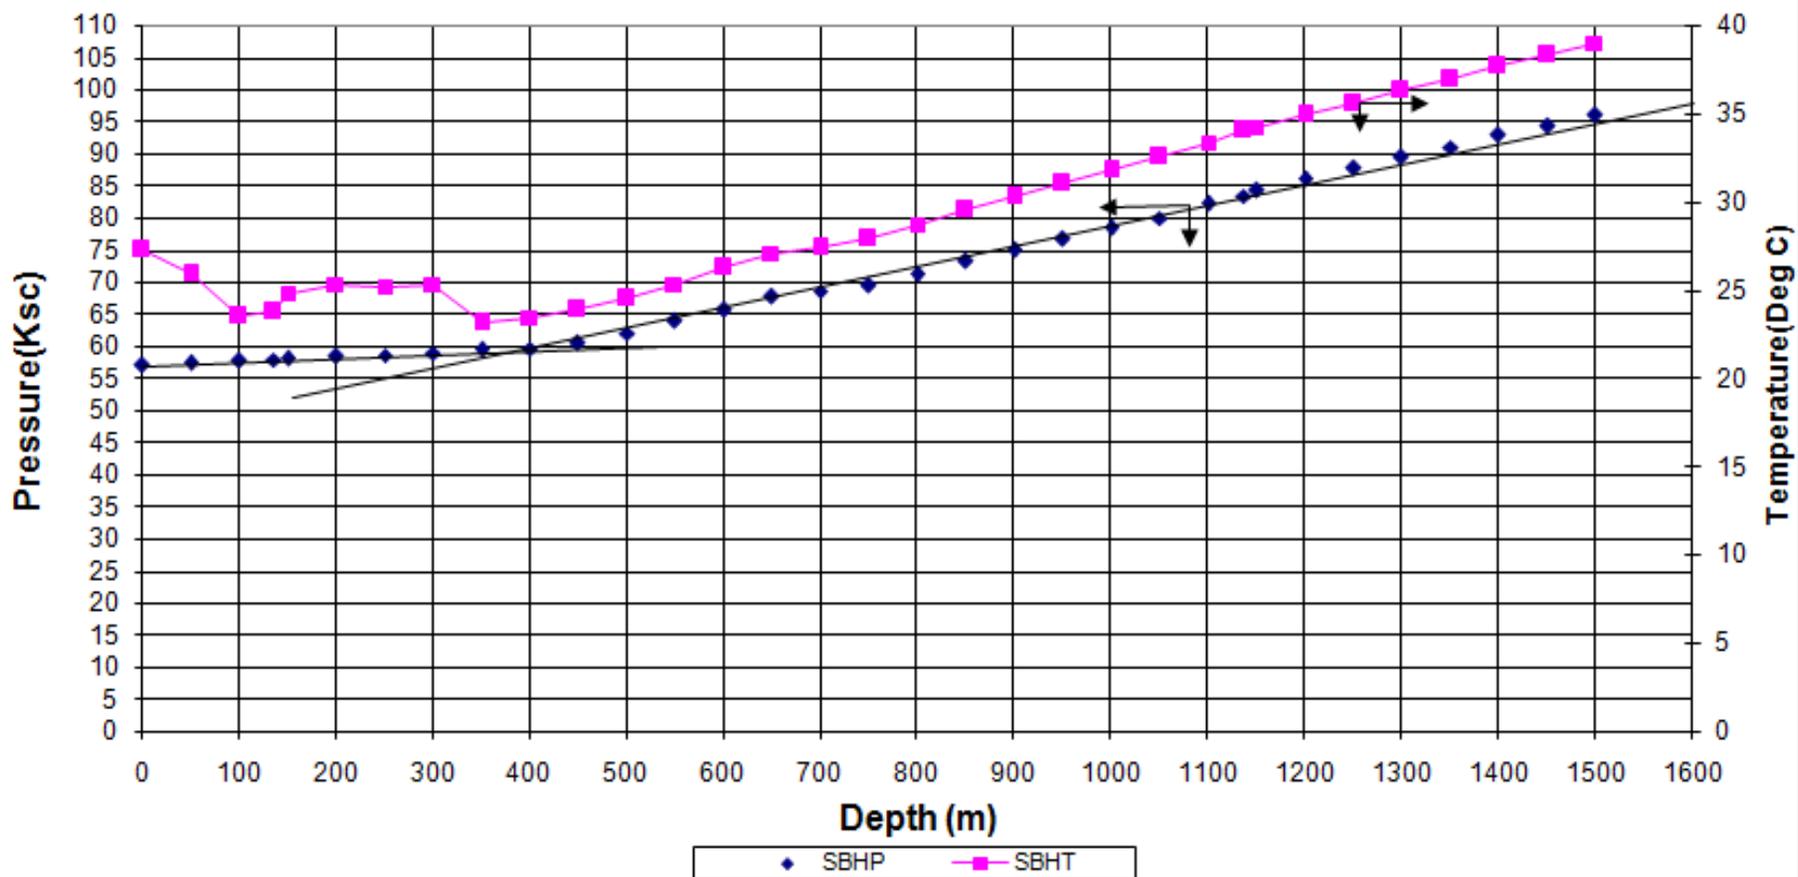
Depth vs SBHP & SBHT (NHK #285) Recorded on 12.01.2012

Thereafter, lowered BHP tool with slick line which got held-up at 1513m. Took BHP & Temperature measurement survey from 1500m upward and the results indicates that there is outward flow from the well at depth @ 400m.

The BHP survey and logs indicate that there is outflow from the well at around 400m.

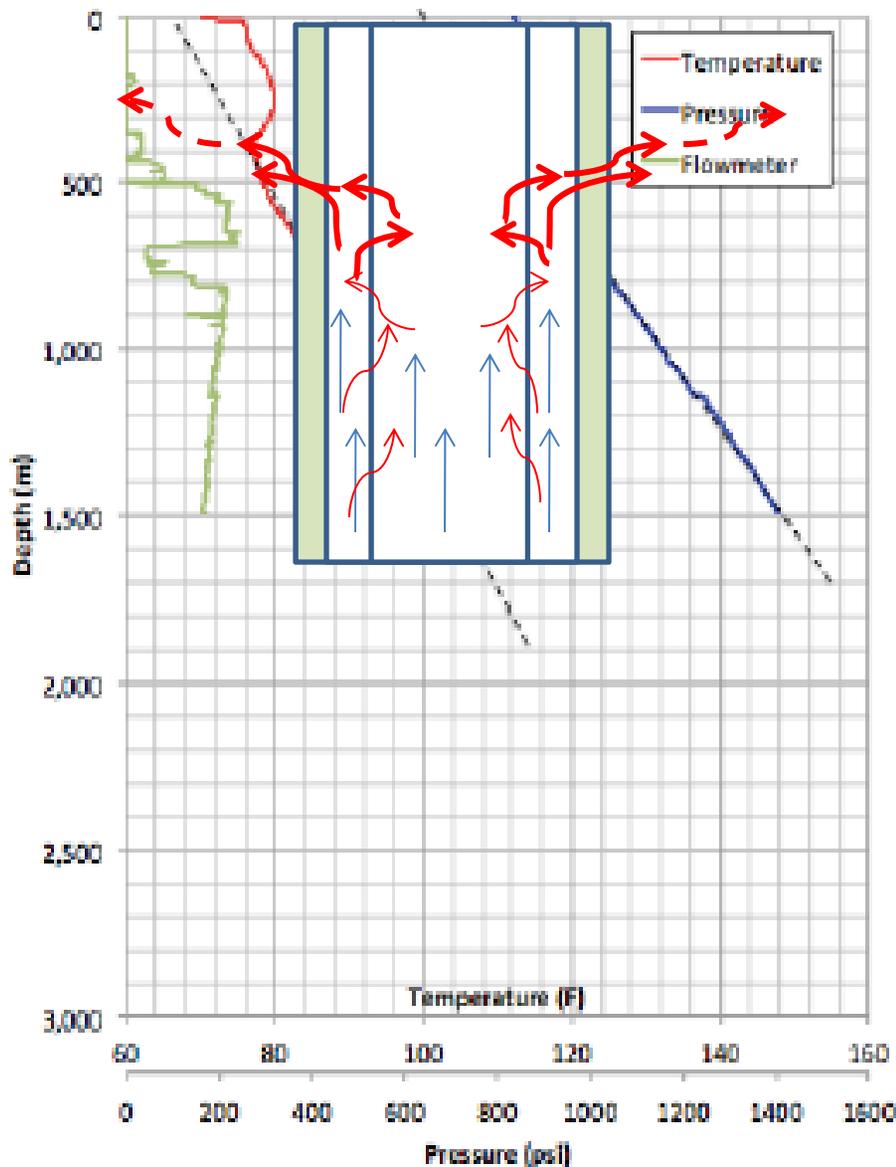
**Temperature Log  
NHK 285 06Jan2012**

After getting anomalies in bottom hole pressure and temperature from BHP survey, a temperature log was recorded to reconfirm the results from a depth of 1500m (as logging tool could not be lowered beyond this point). Spinner log was also recorded along with temperature log.

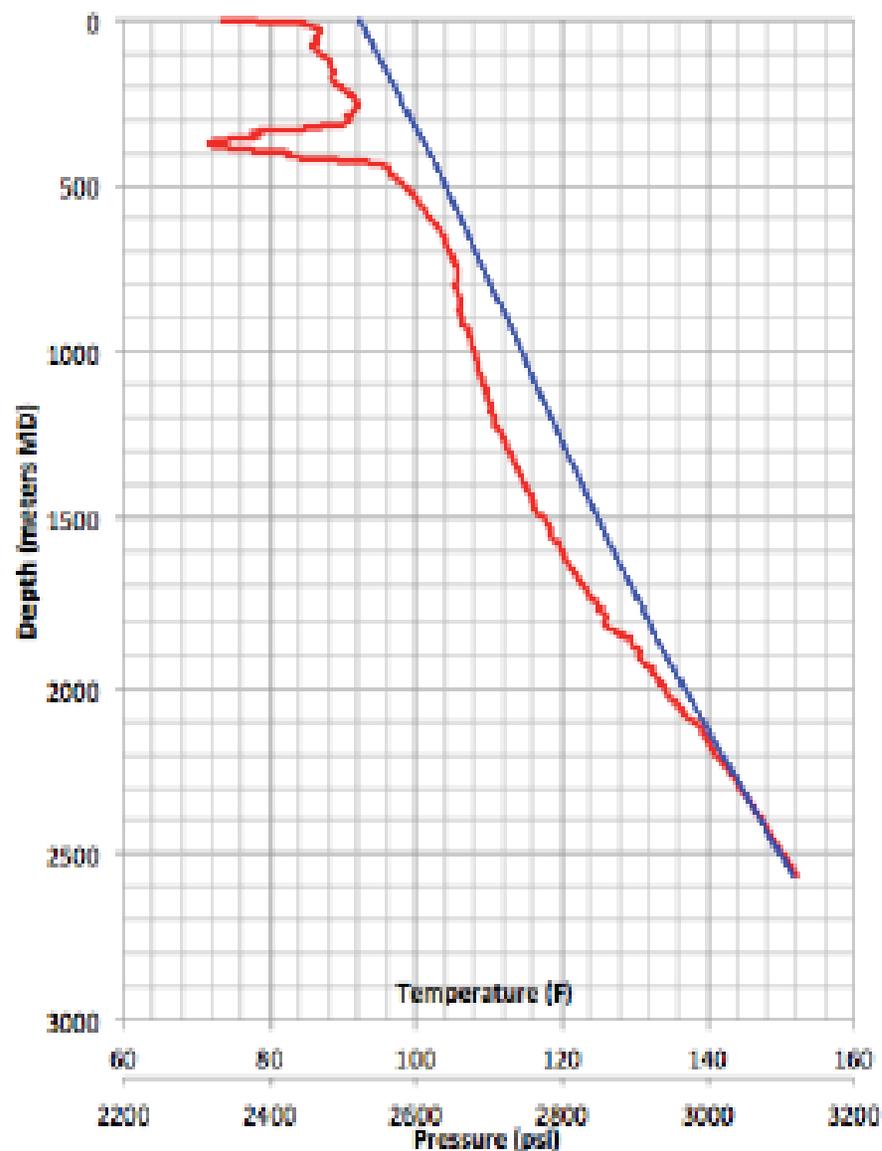
**NHK 558 Temp Log  
19Jan2012**

Another temperature log was taken at the adjacent well NHK#558 from the reservoir depth for comparison. Next Fig. shows the summarized logs at well NHK#285 and NHK#558.

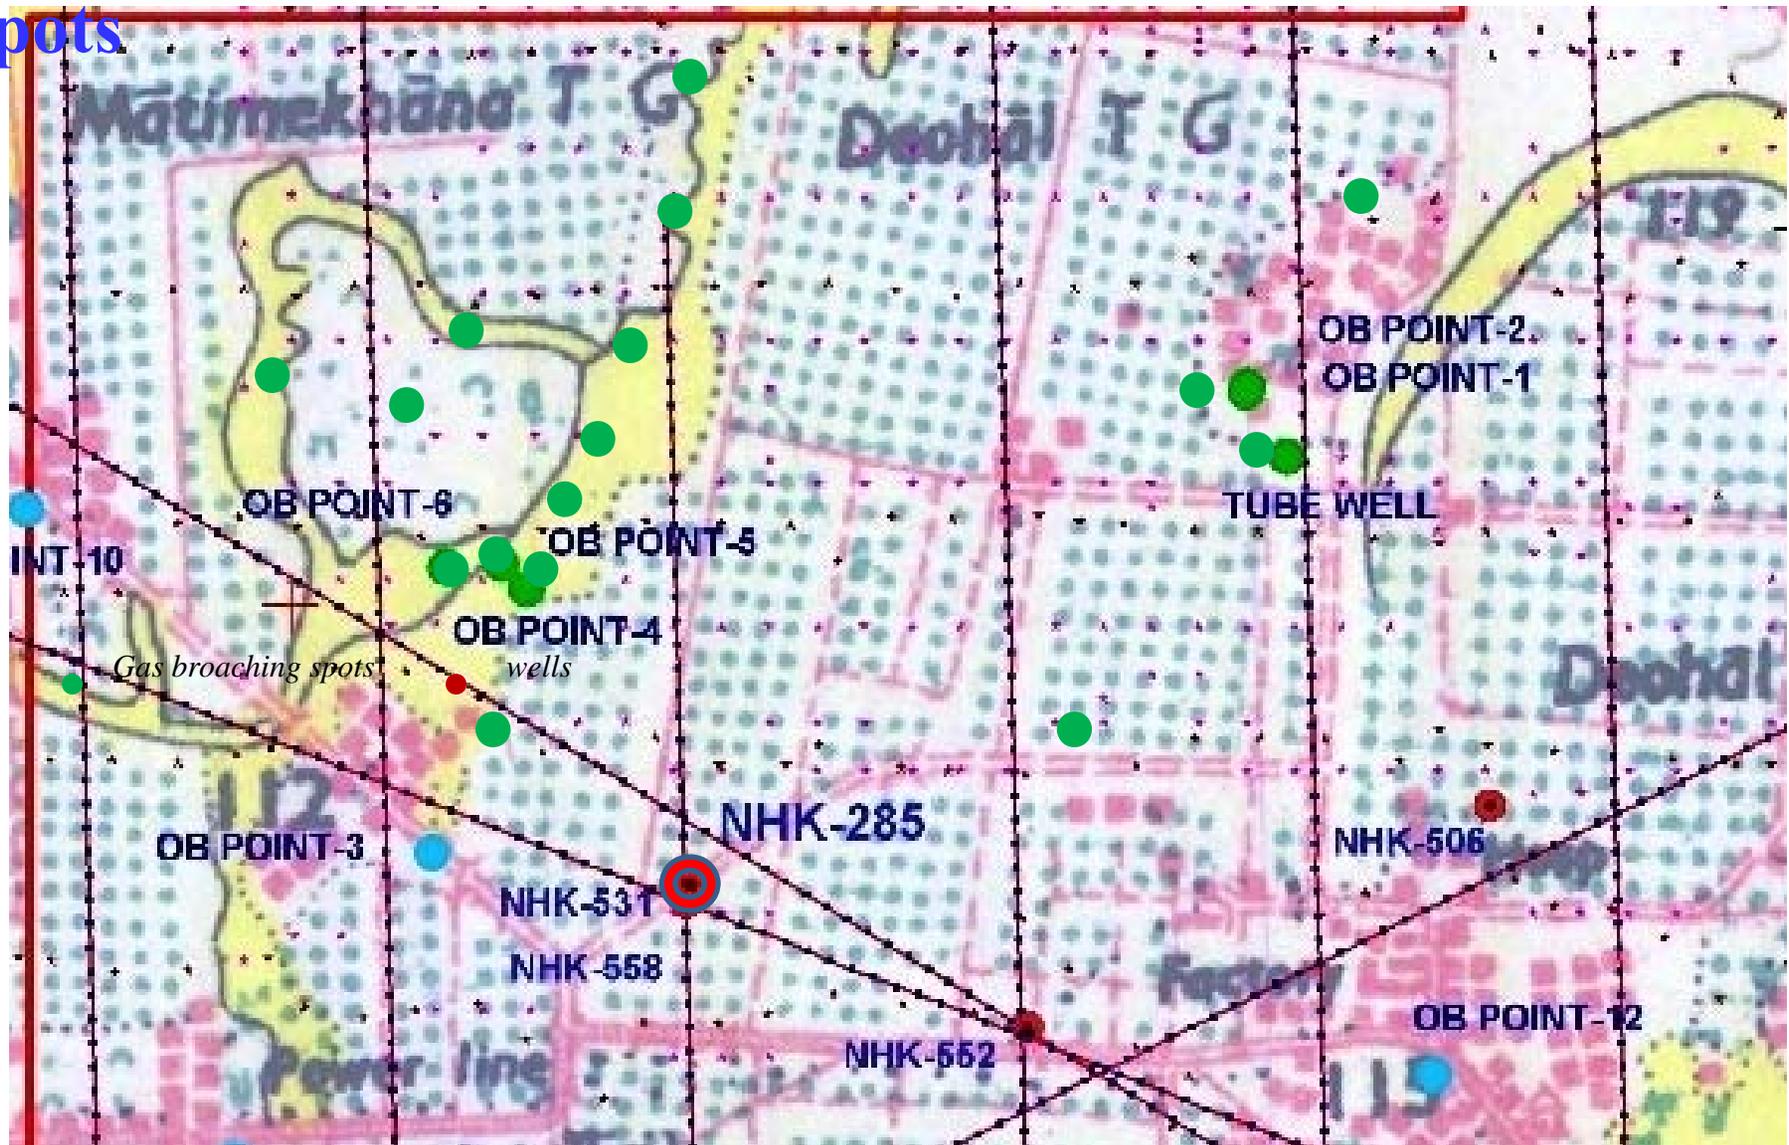
# 5 : Map showing wells and gas broaching spots

During the 2<sup>nd</sup> week of December, 2011, surface broaching of gas at around 1.5 km away from the well NHK#285 in N-E direction was reported and there was a fire incident in night hours on 31<sup>st</sup> Dec, 2011.

Subsequently, in the first week of January, 2012, surface broaching of gas was noticed at an area about 1 km away from the well in N-W direction .

Gas sample was collected from these spots and it was found to be of similar composition as of NHK#285 gases.

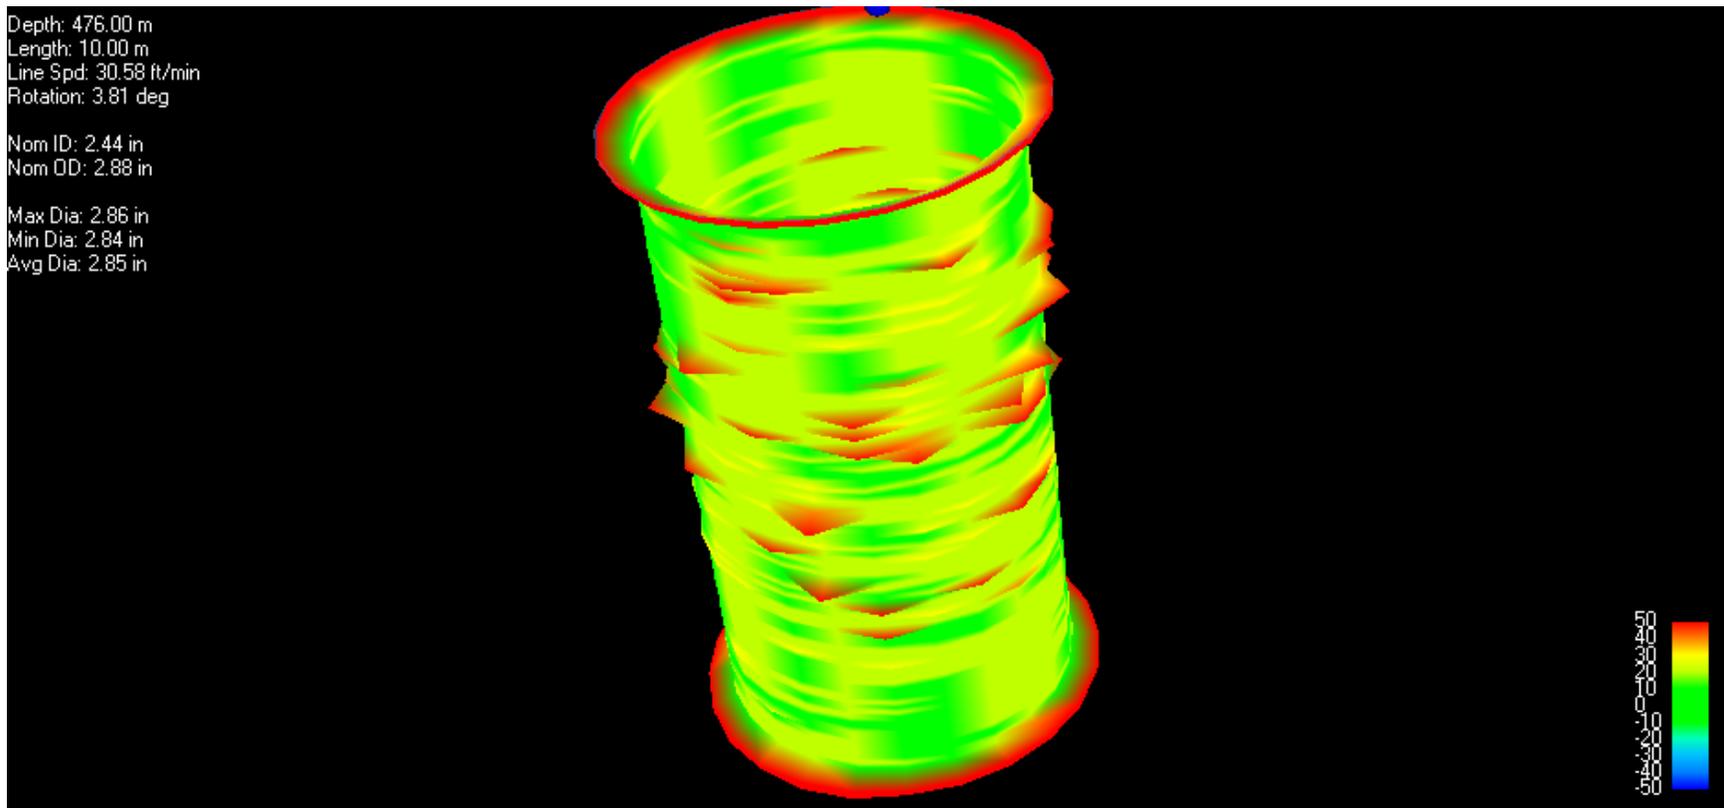
While working on M/s Boots & Coots HWO (Hydraulic Workover Operation) proposal, a tubing inspection log was recorded using “Multifinger Imaging Tool” from 19.01m to 1513.26m (Logging tool could not be lowered beyond this depth) and it indicate that there are possible holes in 19 numbers of tubing at various depths. Fig. shows the 3D view of 49<sup>th</sup> joint.

*(Red spots indicates total metal loss, Yellow indicates partial metal loss & Green indicates no metal loss)*
