SAFETY ALERT

INCIDENT: An accident occurred while lifting of ID fan bearing housing blocks along with wooden packing box (Size:1.1M x 0.7M x 0.6M and gross wt. 252 kg) by using a 100 MT crane from a distance of 40 M to a concrete platform. The lifting was done by putting wire sling & D-shackles in the two eye bolts fixed in the bearing block. Suddenly the wooden box fell down (leaving the bearing block on the crane hook) and hit one worker involved in the job at ground. He succumbed to injuries after 4 hrs.

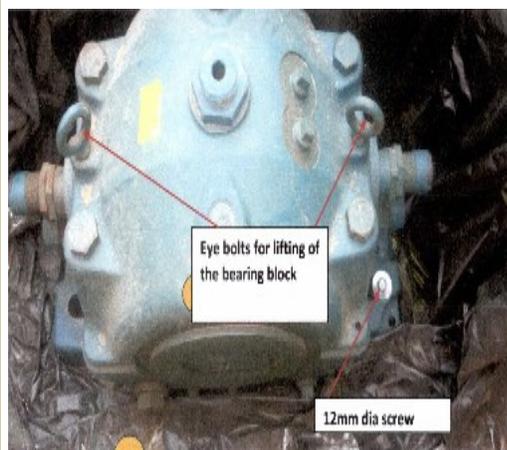
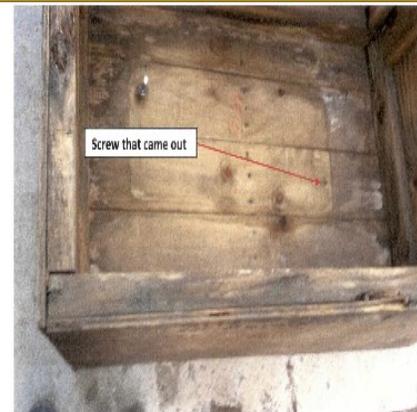
OBSERVATIONS: The supervisor was giving direction from the top of ID fan platform to rigger and the rigger in turn standing on the ground was giving signal to the crane operator. The load while swinging at about 13 M height, collided with overhead structure member. One number of 12mm dia. screw provided on foundation hole of bearing block pedestal got dislodged resulting in tilting of the wooden box. Then the box was further lifted to get proper height for clear passage to swing the load as desired. After swinging, the load was lowered down by the crane operator. At that instant, the box got detached and fell down and hit the victim (i.e. supervisor on the platform) .

ROOT CAUSE: The accident happened due to deployment of inexperienced rigger, supervisor along with use of damaged, improper lifting tools & tackles.

RECOMMENDATIONS: a) Laid down SOP should be strictly followed for all critical jobs involving hanging, lifting / lowering of loads. b) Proper tools-tackles and machinery should be used. c) Job execution to be initiated only after proper planning and Job Safety Analysis. d) Required number of skilled and experienced riggers should be engaged for lifting of loads by crane. e) Before undertaking job of lifting material by crane, critical area beneath and operating area of the crane boom to be adequately assessed and man movement should be strictly prohibited there by adequate barricading and alert messages.
