SAFETY ALERT

(June, 2019)

INCIDENT: Draining of Flare KOD of a process unit to open channel led to a major fire incident in a Refinery. In the beginning of night shift, the shift operator went for field round. One operator started draining flare Knock Out Drum (KOD). After 10 to 15-minutes time, suddenly fire erupted around the draining location, which immediately engulfed the entire area. The unit was shut down and fire was extinguished within 15 minutes. One employee received severe burn injury and succumbed to injury after 9 days.

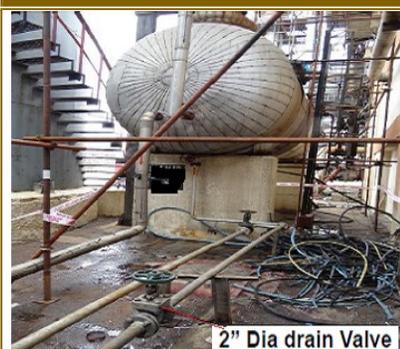
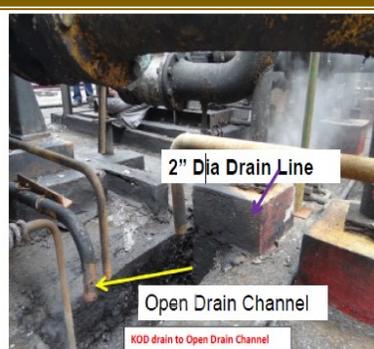
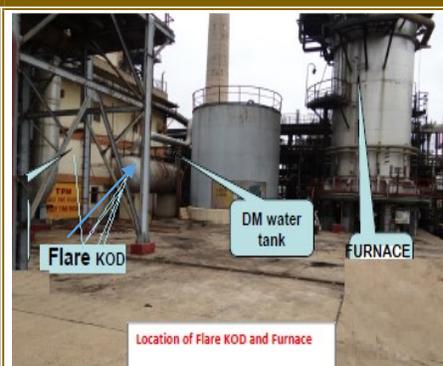
OBSERVATIONS: (1) The unit start-up was in progress since a day prior to the incident date and the unit was under stabilization. (2) Unit flare KOD vessel was drained at the start of morning & evening shifts. (3) After the incident, flare KOD drain line root valve & 2nd isolating valve were found in open condition which suggested that draining was under progress at the time of eruption of fire. (4) The liquid drained from KOD comprising of low boiling lean gas condensate, LPG, un-stabilised Naphtha component etc. started evaporating and formed vapour cloud around the area. (5) As per the design provision, KOD drain is to be routed to Closed Blow Down (CBD); But since the line to CBD was defunct, liquid was being drained to Oily Water Sewer (OWS). (6) The distance between the unit furnace and location of the flare KOD / drain nozzle was less than OISD norm of 15 meter.

ROOT CAUSE: Draining of low boiling liquid containing LPG and Naphtha component in the OWS was the main cause of fire. The vapour cloud which formed from the drained liquid migrated towards the nearby furnace and caused fire.

Closed Blow Down (CBD) system **was defunct since last six months** and liquid was drained to Oily Water Sewer(OWS) .

RECOMMENDATIONS: (1) Immediate restoration of CBD system should be ensured. (2) Liquids from KOD should be routed to the CBD as per OISD-STD-106 and never to open drain / OWS. (3) The field operator must ensure that the drain valve is fully closed after any manual draining operation. (4) The present OWS manholes near the furnace should be immediately sealed.
