## SAFETY ALERT

**The Incident:** While cutting spool piece of Cooling Water Supply line of an exchanger for replacing the clamped leaking portion, pipe line along with two valves (12",150#) got tilted suddenly and gear box handle of one of the valves presumably hit a worker (grinder) who was standing near the valve. He lost his balance and fell on the adjacent line and sustained head injury. He later succumbed to his injuries.

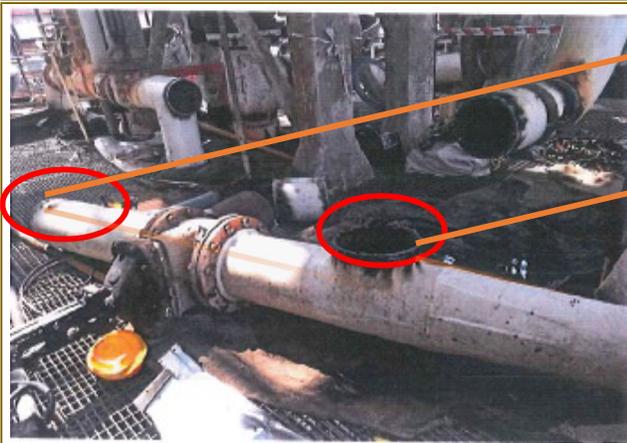
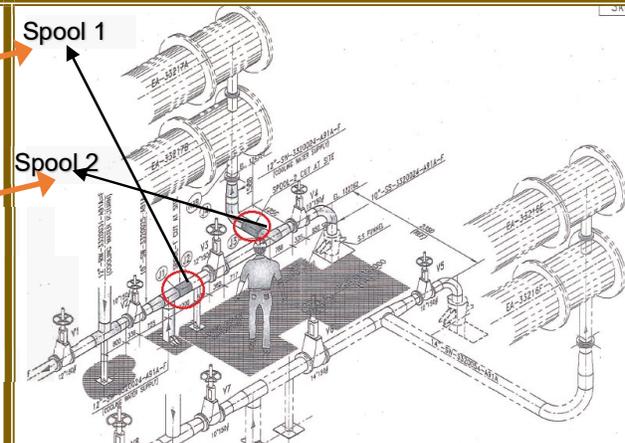
**Observations:** (1) Spool piece-1 was cut one day before and face preparation job was under progress.

(2) Before cutting spool piece-2, a polypropylene rope of 12 mm dia. was tied to the main line to avoid flinging. Other end of rope was tied to the existing scaffolding pipe.

(3) As the spool piece-2 was gas cut to about 90% of the dia., the pipeline (weighing approx. one MT) got accidentally tilted.

(4) This imbalance of pipe tilting resulted in disconnection of rope from the scaffolding pipe and caused sudden shearing of the balance 10% pipe cross section, leading to tilting/ rotation of about 3 meters long pipe section (12" Dia.) along with two valves.

**Cause(s) of Incident:** (1) No proper rigging plan (2) Improper supervision (3) Simultaneous operations without proper risk assessment (4) Lack of knowledge of Job

**Recommendations:** (1) Job Plan including Rigging Plan should be reviewed by experienced person w.r.t. risk involved. (2) In case of simultaneous jobs at one location, proper risk assessment should be done and it is to be ensured that all the workers at that location know the possible risks of nearby ongoing jobs. (3) Proper supervision should be ensured.

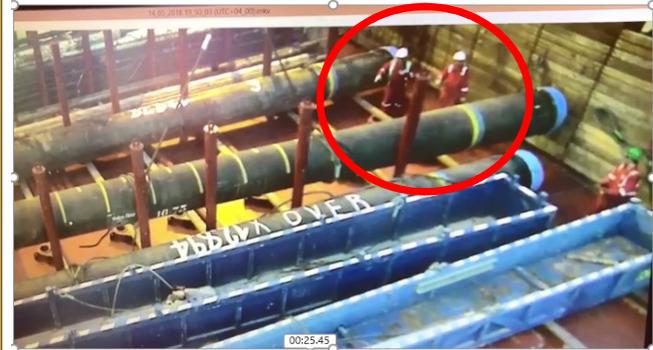
## Check, are you working in the line of fire

What happened to those two workers (encircled)? Are they standing in the line of fire?
