## SAFETY ALERT-COMPRESSOR SAFETY

**INCIDENT:** Continuous Catalytic Reforming (CCR) unit was in steady operation. Around 14:13 hrs, huge dust cloud followed by fire was observed at CCR compressor shed at the CCR Net Gas Compressor. The fire was put off. The unit was shut down in view of the incident.

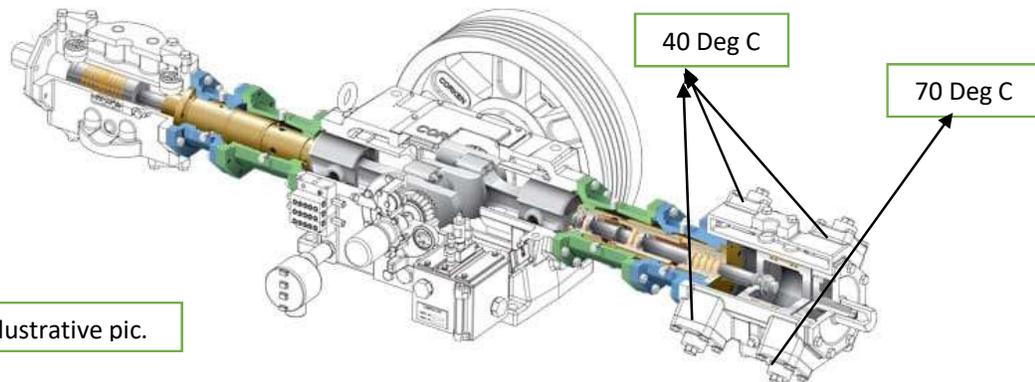
**OBSERVATIONS:** (1) The net gas compressor comprises of two stage compression and knock out arrangement for each stage. Each stage has two cylinders and each cylinder is equipped with 4 suction & discharge loader valves along with one clearance pocket. (2) Abnormal noise at the 1st stage suction, Cylinder 2 area was observed during the routine field round. (3) Temperature of one of the loader valves was observed to be high at 70 Deg. C (others at 40 Deg. C) (4) Unit load decreased and accordingly compressor loading reduced by 6% but no change in loader valve temperature was observed. (5) It was decided to changeover the compressor. (6) Before the changeover process could be initiated, a huge dust cloud followed by fire was observed at running CCR compressor. After the fire fighting activity was started, isolation of the compressor valves was carried out.

- 1) The ejection of the north east valve assembly of Cylinder 2 of compressor is due to mechanical failure of studs.
- 2) The ejection of the valve assembly resulted in discharge of hydrogen rich gas to atmosphere and subsequent ignition of the same. The possibility of a potential ignition source by spark generation due to metal to metal surface contact during valve ejection exists.
- 3) The failure mechanism of the studs is of fatigue type due to possible loosening of bolts during operation.
- 4) The loosening of the valve during the service may be due to the following reasons or as combination as indicated by the OEM:

- a) Incorrect and/ or inconsistent torque settings
- b) Applying non-recommended anti-seize compound on thread of studs and on nuts will reduce friction factor greatly. This makes nuts in dynamically loaded applications prone for loosening (this also increases risk of fatigue failure)
- c) Non-recommended gaskets (aluminium gasket) may have resulted in gasket being compressed too much. This will result in loss of pretension of the valve cover studs, increasing the risk of fatigue failure.

- 1) The best engineering practices as per OEM for applying torque to be complied for the compressor.
- 2) Anti-seize compounds are not to be used for the Net Gas compressors as per OEMs recommendation.
- 3) Usage of OEM recommended valve gasket to be ensured.
