SAFETY ALERT

OISD/SA/2020-21/P&E/02

Title: **Fatal fire incident during blind removal**

Location: **Refinery**

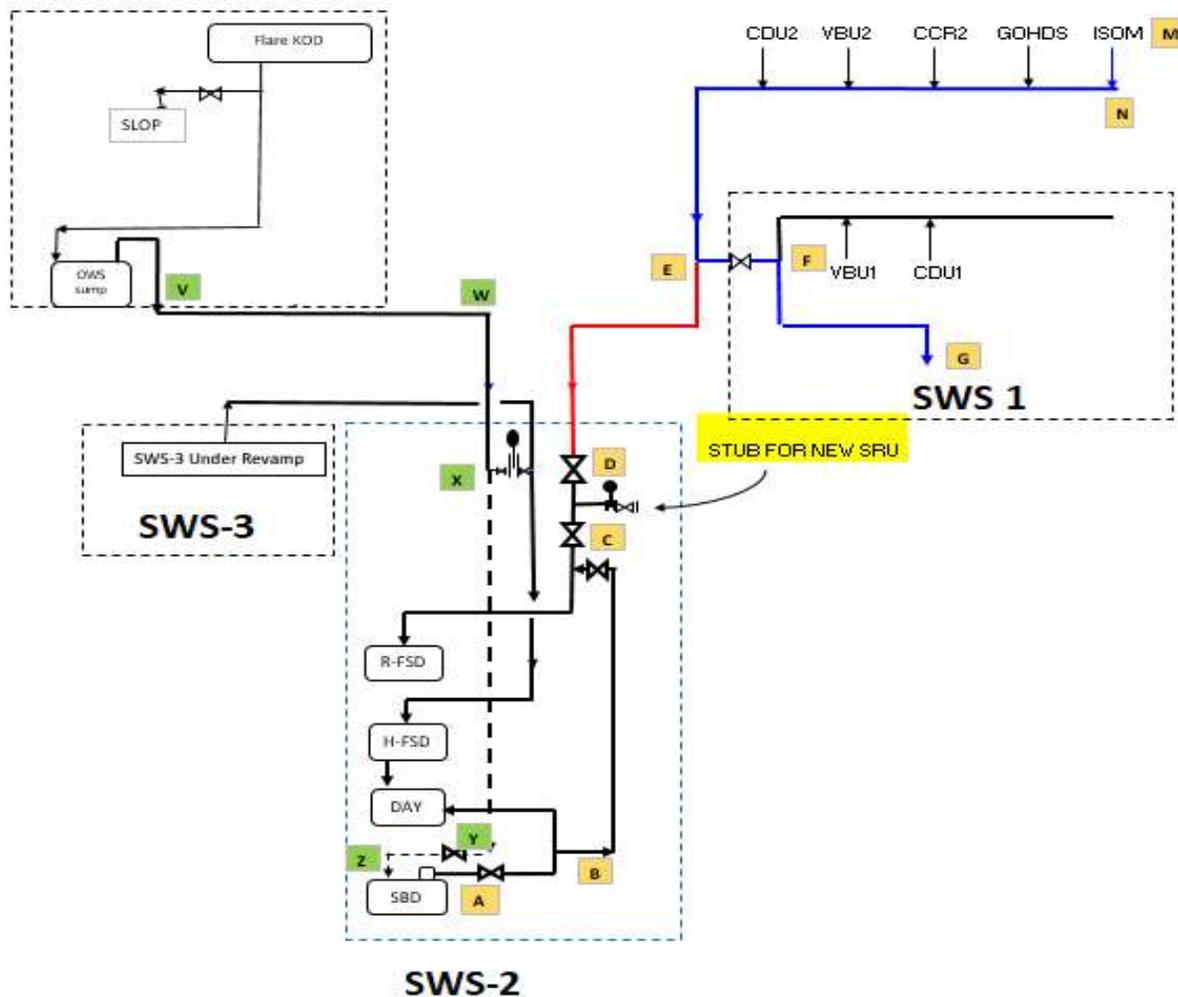
(Refer attached PFD for clarification of following point)

- As flare OWS linked SWS-3 was under revamp, a temporary hook up (circuit X-Y-Z) was made from battery limit of SWS-3 to Sour Water Blow Down sump (SBD) of SWS-1, through which flare OWS was received in SWS-1 (Via circuit V-W-X-Y-Z) and then routed to SWS-2 via an interconnection line (Via Circuit A-B-C-D-E-F-G).

- ISOM unit was started just one day after the flare start-up and trend showed unit disturbance and liquid (containing HC) carry over to flare KOD during start-up. This reached SWS-2 via SWS-1 (via circuit V-W-X-Y-Z-A-B-C-D-E-F-G).

- Sour Blow down (SBD) content was fully discharged to running SWS unit (SWS -2) just hours before the incident (via the routing A-B-C-D-E-F-G mentioned above). In the process, line content of the long pipe section 'D-E' also got filled up with HC+ Water mixture.

- Subsequent to above operation, both battery limit valves (C and D) of sour water line (SWS-1) were isolated and section C-D was drained. No liquid was observed by operator during the draining through hose connected to Low Point Drain (LPD).

- The presence of hydrocarbon pocket in the stagnant pipe section 'D-E' was not anticipated by the Operating staff.
- The drain of the spool could have got choked during draining due to the sludge/ air lock; But since the line was used earlier in the morning and no liquid was observed during draining of Section C-D (after its isolation), the operating crew might have derived the wrong inference that the spool had got completely drained and was under full isolation by the battery limit valves.

- The isolation valve (D) of the refinery sour water header might have been passing due to the sludge under its seat.
- The hydrocarbon in the sour water line had predominantly come from the flare KOD subsequent to ISOM start-up.

- Any new modification job shall be thoroughly checked based on drawing/ format (e.g. the wrong position of blind in stub).
- Any temporary modification (e.g. Section X-Y-Z) should be done through MOC procedure only. If a modification is interlinked with different units, a standard operating procedure/ JSA involving all stakeholders to be developed and explained to all concerned.

- a. Routing to SWS should have been stopped based on the level rise (due to HC) in flare KOD and checking of material in the KOD drain to OWS.
 - b. No liquid flow during draining of the previously used line should have been interpreted as a possibility of choking of hose / LPD also.
