SAFETY ALERT

OISD/SA/2019/E&P/01

Dt.: 02/12/2020

Title: Accident Due to Failure of Monorail Hoist
Location: Offshore Platform
Loss/ Outcome: Major Injury

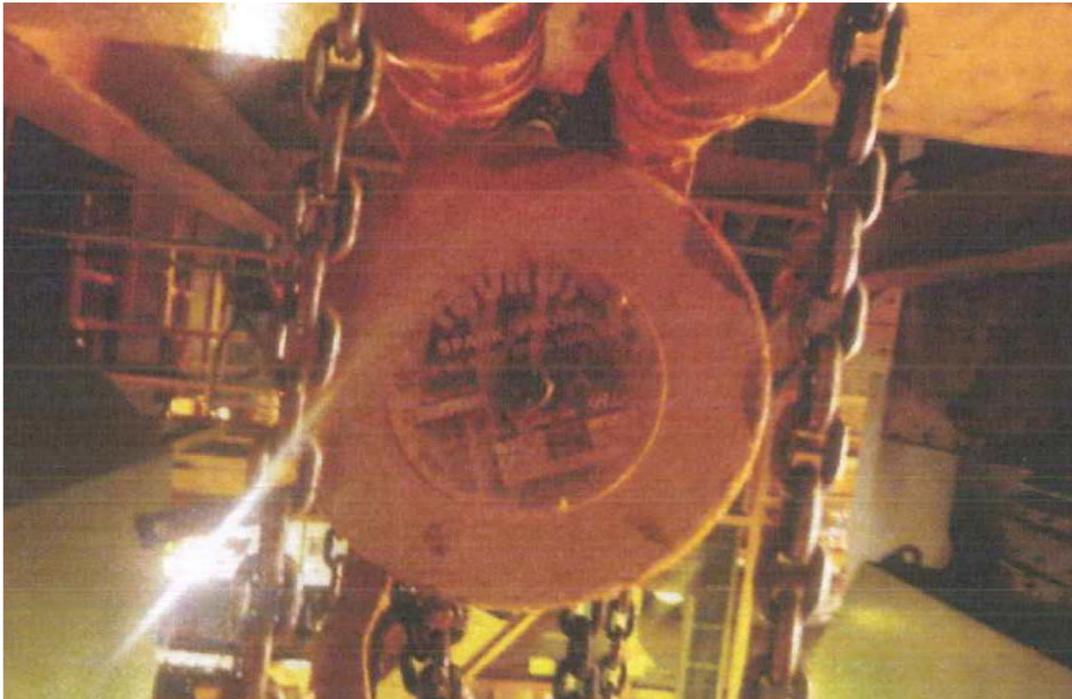
Monorail Hoist

- ✓ Observed illumination in the area was poor for carrying out such major operations after sunset.
- ✓ Housekeeping of the area was very poor and a lot of accumulation of lube oil was observed on the floor in and around the PGC area.

- ✓ Operating mechanism failure of the Monorail Hoist, resulted in Engine coming down to floor.

View from Upper Platform Deck

- ✓ Load testing of all the Lifting equipment is to be done as per their schedule and record of certificates/ details of the testing/ repairs done, to be maintained, for reference according to OISD-RP-126 clause 8 which states
 - To ensure safe utilization of lifting tools & tackles, periodic inspection and testing as per applicable statutory rules and regulations applicable shall be carried out.
 - Each lifting tool & tackle shall have unique identification and shall display the safe working load, testing date and next due date for testing.

- Records shall be maintained for verification
- ✓ Illumination survey of the PGC area to be carried out and action to be taken accordingly, to improve the same for safe working according to OISD-RP-149, clause:9
- ✓ Proper Housekeeping of the complete area to be carried out to make the area a safe working place.
- ✓ Before taking up such major work, it should be ensured that people attending the job are in sound health and stress free .
