SAFETY ALERT

OISD/SA/2020-21/POL/02

Incident Title: Motor Spirit (MS) spillage from Tank

Location: POL Terminal

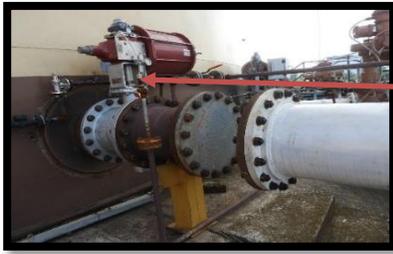
- Though the majority of the product was contained within the dyke, some product spilled outside the dyke through the delivery line section (Fig. 1), laid on the downstream of ROSOV axially in line to the spool piece. The flange joints of this pipeline were loosely fitted leading to the product leak inside the TLF Pumphouse manifold area.

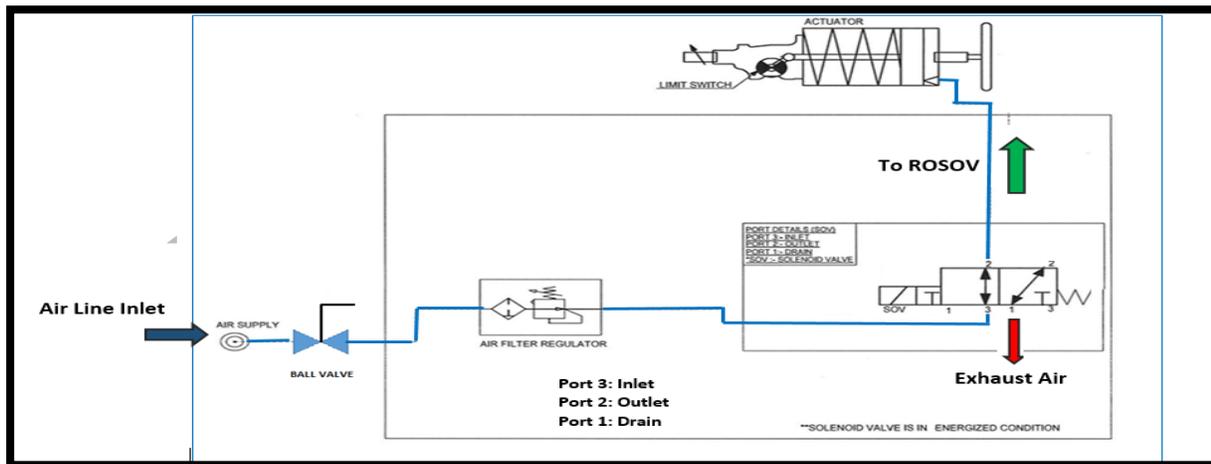
(Fig. 2: Correct connection of energized solenoid valve)

- The airline is connected to port 3 (inlet) of the solenoid valve through the Air Filter Regulator (AFR). When the solenoid valve is electrically energized, ports 2 (outlet) & 3 (inlet) are connected and port 1 is blocked. Air will be flowing from port 3 to port 2 and ROSOV will open. When the solenoid valve is electrically de-energized, port 2 & port 1 (drain) is connected and port 3 is blocked. Air will be vented out from port 2 to port 1 and ROSOV will close.

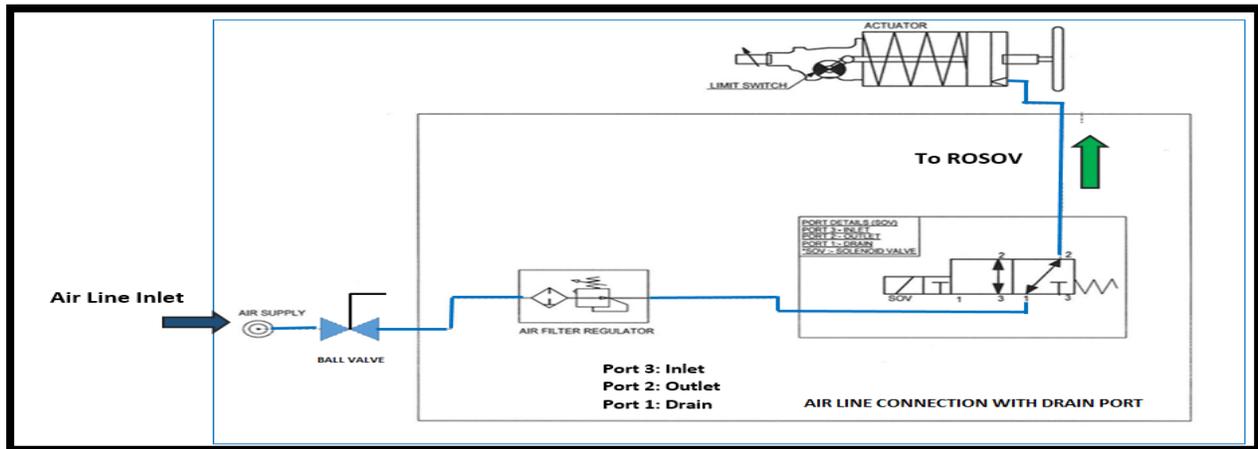
- In ROSOV of MS tank T-18, the airline connection was wrongly given to port 1 (drain) instead of port 3 (inlet). Port 1 is directly connected to the air chamber of ROSOV through port 2. The air traveled to the air chamber of the ROSOV directly, on the opening of the airline, even though the solenoid valve was electrically de-energized, resulting in the instant opening of ROSOV.

(Fig. 3: Wrong connection of solenoid valve of ROSOV of MS tank T-18)

- To ensure ROSOV is fail-safe as per clause 7.6.2.(iii) of OISD-STD-244.
- The process of Factory Acceptance Testing (FAT) & Site Acceptance Test (SAT) of critical equipment needs to be implemented robustly.
