# Learning from Incidents in Process Industry

**Workshop on Hazards and Safety in Oil & Gas Industries**  
**23rd – 25th February 2026**  
**Seminar Hall, IIT Delhi**

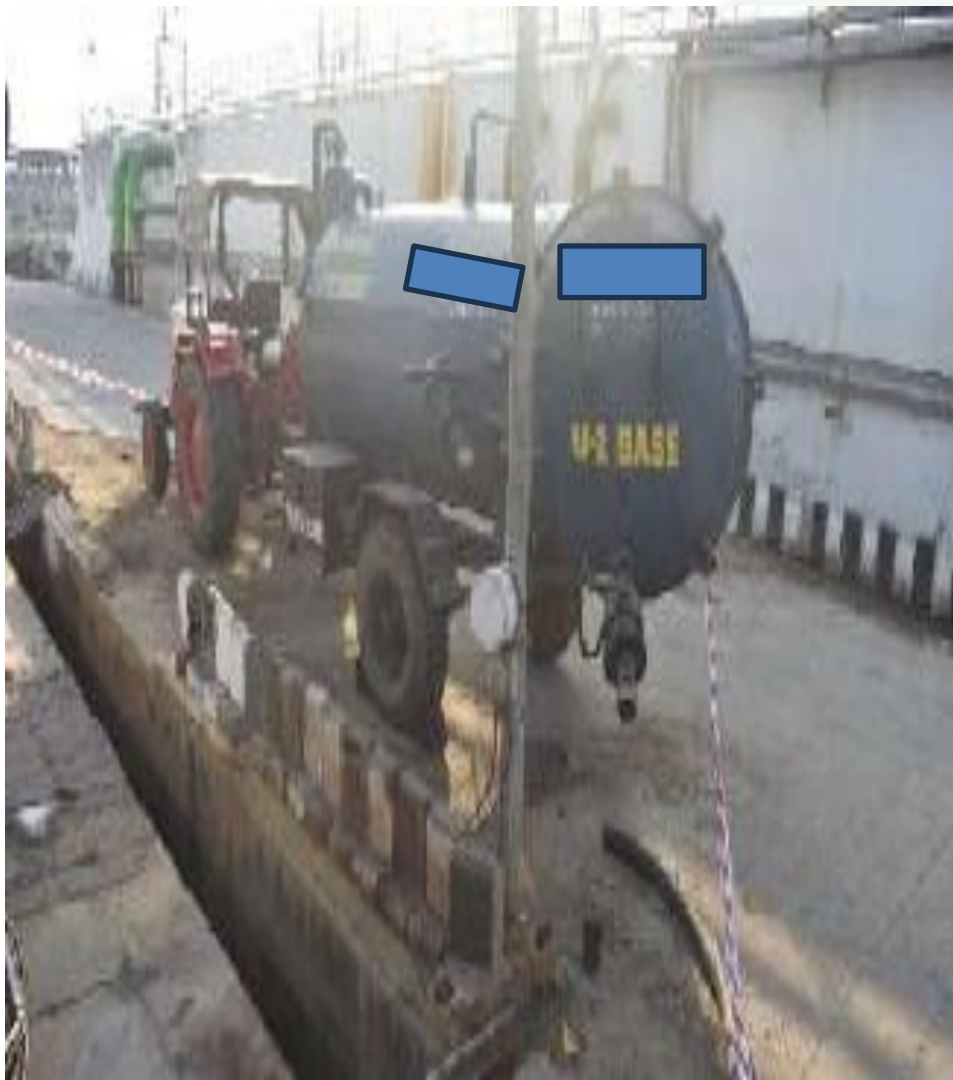
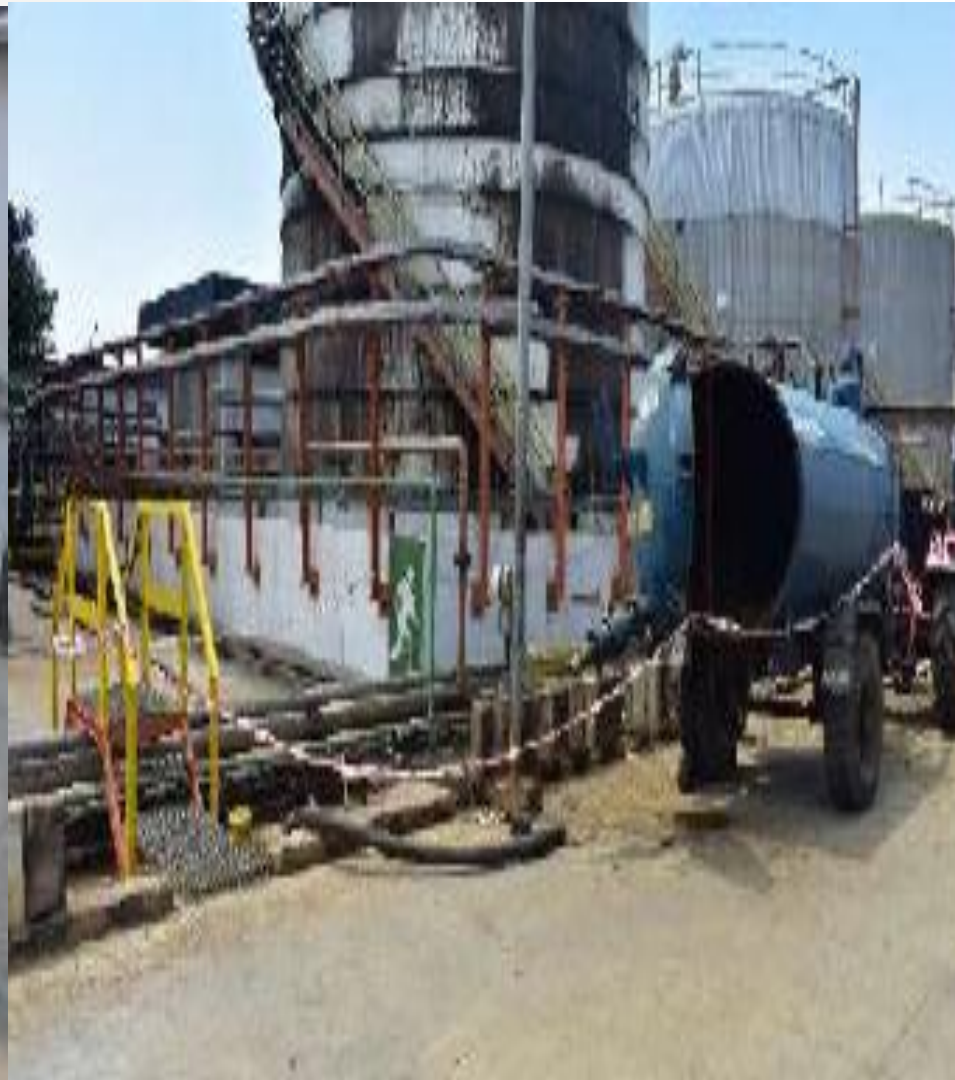
**Fatal accident during discharge operation from Gully sucker.**

**Location:** Refinery

**Loss/ Outcome:** Fatality of a contract worker.

**Root Cause:** The root cause of this incident is due to backward movement of gulley sucker which was parked on slope and resulted into swing opening of back cover due to loose bolting and hydraulic load.

- Ensure robust bolting mechanism in back cover of all gulley suckers.
- Ensure all gulley suckers are included in equipment list, prepare a schedule for gulley sucker preventive maintenance and corresponding detailed checklist to ensure its healthiness.
- Daily and Weekly checklist for Gulley sucker inspection to include the checkpoint of ensuring integrity of back cover and associated bolting mechanisms as well as application of wheel chokes when parked.

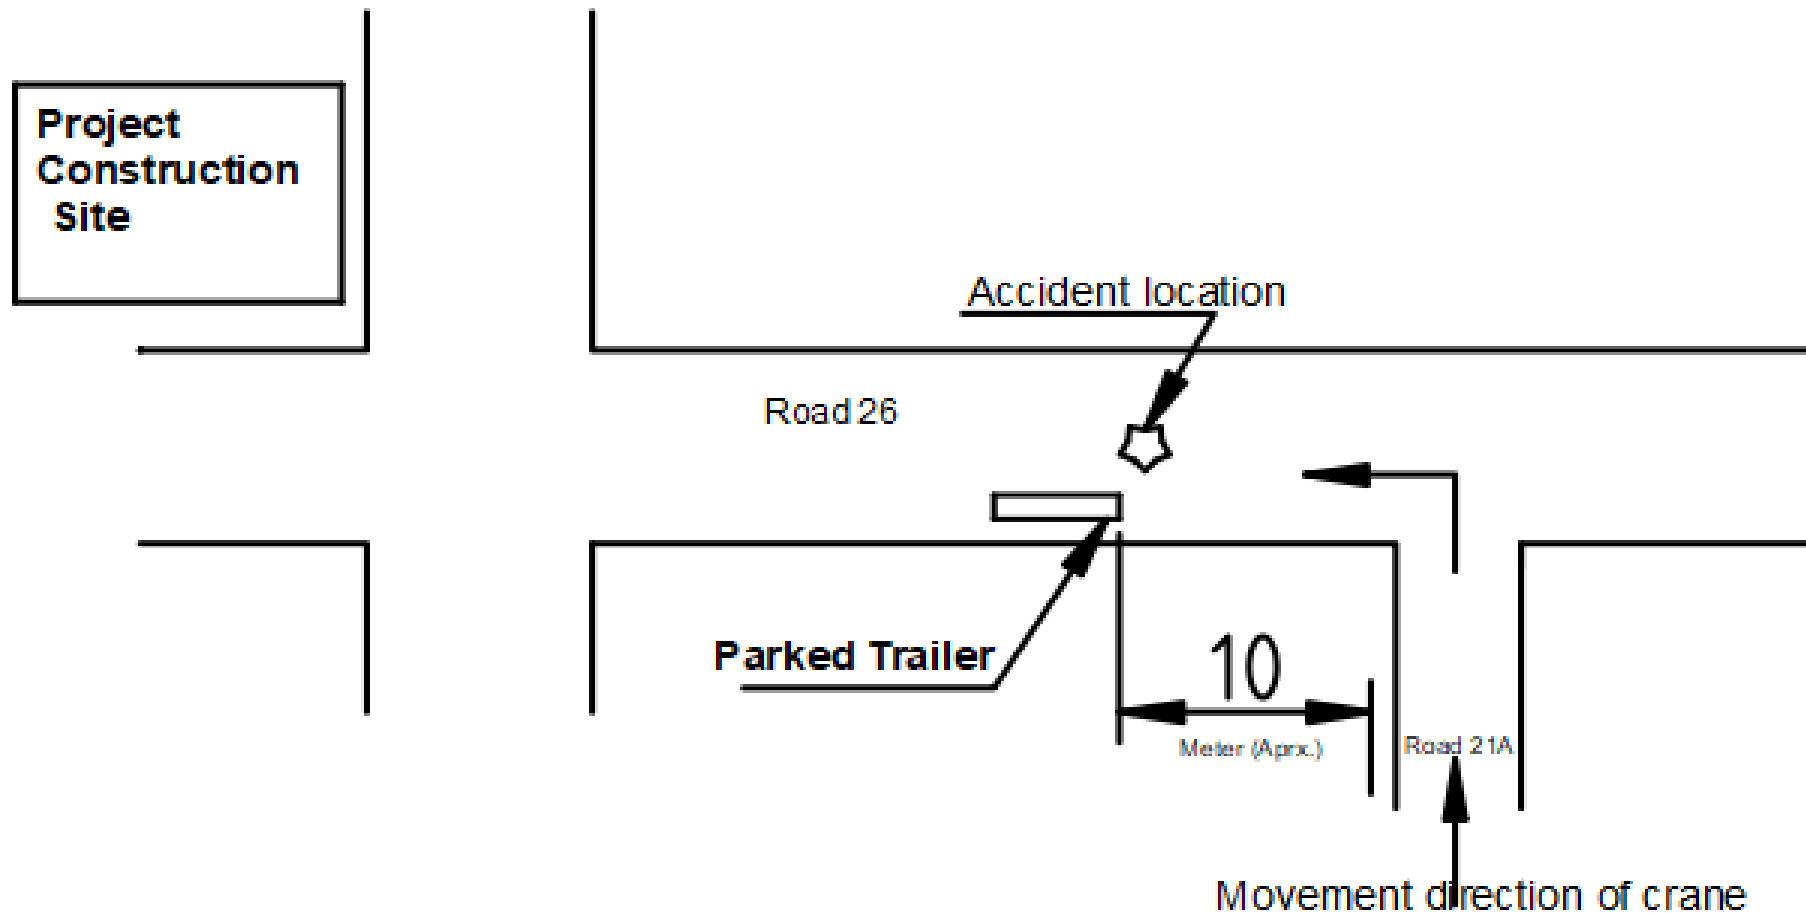
Fatality due to accident by a FARANA crane.

**Location:** Refinery (Project Site)

**Loss/ Outcome:** Fatality of 1 contract worker.

- Shifting of hook loaded material for a long distance by Farana crane.
- Inadequate experience of crane operator coupled with possibility of driving fast as they were getting late for lunch resulted in the accident.

- Crane (inclusive of Farana/ Hydra) should not be used for transportation of hook loaded materials.
- Jobs shall be carried out with supervision and shall not be carried out during recess/ absence of adequate manpower.
- Only experienced person shall be deployed for tasks involving skills. A robust mechanism should be developed for competency assessment before deploying the person.

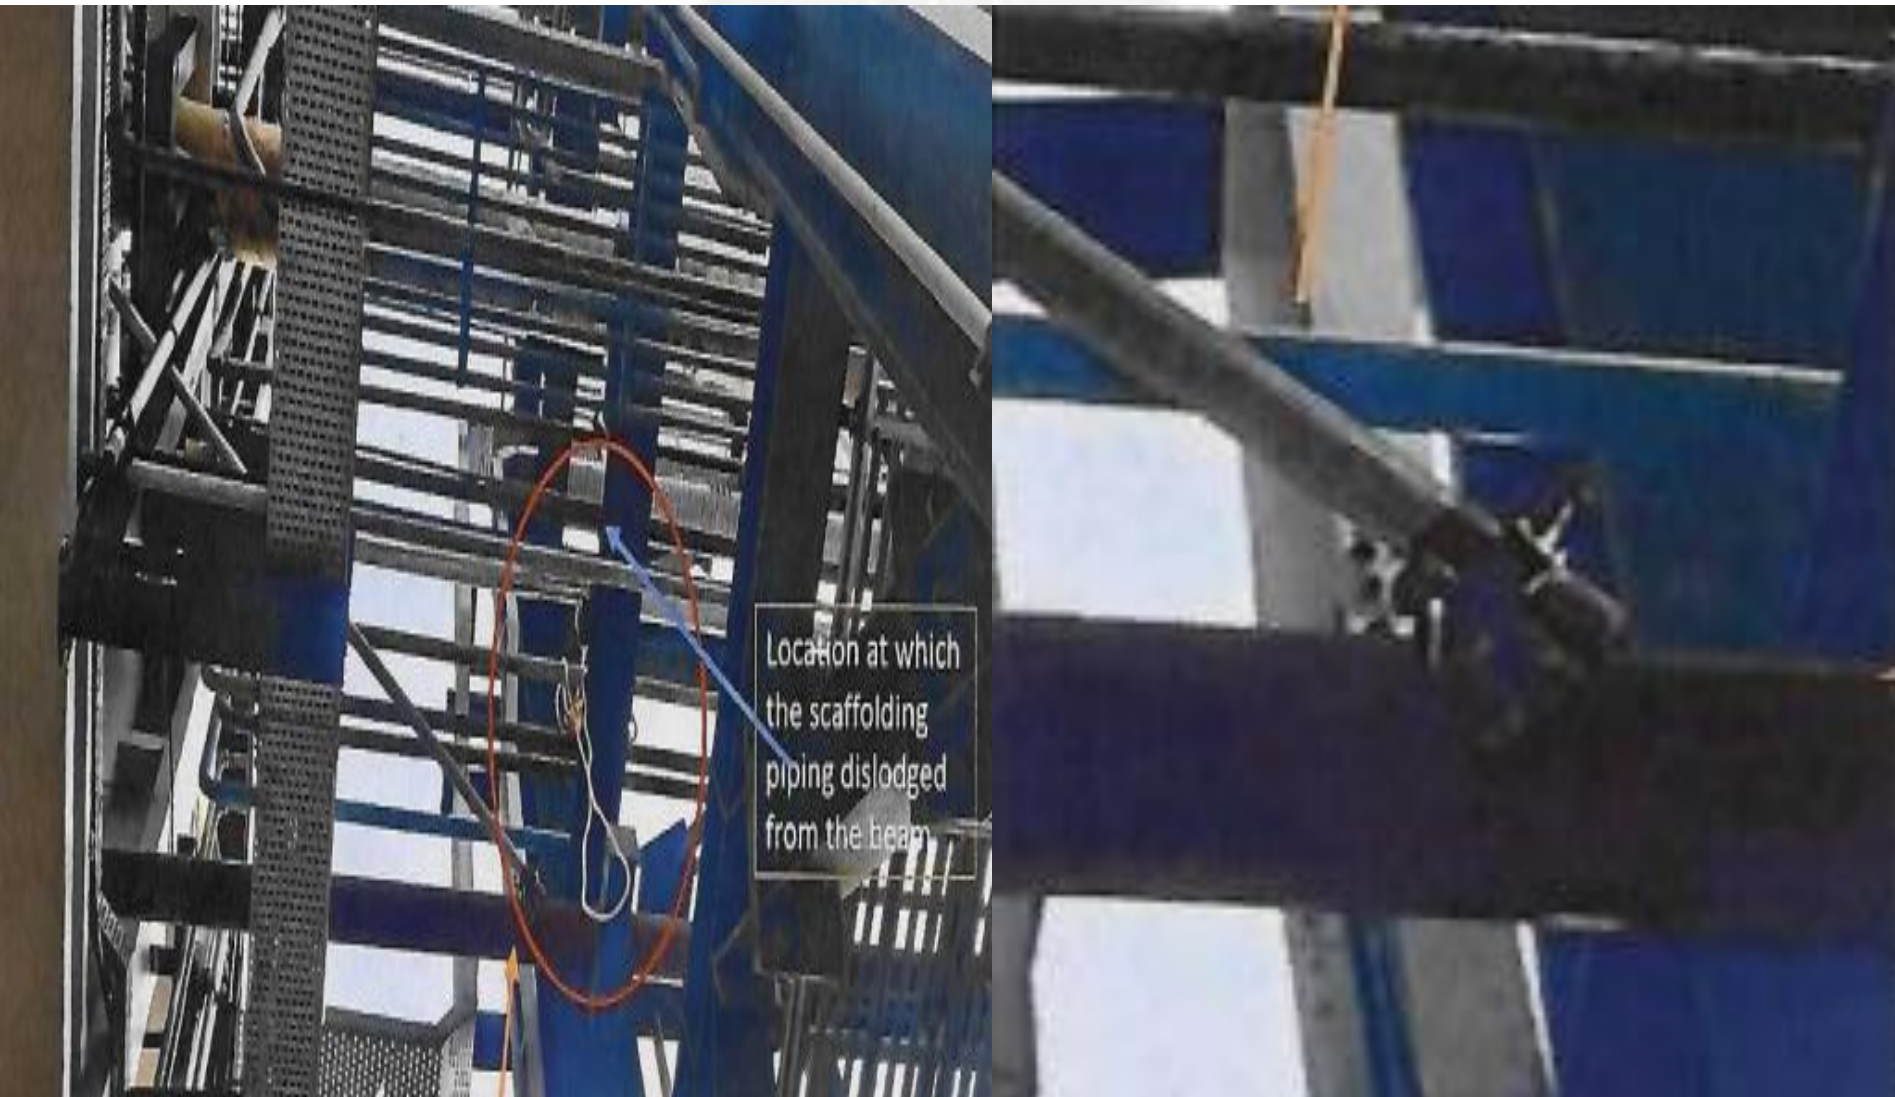
**Fatal accident due to fall from height.**

**Location:** Refinery

**Loss/ Outcome:** Fatality of a contract worker

- Simultaneous removal of both the hooks of lanyard or full body harness while movement.
- Slippage of support clamp of the scaffolding pipe.
- Inadequate supervision and monitoring, disregard of JSA.

- In scaffolding red tagging/ signboard should be displayed at the entry exit points and the transition location for all not fit for use scaffoldings.
- Safety net for arresting fall from height to be provided wherever it is required and feasible.
- Safe working platform and proper access to work site at height to be ensured before permit clearance.

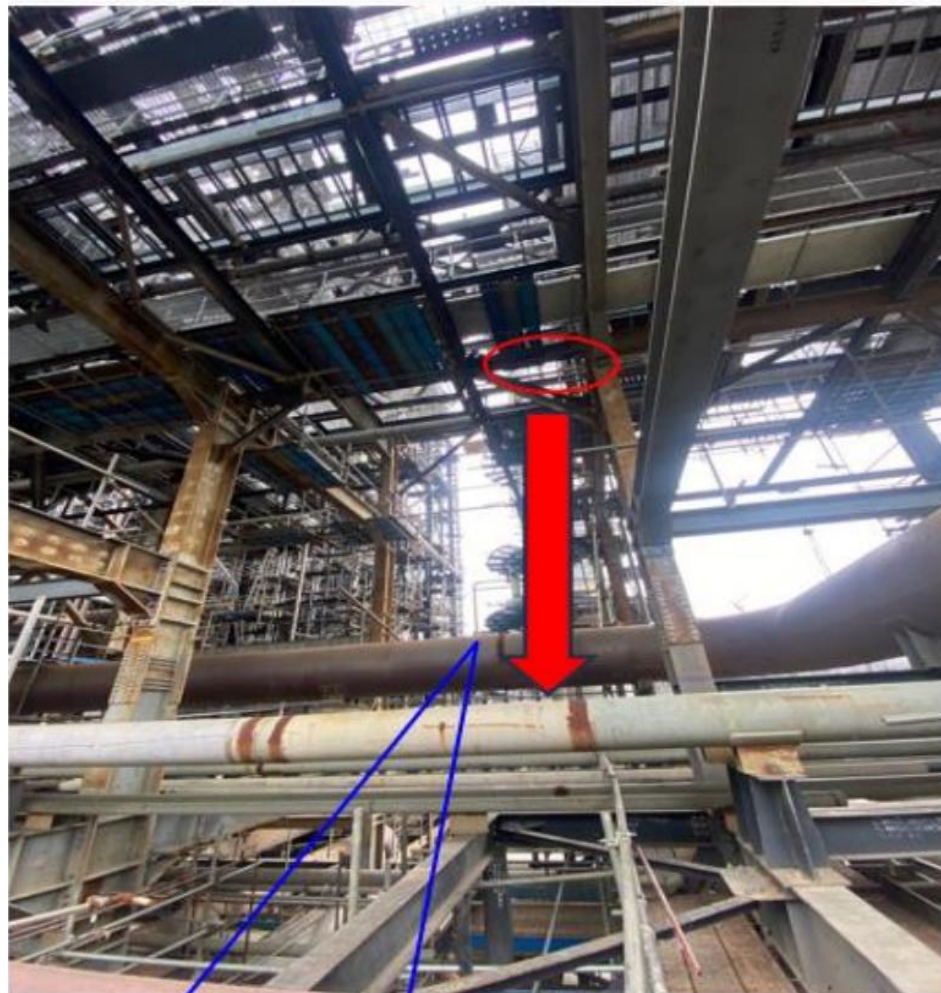
Line of Fall (Height ~ 6m)

Unsafe act (by contract worker) of not anchoring the double lanyard. Further, mechanism to prevent the unsafe act/ condition (inadequate scaffold working platform and not anchoring the double lanyard while working at height) was also missing.

- Monitoring of project activities through CCTV to be done. Scrutiny of the footages, manually or through AI techniques, should be explored to identify unsafe acts/ conditions and take rectification measures thereof.
- Alternative rescue arrangements should be developed and implemented for inaccessible areas where cranes with baskets cannot approach..
- Safety awareness training shall be ensured in line with OISD-STD-154.

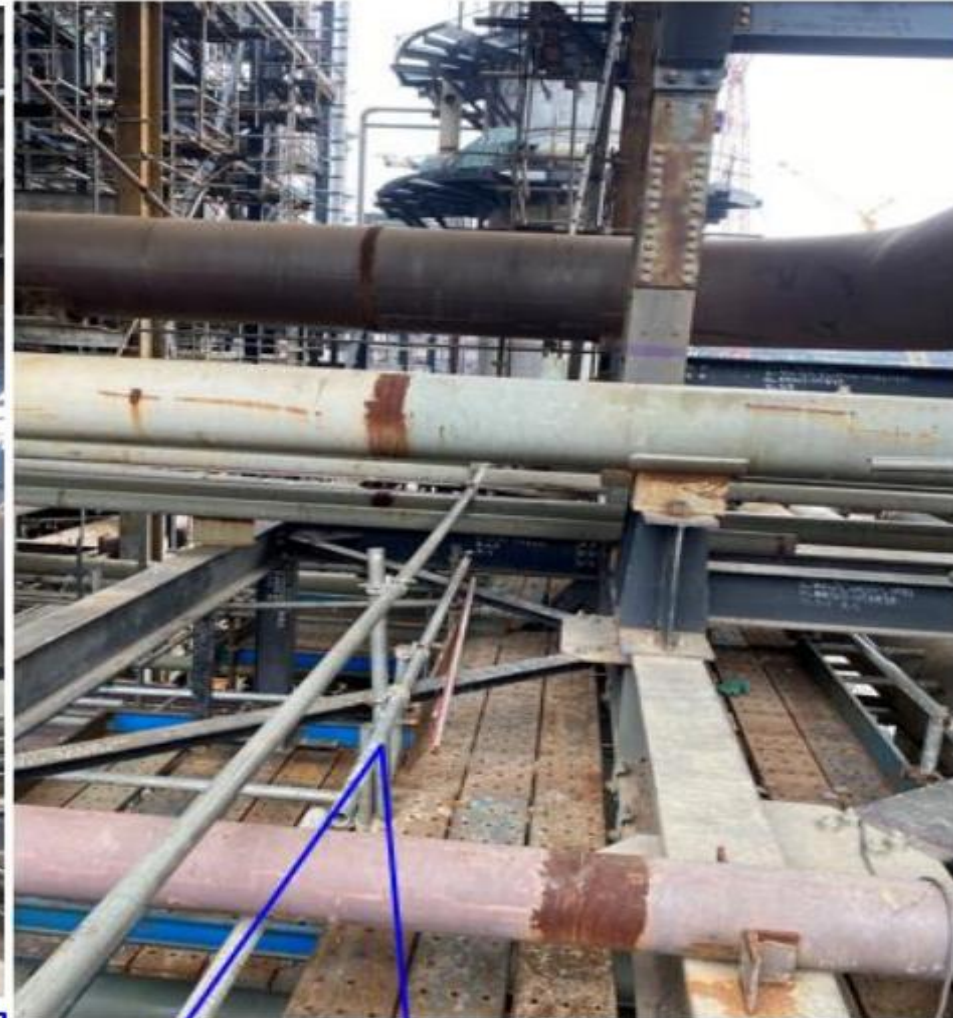
Site of Fall

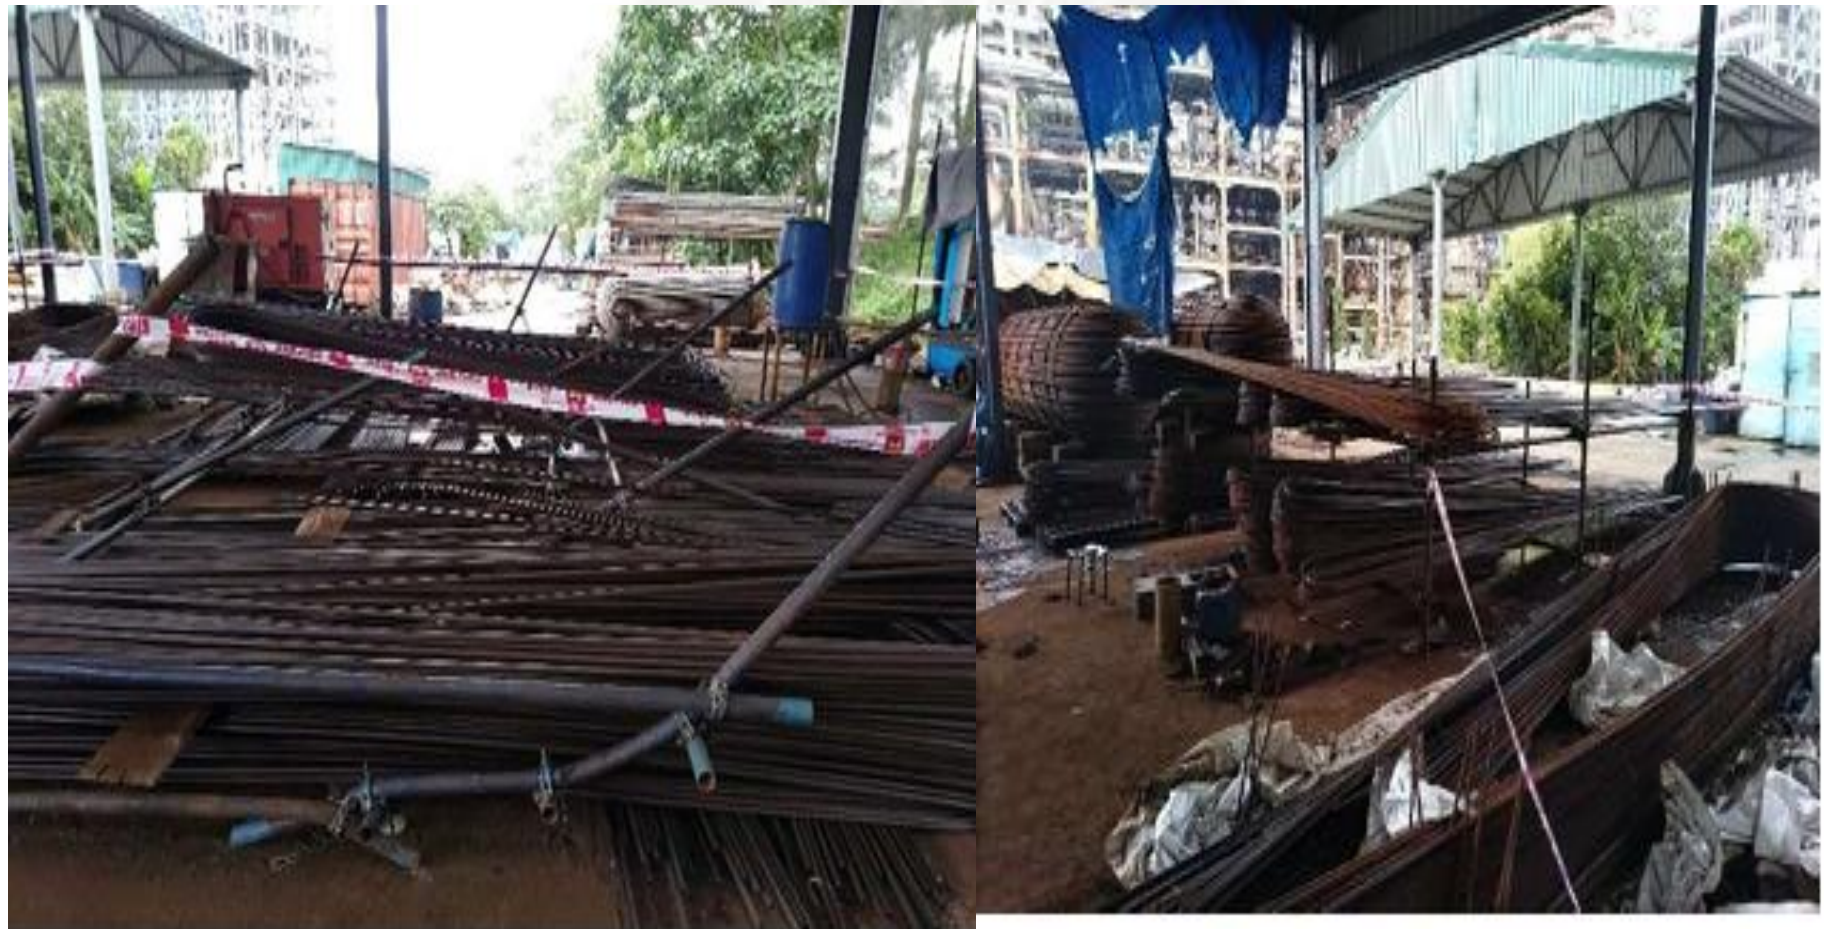
**Fatal accident at maintenance fabrication yard during cleaning & stacking of tubes.**

Collapsed structure without base plate, braces, safety signage

Stacking of U-Tube bundle beside the collapsed structure

Usage of an inadequately constructed structure and the failure of system to prevent/ check the same.

- For jobs for which SOP is unavailable (for safe execution), it is mandatory to carry out JSA before issuing the work permit
- Guideline for temporary structures and its usage should be developed. The usage of the temporary structure should be restricted to the load for which it is designed.
- Rescue activities should preferably be carried out by trained personnel. Ambulance services should be preferably utilised for movement of casualty. Mock-drills for rescue should be carried out to ensure awareness to all.

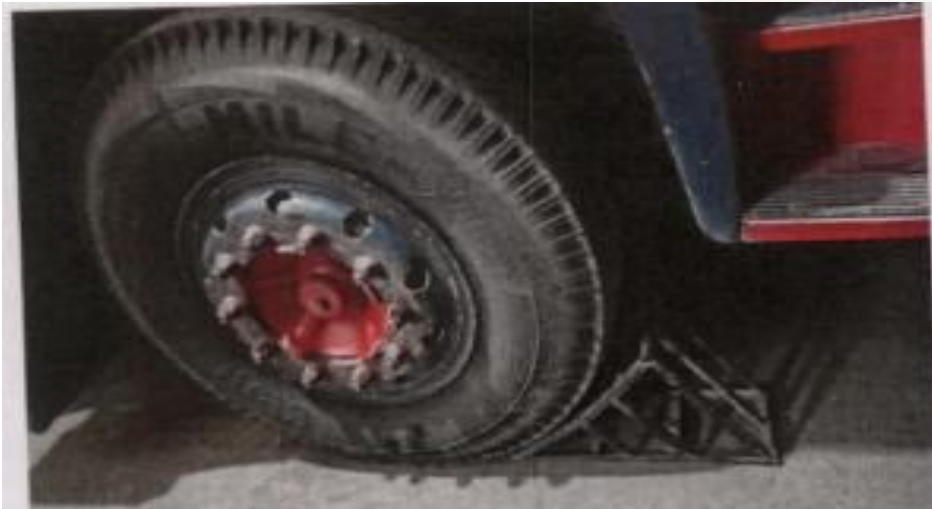
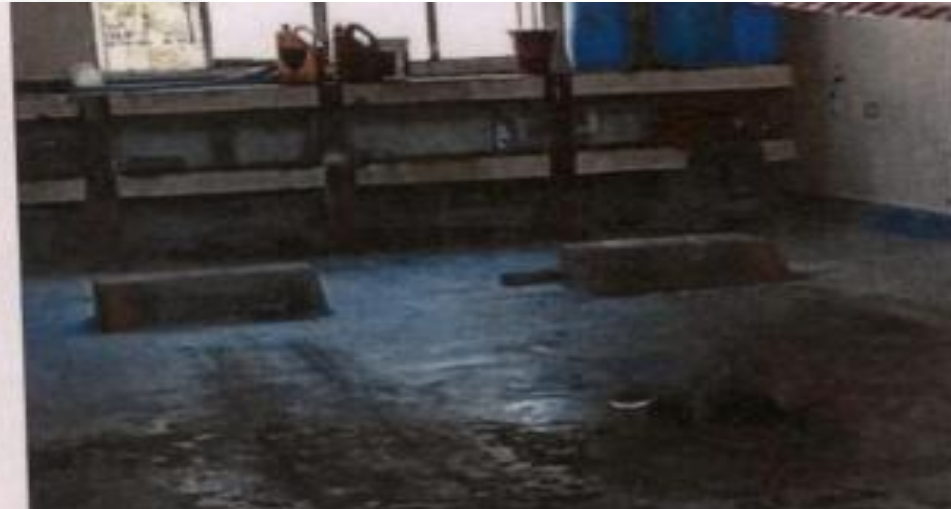
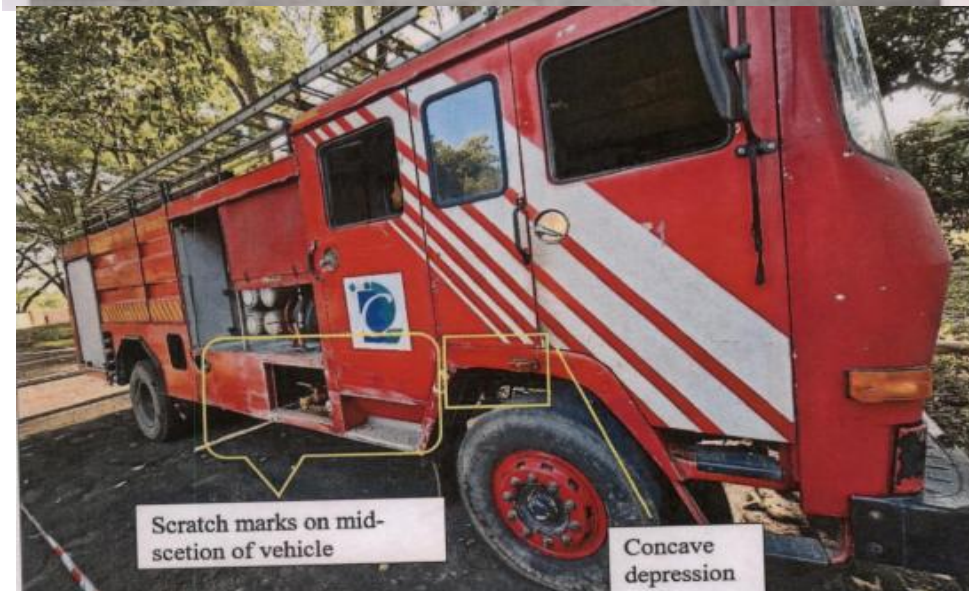
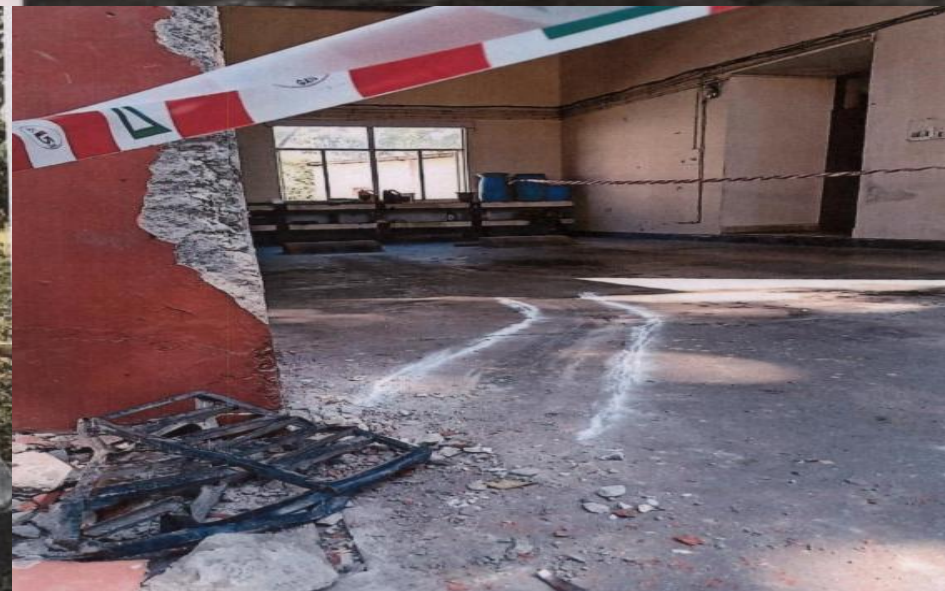
**Fatal incident during static running of fire tender.**

**Location:** Gas Processing Plant

**Loss/ Outcome:** Fatality of fire crew.

- Most probable cause was that the tender, was started while the driver (fire crew) was standing outside of the vehicle. When the vehicle moved (probably due to gear being engaged), he was trapped between mudguard of front wheel and adjacent concrete column.
- The above action was in deviation from Standard Operating Procedure: “Start the engine with operator positioned on driver seat & run at idle speed”.

- Strict adherence of Standard Operating Procedure to be ensured.
- The activity to be incorporated in HIRA (Hazard Identification & Risk Assessment) register of the company and risk rating to be revised.”
- Behaviour based training to be imparted to all employees/ workers periodically.

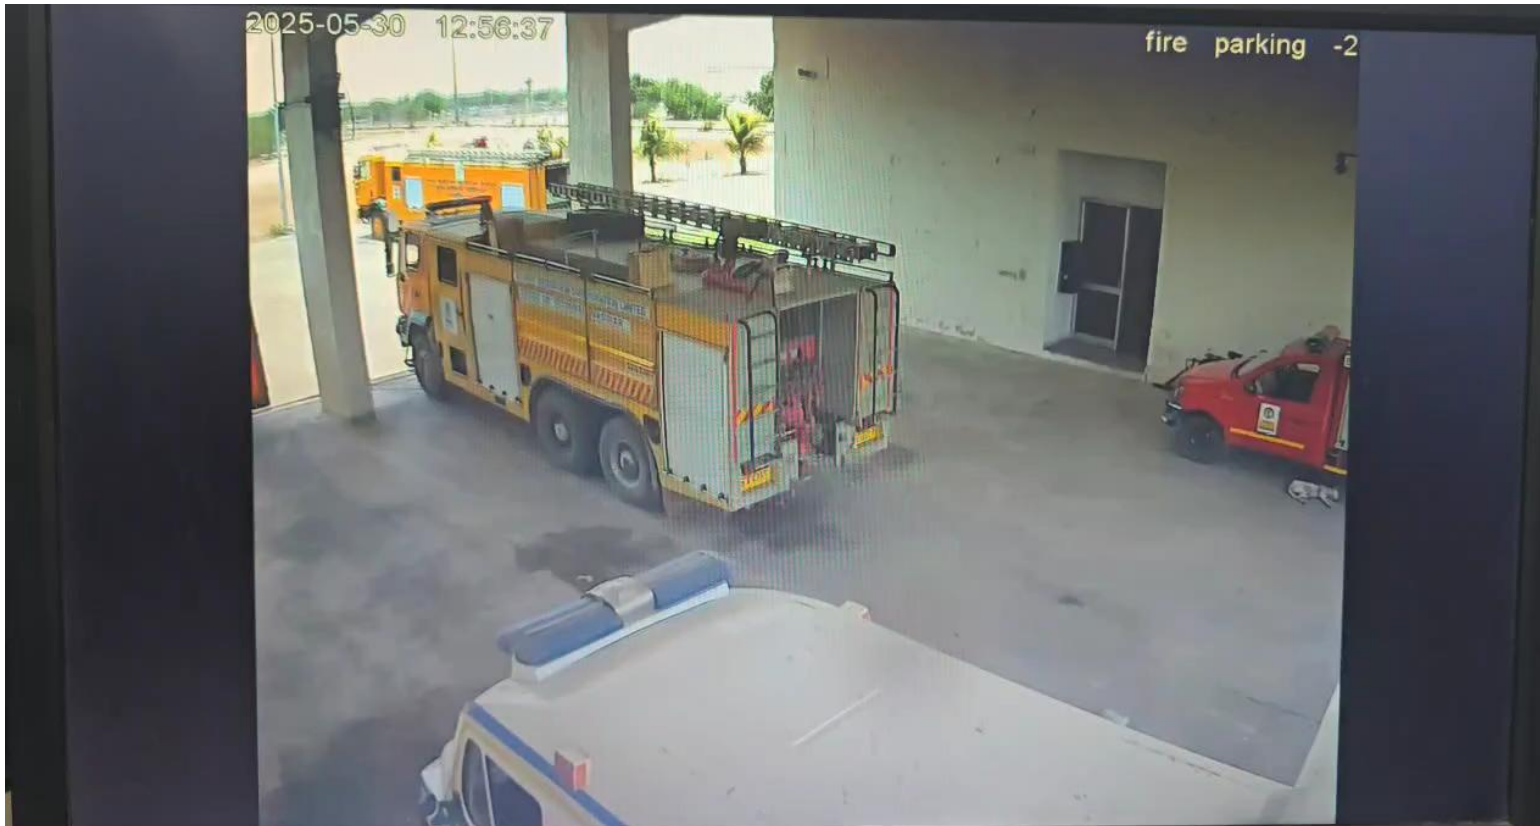
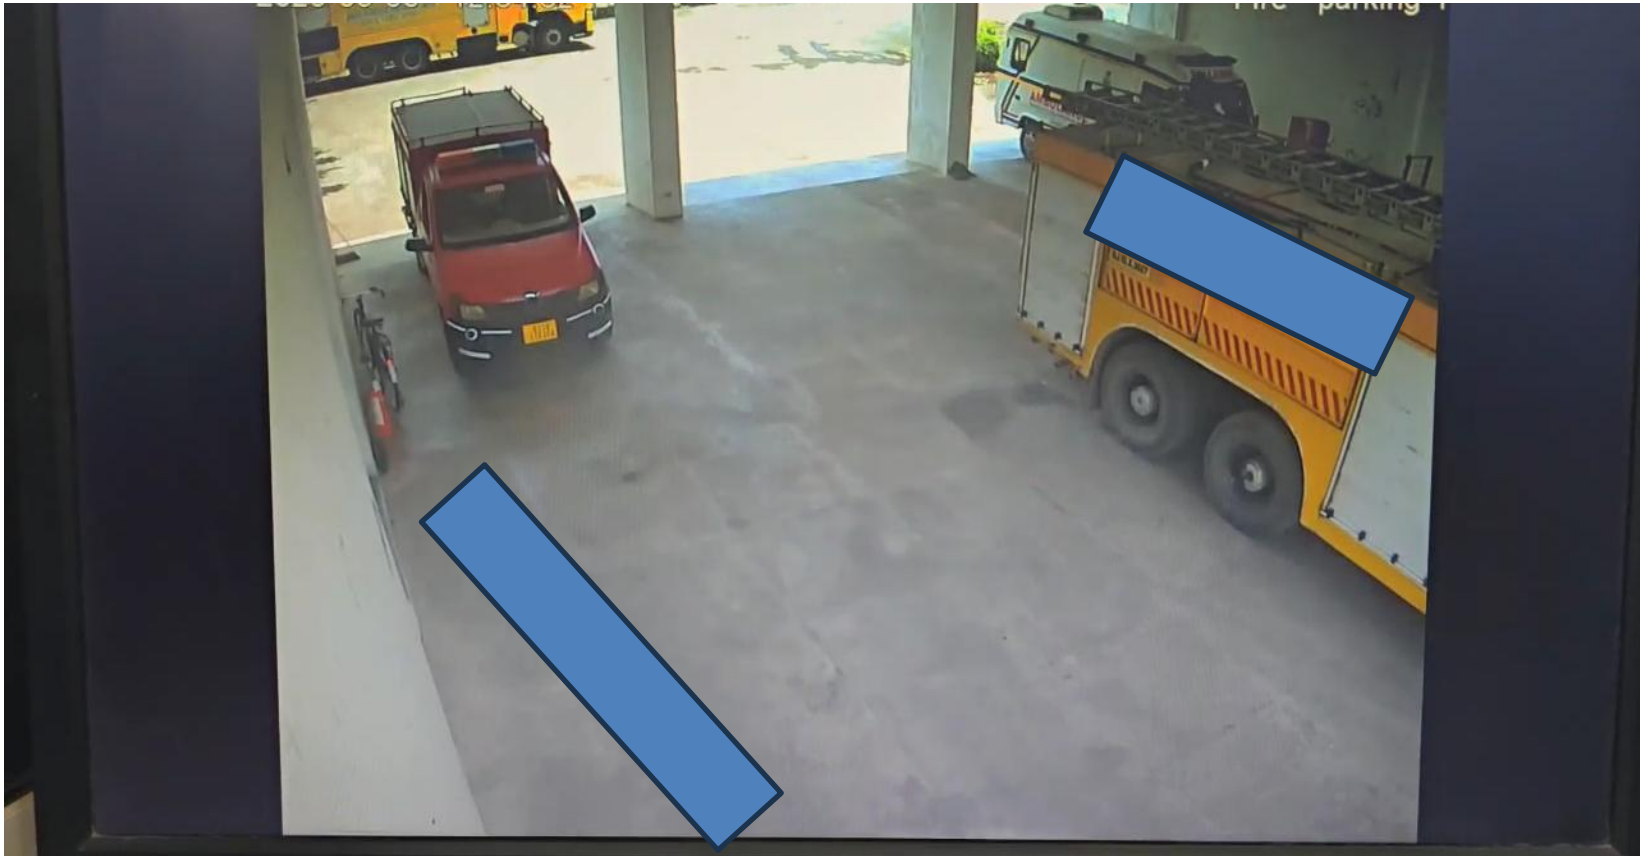
**Fatal incident during Parking of fire tender in reverse.**

**Location:** Crude Oil Terminal

**Loss/ Outcome:** Fatality of fire crew.

- Negligent/Lack of coordination between fire tender driver & Fireman while reversing of vehicle inside parking bay.
- Inadequate driving skill of the driver cum pump operator.
- Casual behaviour of deceased fireman during guiding the fire tender in parking.
- Non-availability of reverse parking sensors as mandated by The Central Motor Vehicle rules, 1989 and its amendments.
- **Learnings:**
- Reverse parking of fire tender/other heavy vehicles, especially in enclosed areas, to be avoided
- SOP should address positioning of the person guiding the tender should be visible in the rear-view mirror during parking.
- Heavy vehicles like Fire tenders, foam nursers, Mobile Oil Spill Recovery Unit (MOSRU's) etc. to be fitted with Reverse Parking sensors. It is also suggested that rear view camera may be included in specification,

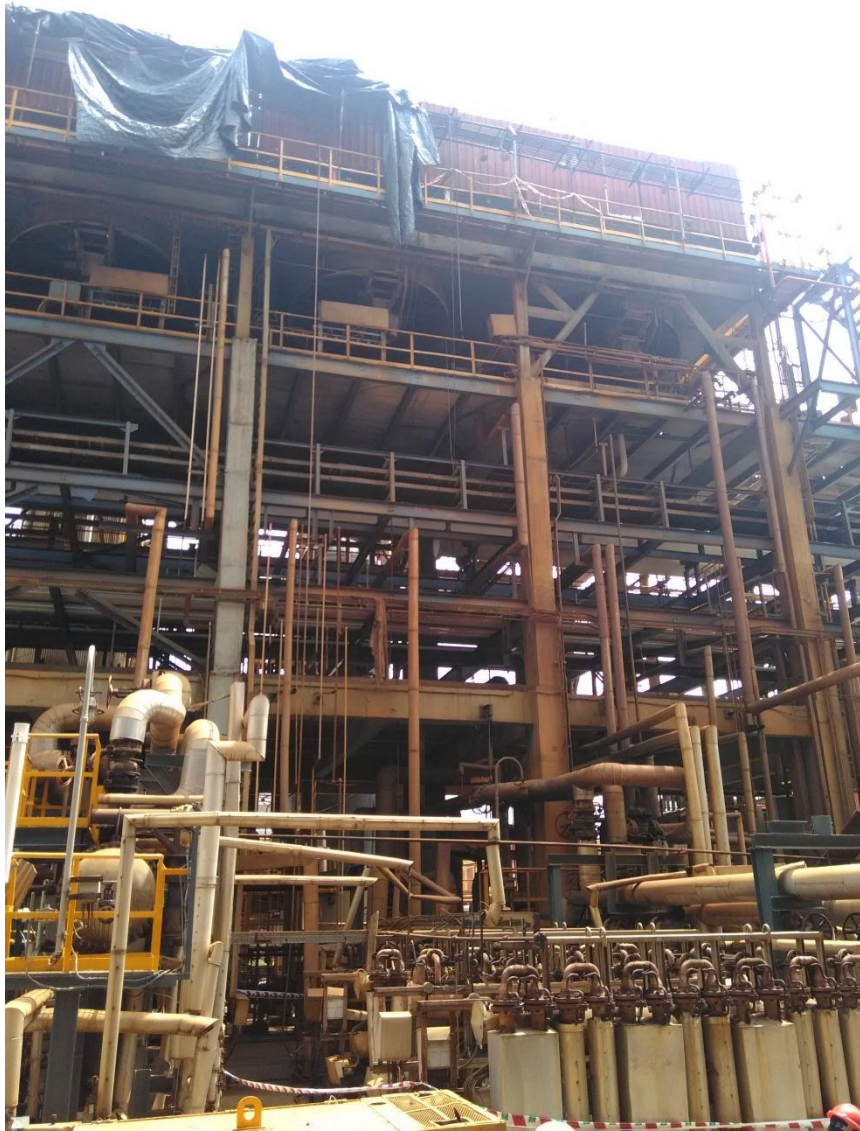
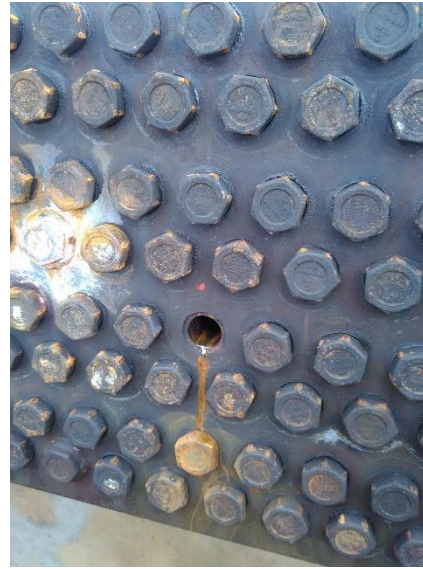
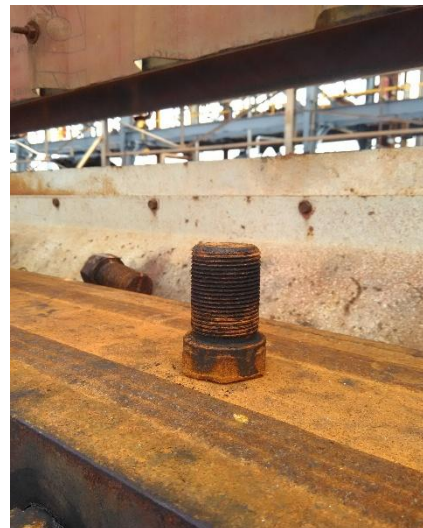
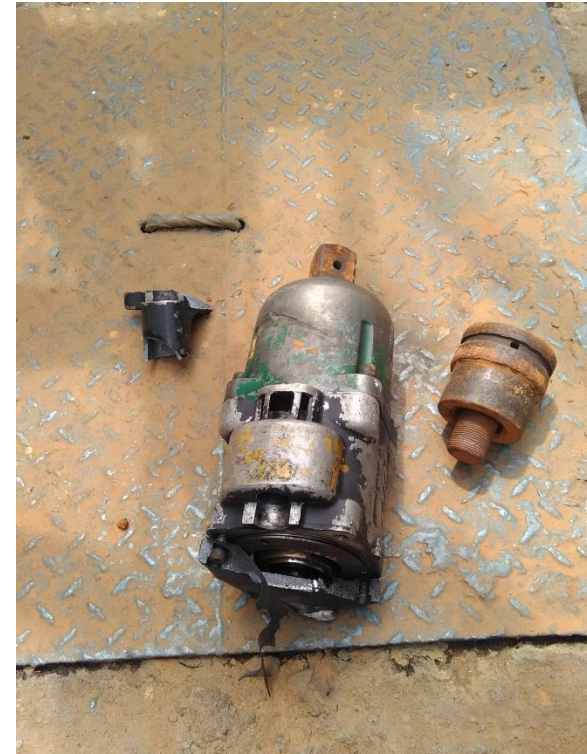
## Fatal Accident due to fall from height

**Location:** Refinery unit Air fin cooler

**Loss/ Outcome:** 1 Fatality.

- Injured person attempted to tighten the plug to arrest the sweating (leak) and might have accidentally loosened it (The thread of the plug and the tube were intact and there was no sign of shearing) while the equipment was still in pressurized condition for hydrotesting.
- Due to the continuous work hours and resultant fatigue, IP might have thought of finishing the job by tightening the bolts.

- No repair activity shall be carried out while the equipment is pressurised for hydrotest.
- SOPs specific to the nature of job should be shared to the executing agency or the agency should be made aware of the practices/ procedures for executing the job in a safe manner.
- For critical activities like hydrotest, a competent supervision shall be ensured.
- Effective communication should be ensured between crew members.
- Tool-box talks should cover job specific actions. Precautions against all potential hazards should be reinforced through daily tool-box talks.

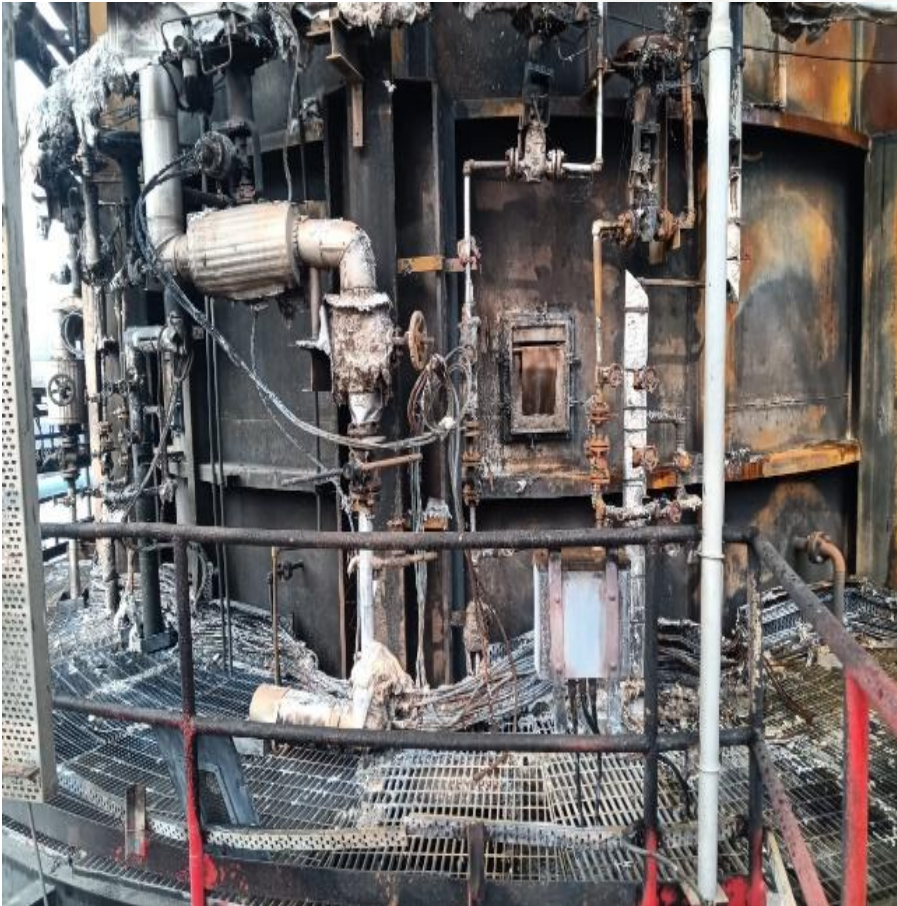
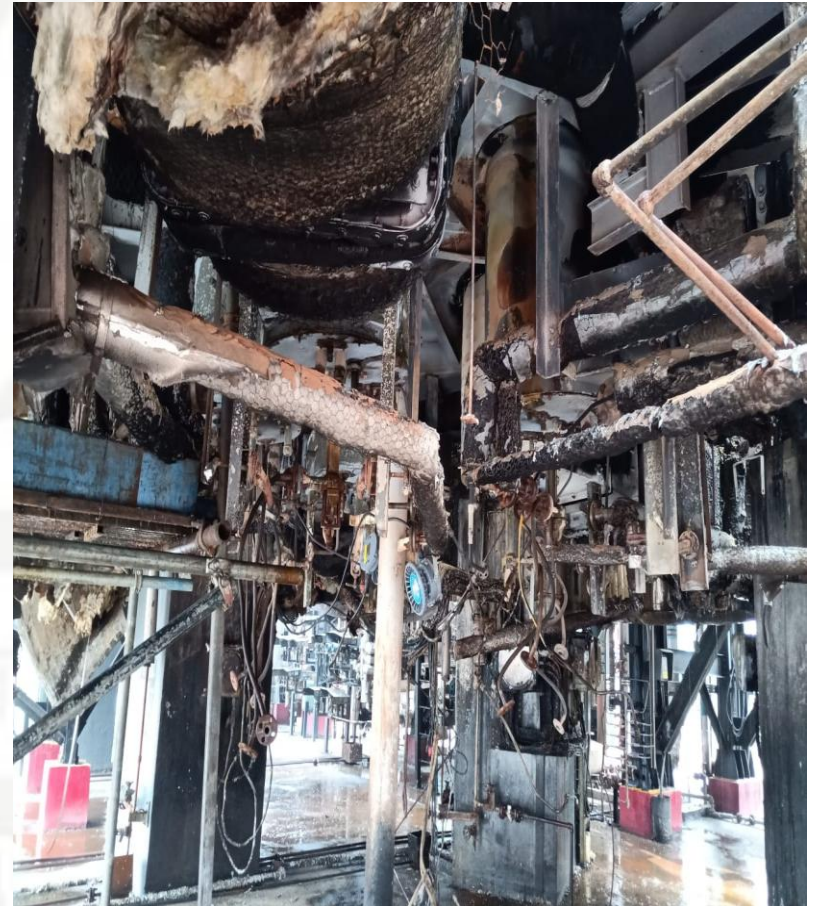
## Fire in Naphtha Splitter Reboiler Furnace

**Location:** Refinery

**Loss/ Outcome:** No Loss of life/ Injury.

**Root Cause:** Fire in the furnace was result of naphtha leakage from the Naphtha Splitter -1 reboiler convection bank tube. Naphtha caught fire due to the high temperature (around 720°C in arch) in the furnace. Tube failure can be attributed to high rate of corrosion .

- MOC system in line with OISD-STD-178 to be followed for all changes.
- Any scheme raised in MOC system should be drawn to its proper conclusion.
- Inspection report shall include all the observations in details.
- The monitoring of critical parameters, feed quality, etc. should be strengthened/ frequency increased for known failure cases.
- API standard 530 shall be used to calculate remaining life of heater tubes as stipulated in clause no 10.2.4 of OISD-STD-133.
- Process trip incidences should be properly investigated and record to be maintained.
- Shut Down planning of units shall be decided based on the health of the critical equipment and activities shall be taken up accordingly.

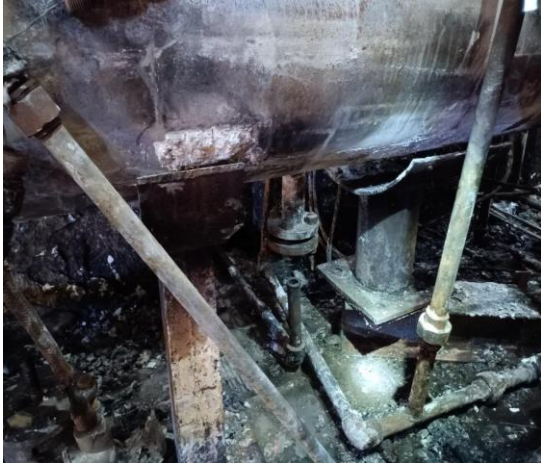
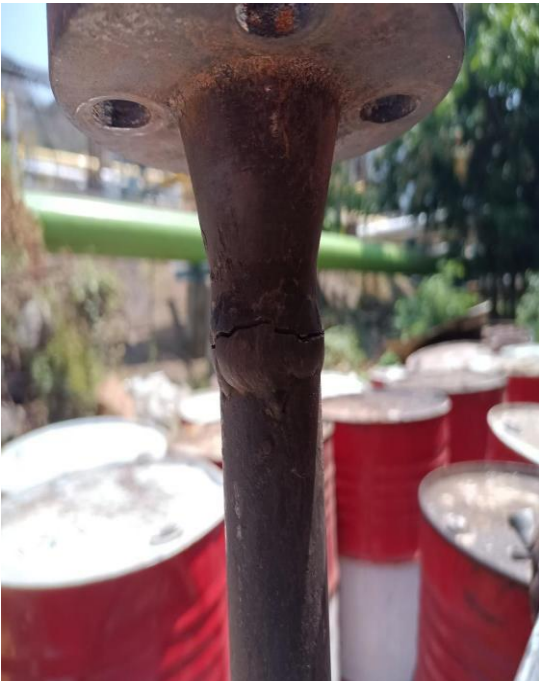
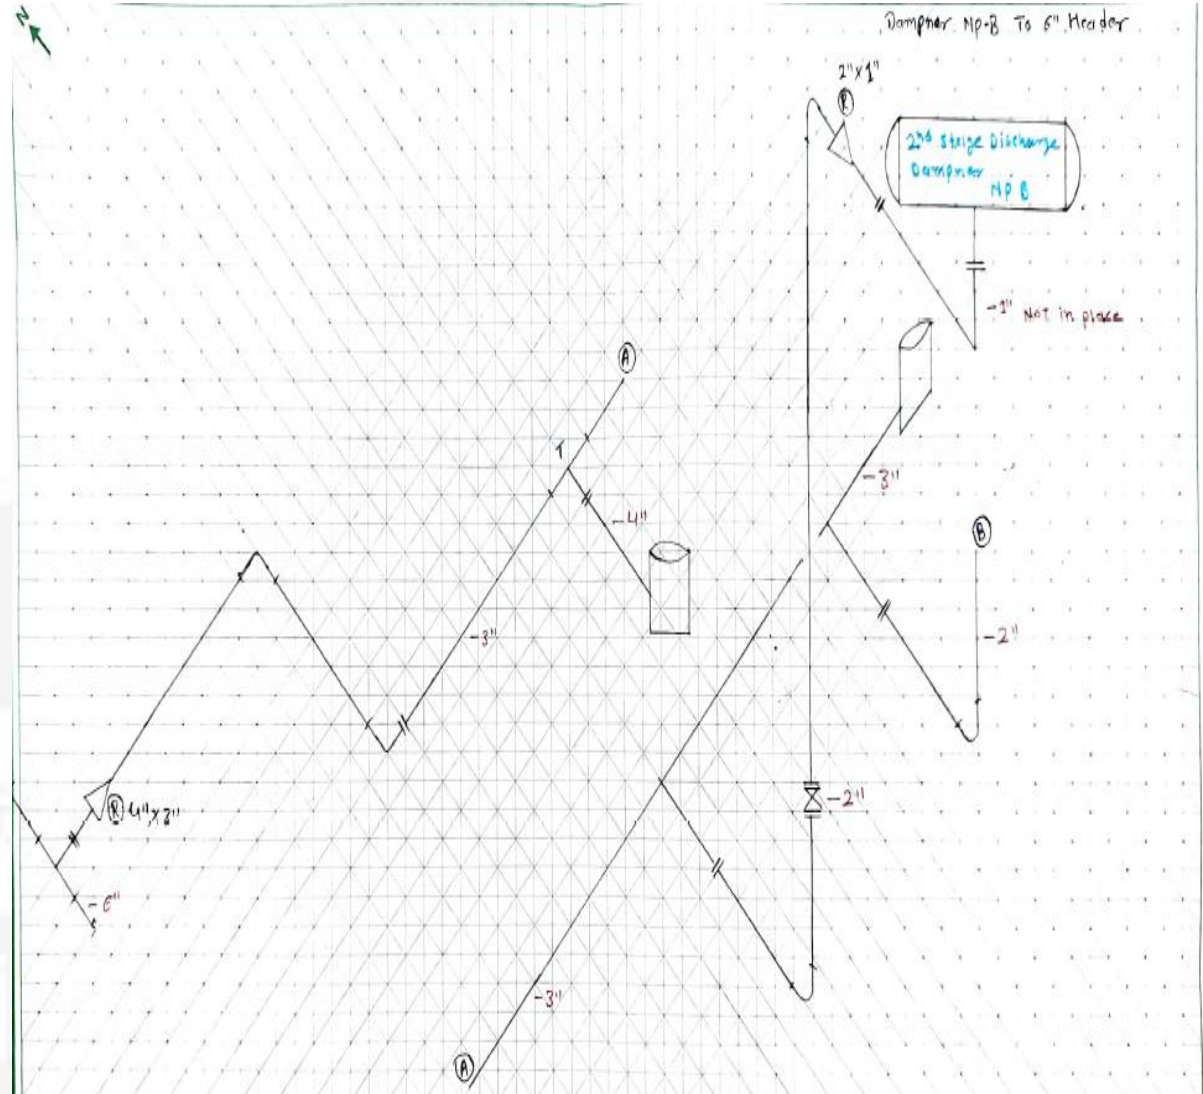
## Fire Incident in Gas Compressor House

**Location:** Gas Processing Plant

**Loss/ Outcome:** No Loss of life/ injury.

- 1” drain line from the weld joint connected to the discharge volume bottle of the compressor snapped at the weld joint, weakened by internal corrosion & erosion. The failure was aggravated by mechanical stress due to absence of proper pipe support coupled with high vibration.

- Pipeline supports shall be provided based on detailed load calculations.
- Lack of timely response to various alarms should be properly addressed.
- Comprehensive inspection plan for small bore pipe inspection should be followed.
- Casing vibration and bearing temperature should be monitored on periodic frequency.
