# Learning from Incidents in Process Industry

**Workshop on Hazards and Safety in Oil & Gas Industries**  
**23rd – 25th February 2026**  
**Seminar Hall, IIT Delhi**

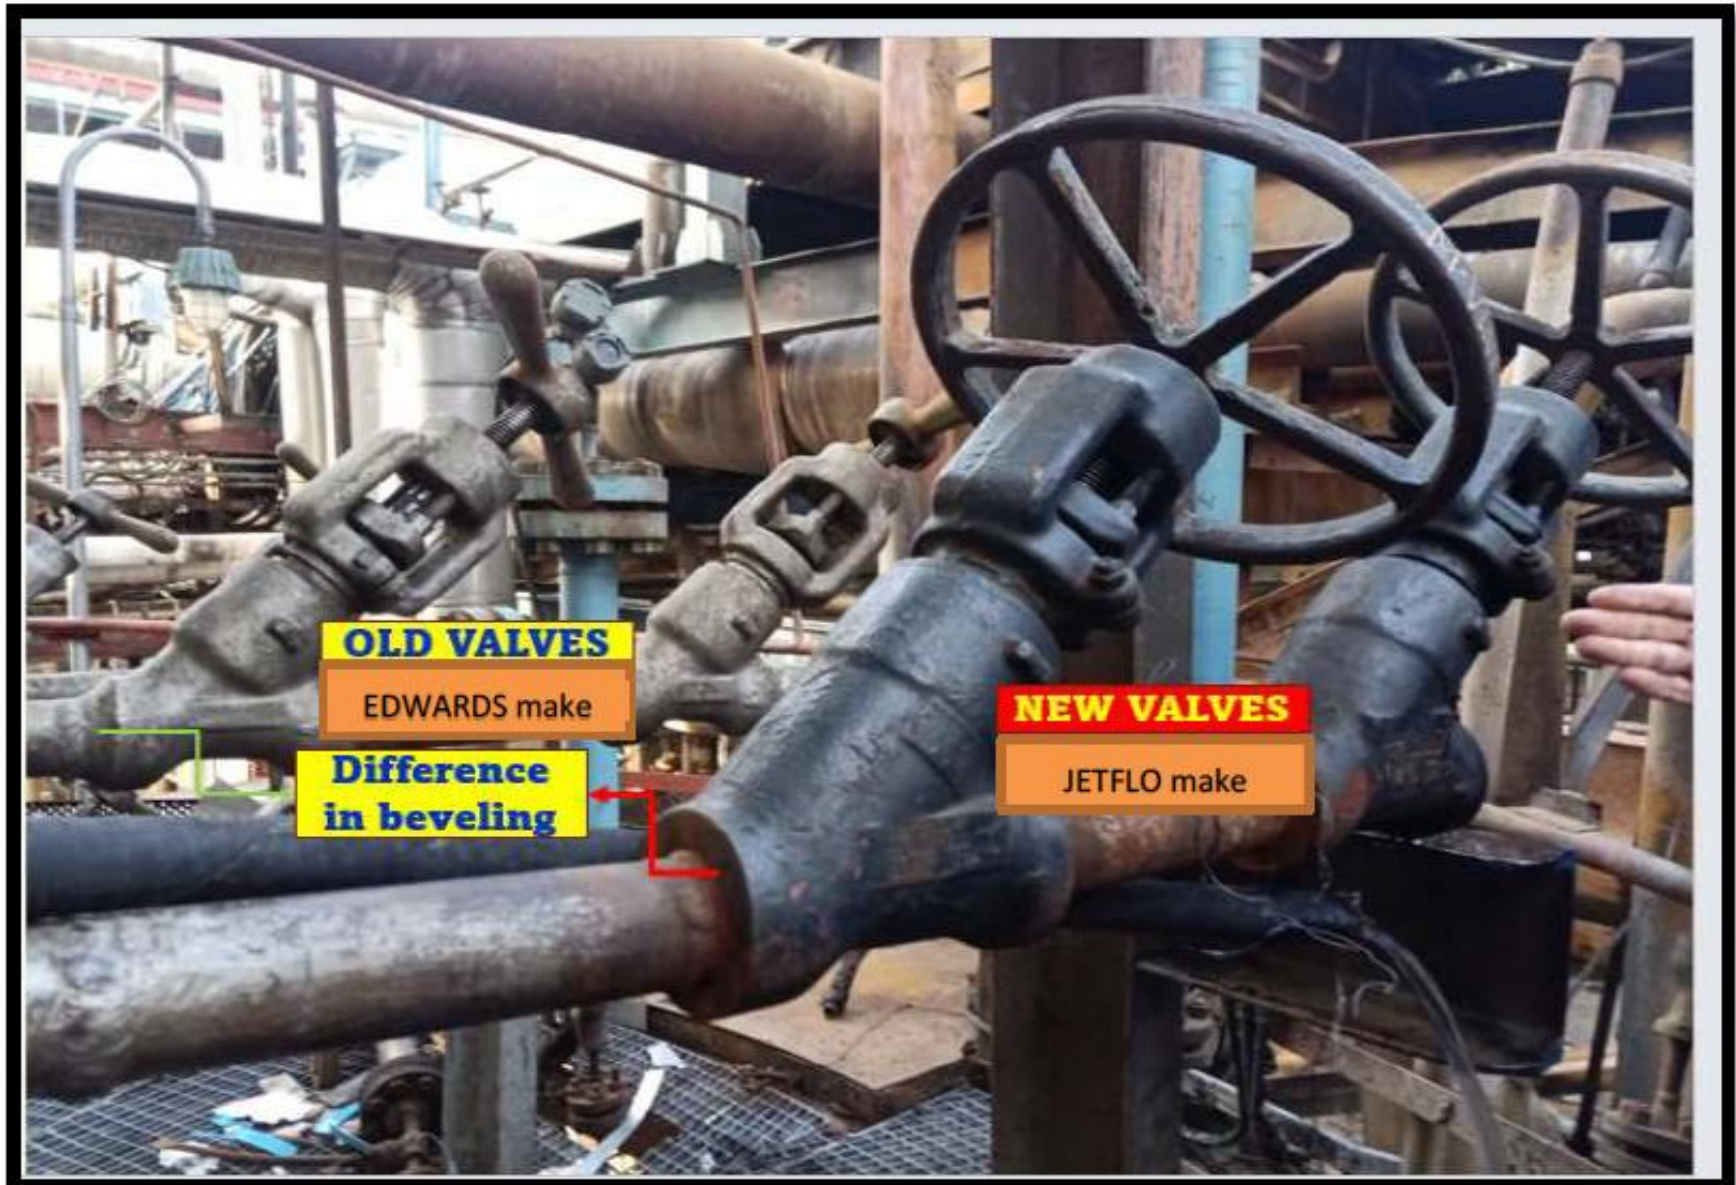
**Location:** Refinery

**Loss/ Outcome:** Damage to HC Pipelines, Electrical/ instrumentation cables, Piperack & Production loss

- Newly installed valve had manufacturing defects.
- Forged TPI by Vendor.
- Brittle fracture has happened at the bevel end of the “Y” type globe valve which resulted in release of hydrogen, hydrogen sulphide and hydrocarbon followed by explosion and fire.

- Proper scrutiny of TPI witness test certificates during material receipt.
- Suitable mechanism should be adopted for confirmation & verifications of inspection certificates directly from TPI
- Industry should directly appoint the TPI rather than selection by the vendor
- 100% Positive material identification (PMI) shall be ensured for all High rating valves in High Pressure section at Site including all carbon steel loop in order to identify the dissimilar metals

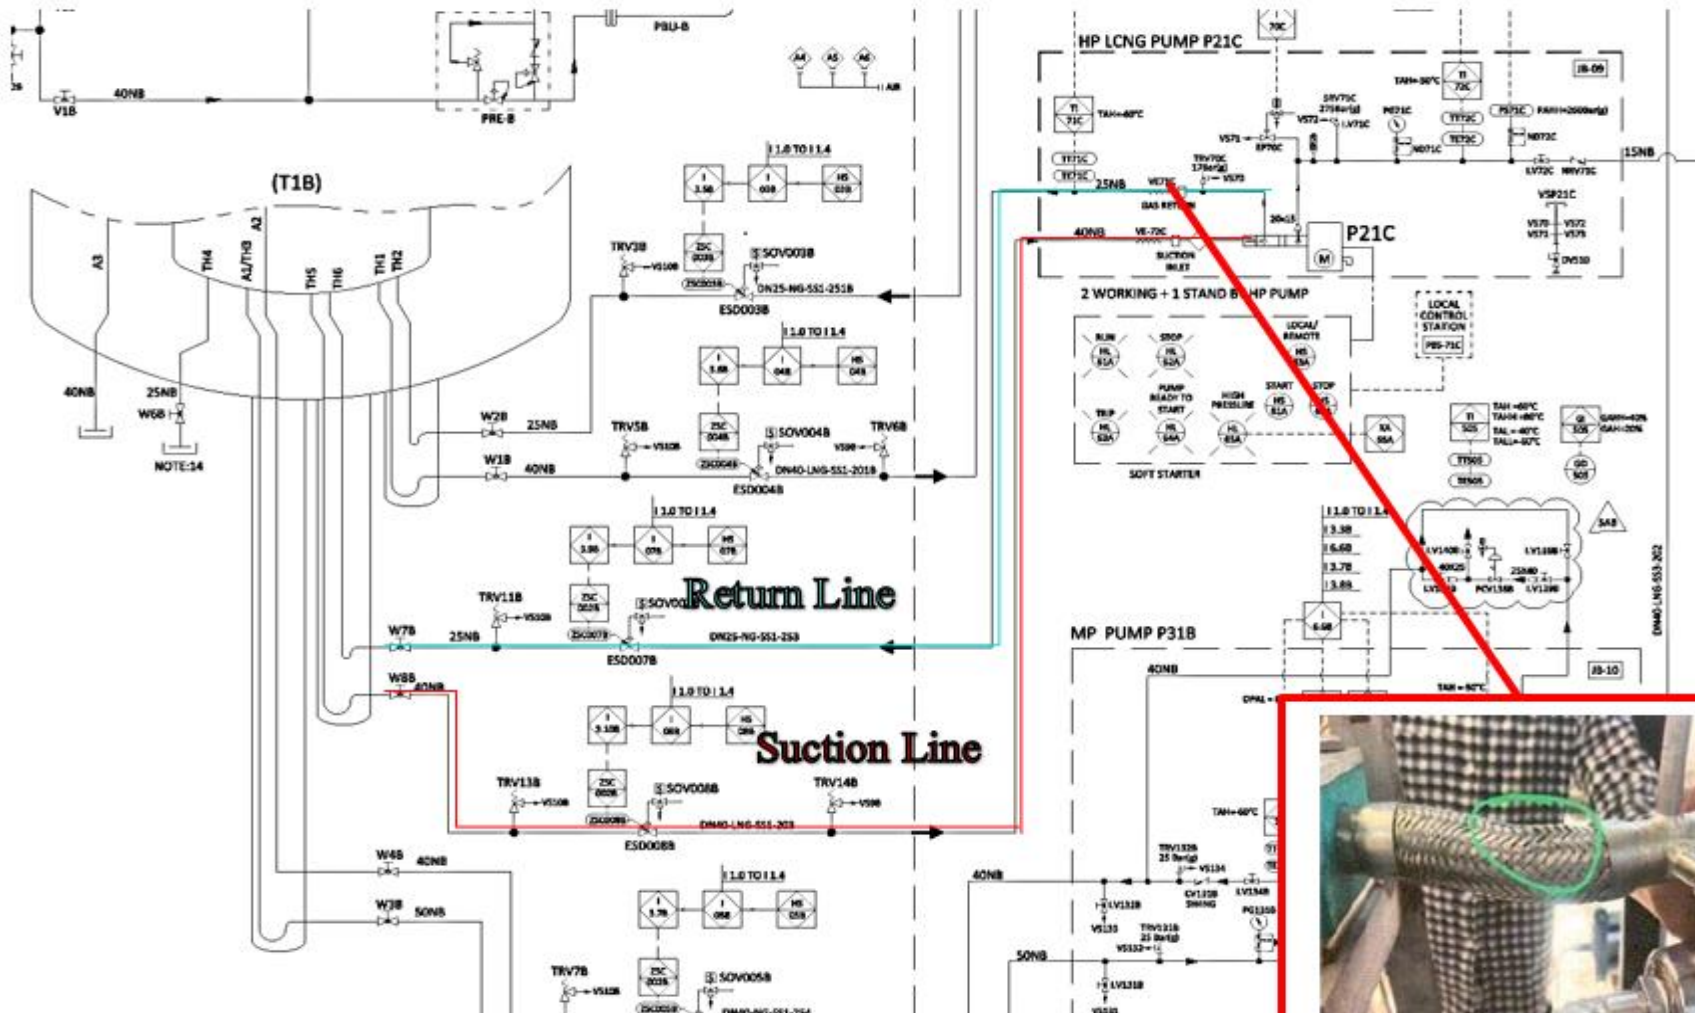
## Fire Incident at Cryogenic storage

Figure 1: Snipped from P&ID showing Pump P-21 C suction, return and

- Return line flexible connector (hose ) of pump which leaked failed due to cyclic exposures to cryogenic temperatures, intermittent operations and continuous vibrations. No hydrotesting of the hose was carried out. Delayed hydrocarbon detector response resulted in icing of the return ESD valve actuator due to vapour impingement and its failure to close.

- Cryogenic Flexible Hoses), all cryogenic flexible connectors (hoses) must undergo routine visual inspections under operating conditions at defined intervals
- Review of the requirement of hydrotesting the connecting flexible connectors may be carried out preferably in consultation with OEM.
- All ESD valves actuators in cryogenic system should be fitted with protective thermal jackets.
- Use of infrared (IR)–type flammable-gas detectors should be considered based on a formal gas-dispersion analysis to ensure optimal coverage

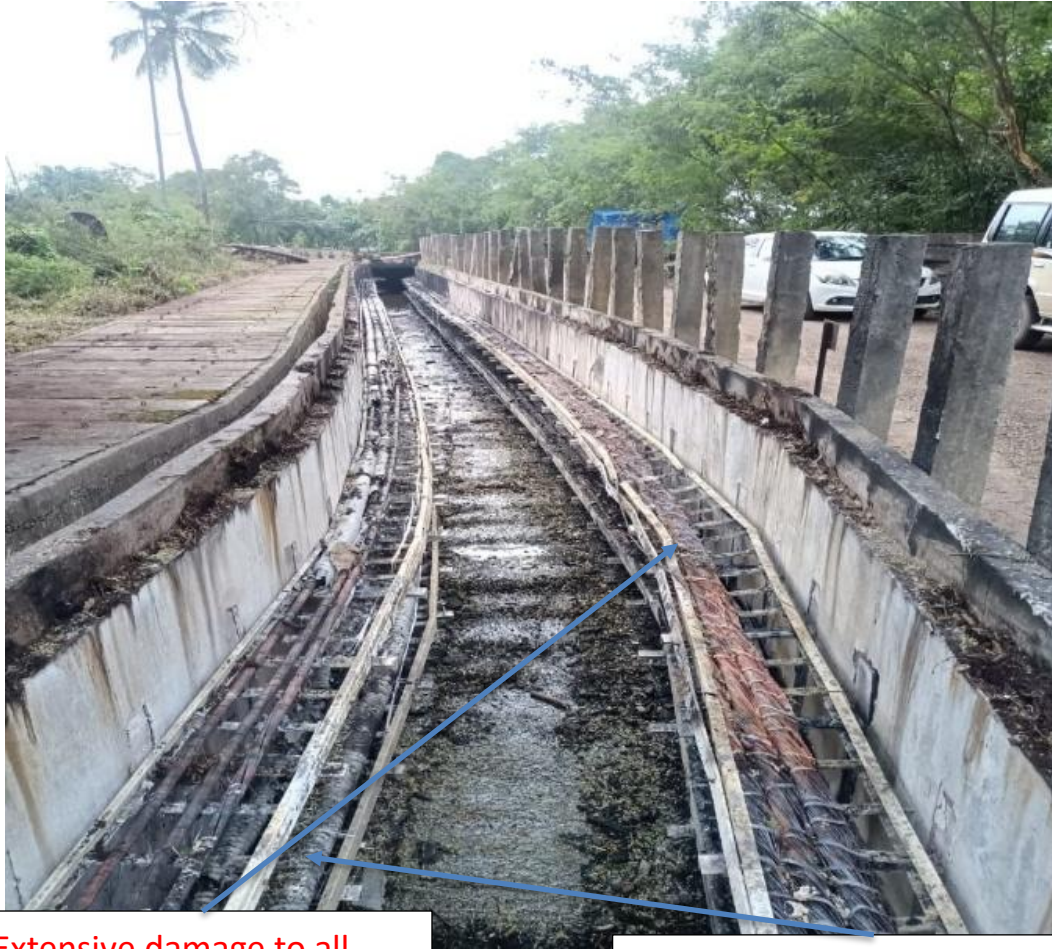
Extensive damage to all 12 power cables in a stretch of 175 m

Bare copper conductor with all outer covering viz XLPE insulation etc. melted away

Initiation point of the damage with extensive damage to cable trays, supports, adjacent concrete structure & melting away of copper conductor

- The cable joint likely deteriorated due to poor workmanship during jointing or manufacturing defects. Upon energization, switching surge triggered joint failure, causing an explosion and subsequent thermal damage to adjacent feeder cable insulations, leading to multiple cable failures.
- Absence of systemic monitoring such as Partial Discharge (PD) detection resulted in undetected deterioration. Additionally, despite availability of the Distributed Temperature Monitoring System (DTMS), early warning and preventive action could not be taken due to non-utilization and lack of monitoring.

- Ensure continuous monitoring of distributed temperature measuring system (DTMS)
- Online Partial discharge (PD) monitoring system for all EHV systems shall be provided for detecting faults at an incipient stage
- EHV Cable joints inside a cable trench should be protected against fire/explosions by suitable means like fire- and explosion-proof partitions, joint protection boxes, fire- and explosion-proof blankets, covering with sand etc.

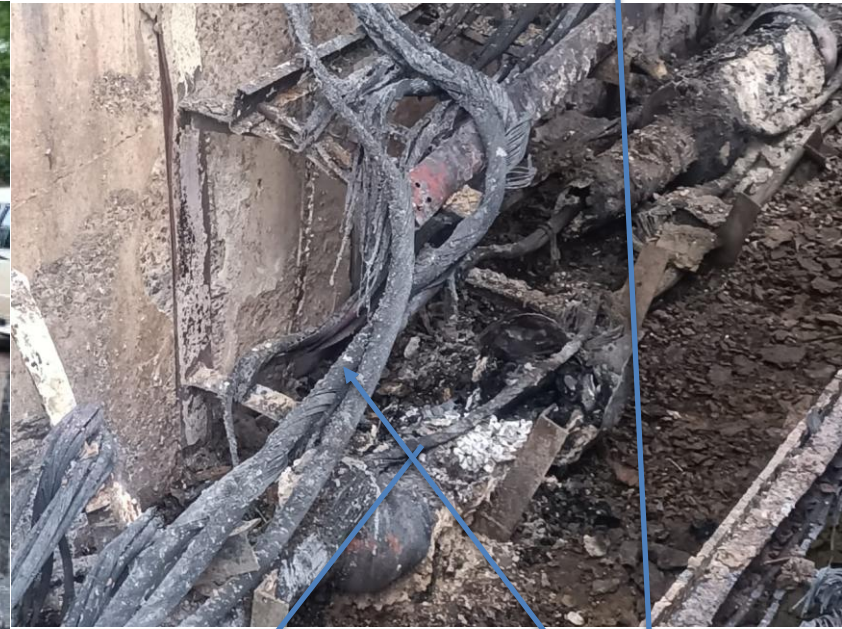
Cable joint after explosion

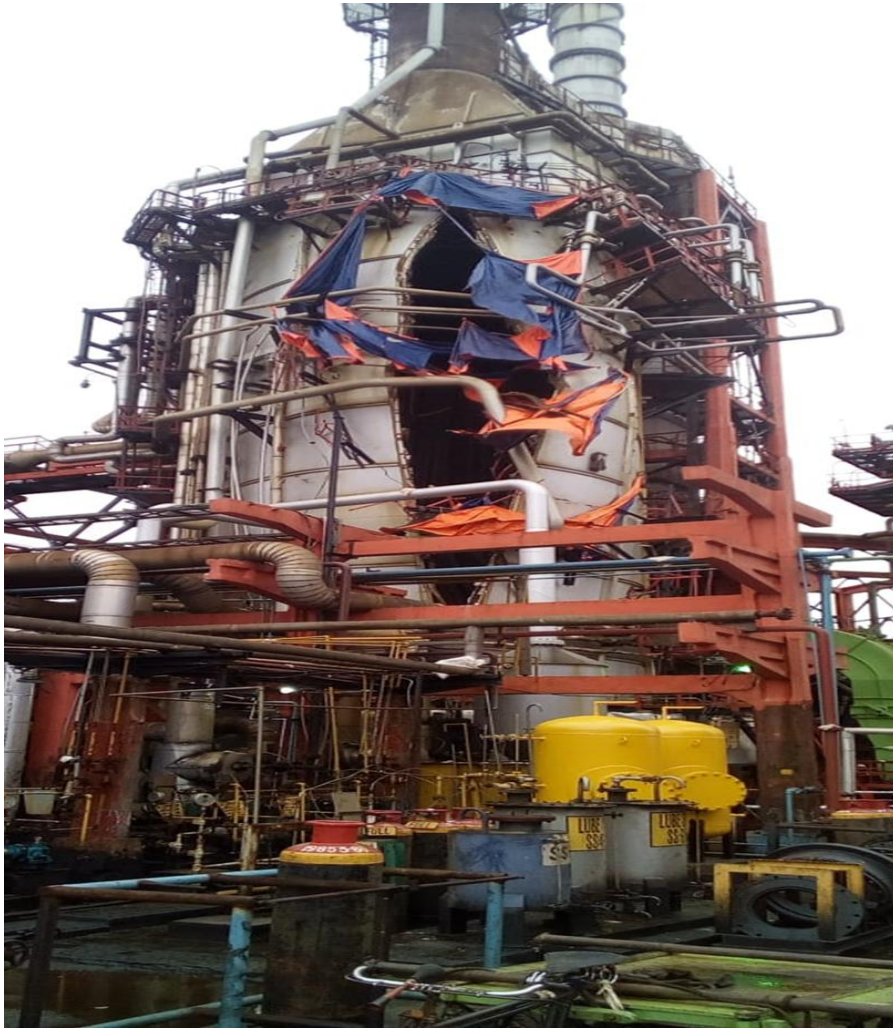
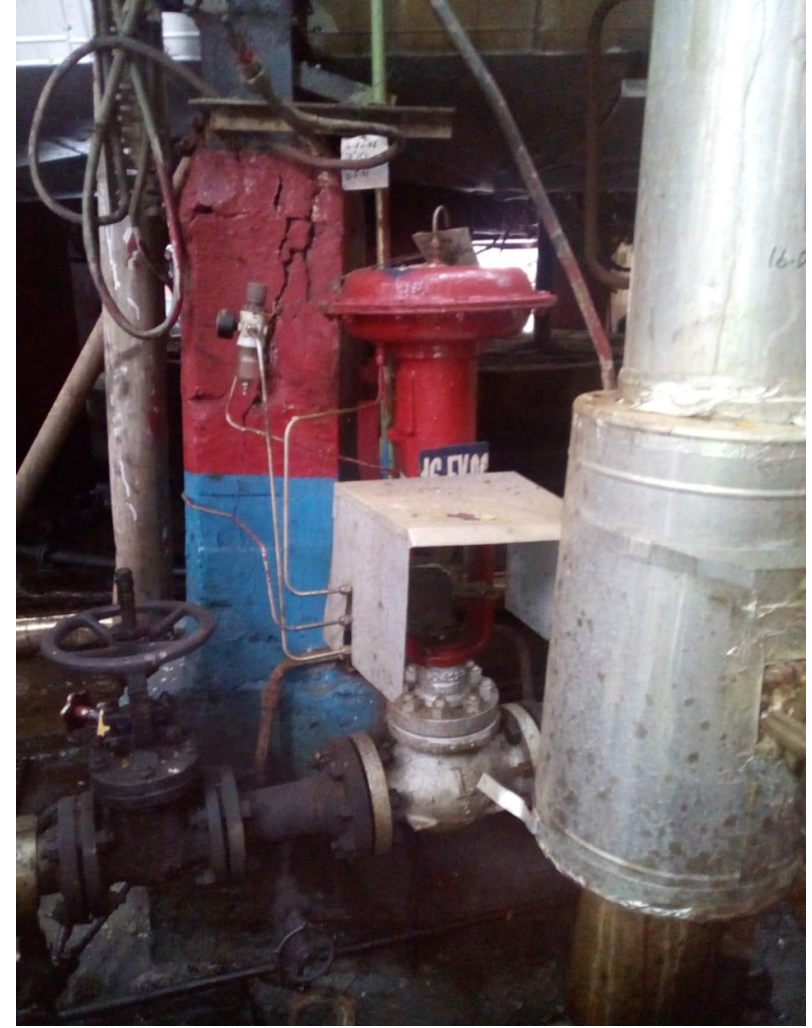
## Furnace Blast in CDU Unit

**Location:** Refinery

**Loss/Outcome:** Property damage & loss of production

- Resetting of the fuel gas control card led to closure of the control valve, extinguishing the burner flames. Subsequent manual opening of the valve without proper furnace purging caused accumulation of unburnt gas, which ignited upon contact with hot tubes, resulting in detonation.

- In case of flame failure/ failure of Fuel Gas/ Fuel Oil, furnace light up procedure i.e., box purging, pilot burner light up, main burner light up etc. shall be followed.
- Lapses in compliance with the work permit system, interlock bypass procedure, SOP for “Managing Exigency During Heavy Rain” to be rectified.
- Installation of Burner Management system (BMS) in furnaces

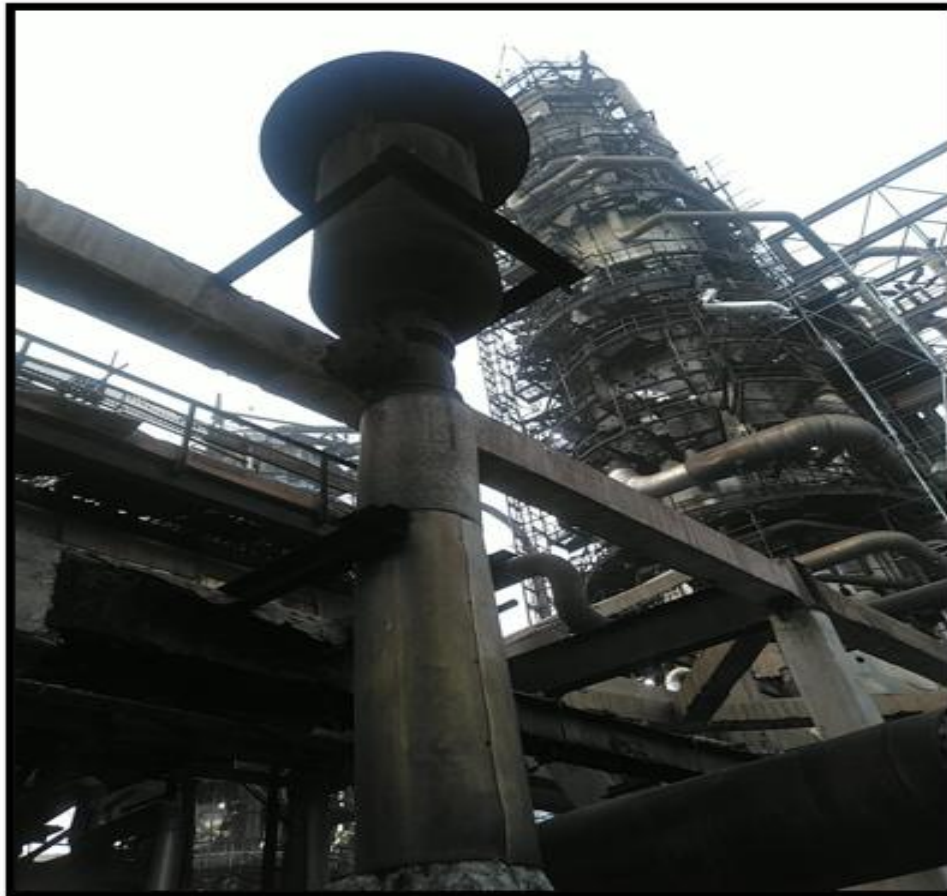
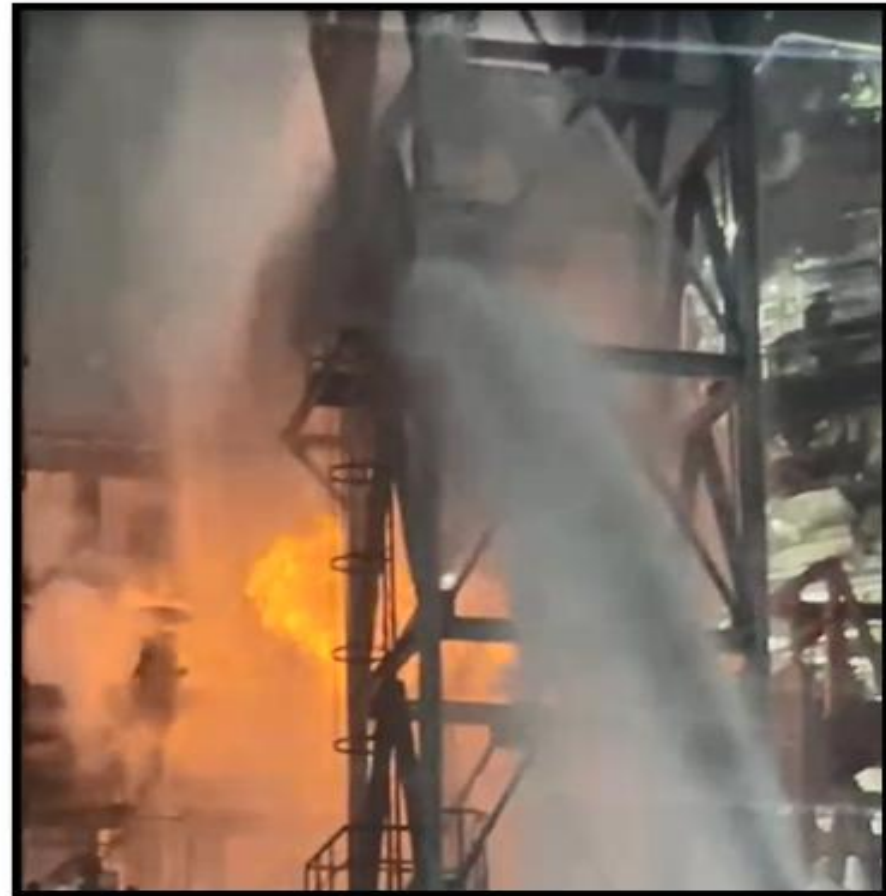
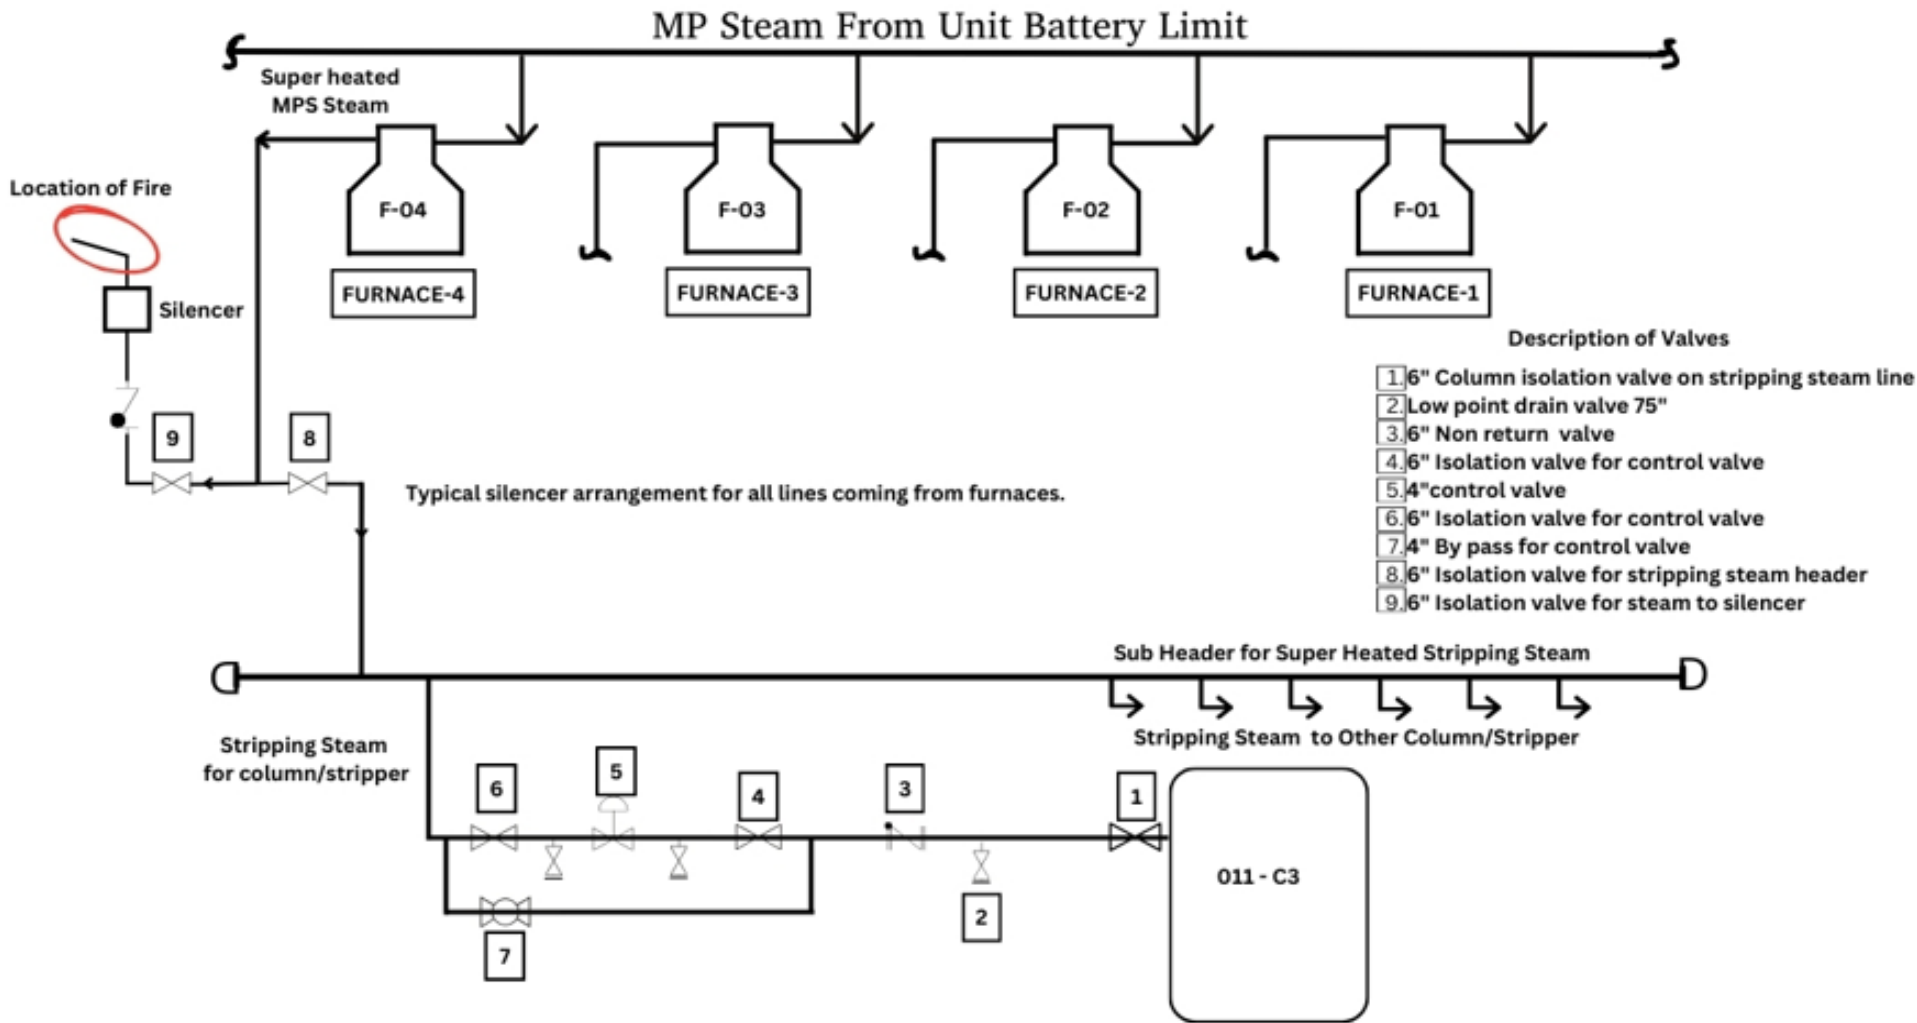
## Fire from steam silencer in Atmospheric Vacuum Unit

**Location:** Refinery

**Loss/Outcome:** Property damage & injury to 9 persons

- Naphtha backed up from heavy naphtha stripper (11-C-3) due to passing of isolation valves and NRV in stripping steam circuit possibly aided by high liquid level in the HN stripper. Hence, the stripping steam line up to the 6" diversion valve located at silencer platform was already full of Naphtha before the 6" diversion valve for routing steam from vent to the stripping steam header was crack opened. The liquid naphtha, when came in contact with superheated steam (320oC) vaporized and discharged through the steam silencer as in the downstream side, there was a blocked outlet condition.

- Installation of double NRV shall be reviewed in utility/ process interface circuit for enhancing system integrity.
- Method to check passing of critical NRVs should be developed. Means should be explored for online checking of such NRVs
- SOP to be developed for charging of steam headers. The same shall be known to all the concerned operating personnel.

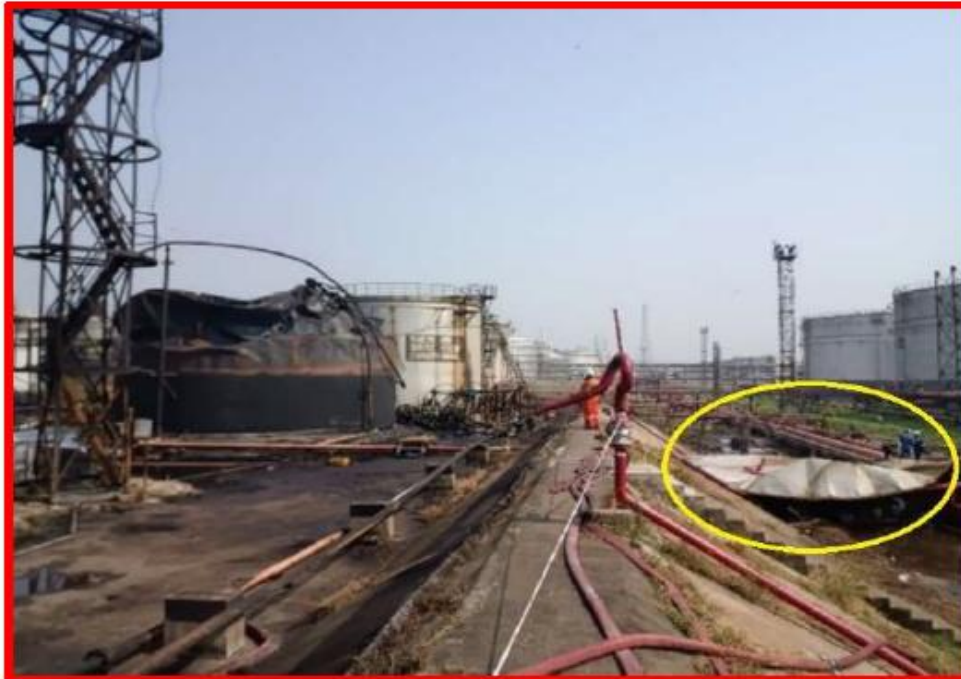
*Figure 1: Dome of the first exploded tank, outside the dyke.*

- The first explosion was caused by the confined vapor cloud explosion between the floating roof deck, and the fixed roof ignited most likely by the discharge of static charge (accumulated during the receipt of material).
- The second explosion occurred due to boiling of material in the second tank, aggravated during the foam application interruption.

- Sampling and gauging devices shall be either completely conductive or completely nonconductive.
- Review the effectiveness of conductive equipment/ earthing system associated with low-conductive flammable liquids on quarterly basis.
- Gauge hatch shall be non-sparking (or lined with non-sparking material) and self-closing type
- Nitrogen blanketing for internal floating roof tanks/ fixed roof tanks should be considered for storing products like benzene, etc.
- Anti-static additives may be added for increasing the conductivity.

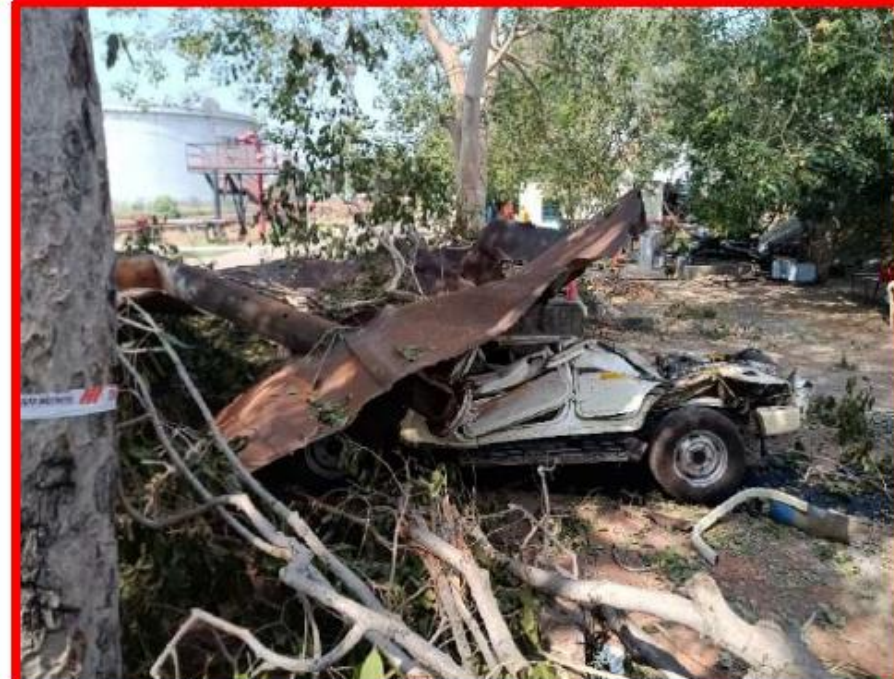
*Figure 2: Dome of the second exploded tank.*

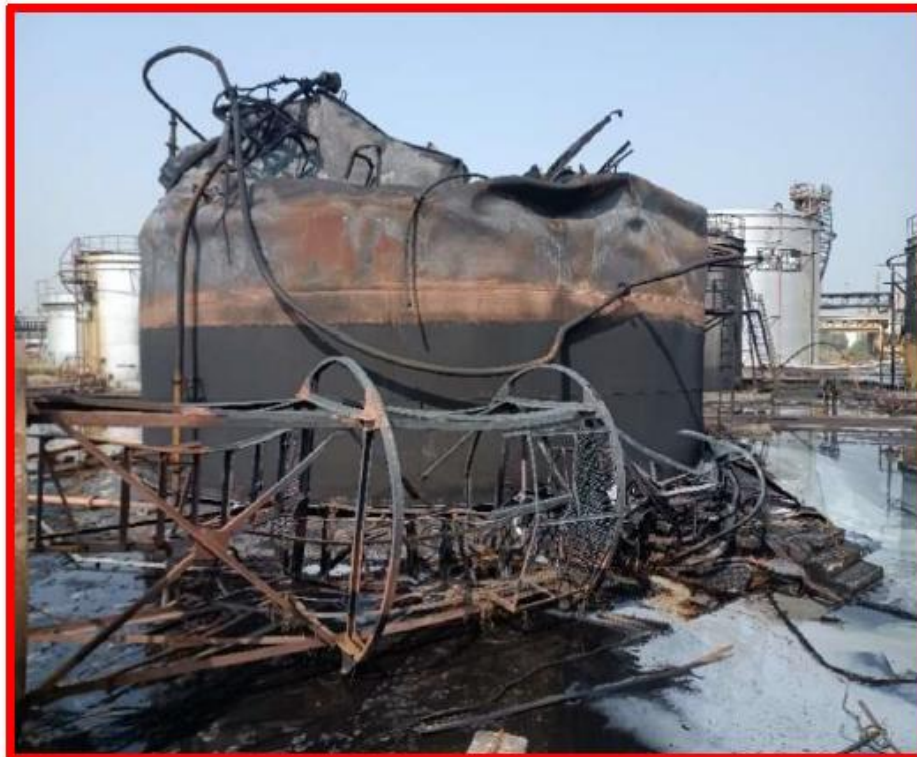
*Figure 3: Image of the first exploded tank.*

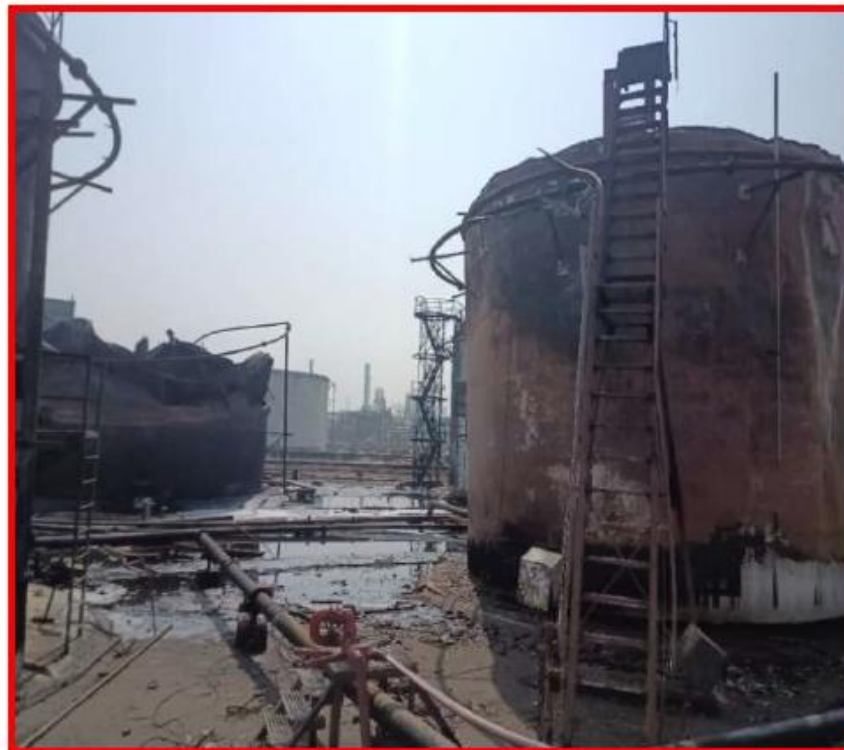
*Figure 4: Image of the second exploded tank.*

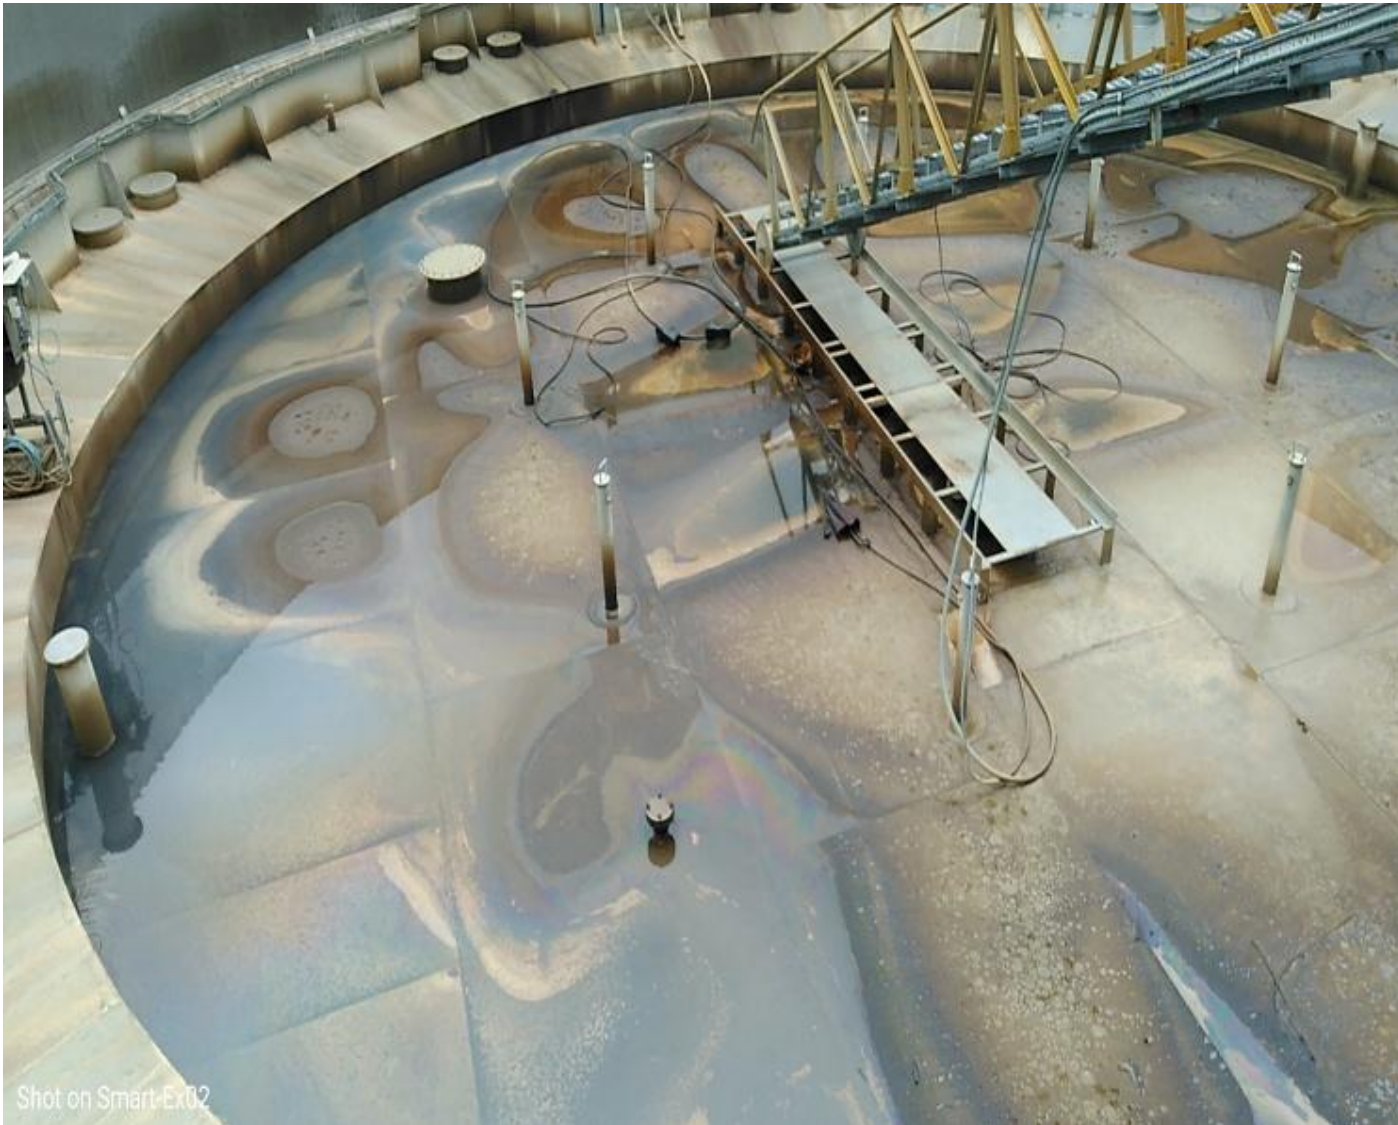
## FATAL ACCIDENT OF H<sub>2</sub>S EXPOSURE IN TANK FARM AREA

**Location:** Refinery Tank Farm area

**Loss/Outcome:** 2 Fatalities

- Acute Inhalation of H<sub>2</sub>S gas at IDLH concentration
- Entering confined space without appropriate precautions
- Cognizance of prior indication of H<sub>2</sub>S in slop tank was not taken and suitable risk mitigation measures were not implemented.
- Lack of awareness amongst operators regarding potential H<sub>2</sub>S hazard in slop tank.
- Lack of supervisory actions against routine violation of entering floating roof deck without confined space permit.

- Identify and control routing of H<sub>2</sub>S-rich streams to slop tanks; implement SOPs for proper communication, monitoring, and recording of slop transfers.
- Install fixed H<sub>2</sub>S detectors with audio-visual alarms, warning signages, and provide peripheral marking at 3-m level inside tank shell to enhance hazard awareness.
- Strictly enforce the Work Permit System, conduct regular training and refresher programs, and carry out periodic rescue drills for H<sub>2</sub>S exposure scenarios

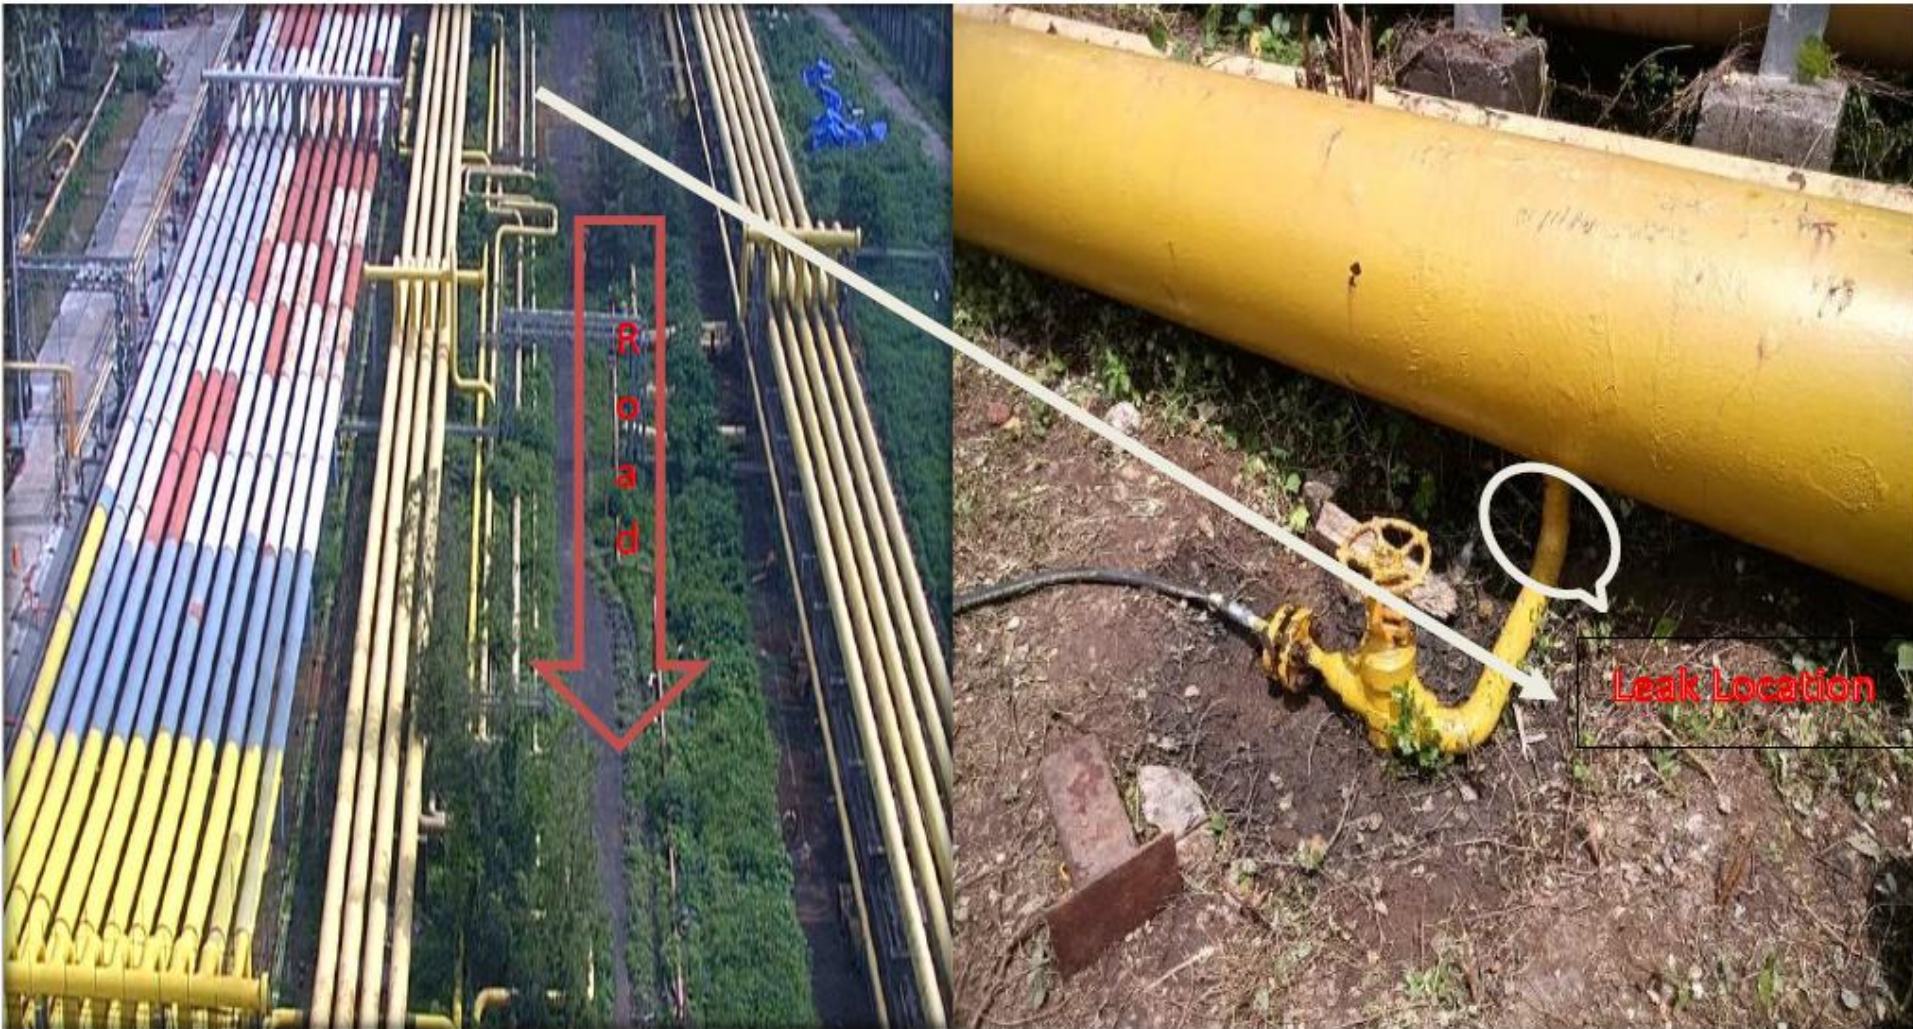
## Fire in 2" hydrocarbon drain line

**Location:** Slug Catcher Area in Gas Processing Plant

**Loss/Outcome:** Unit outage & production loss,

- The cause of hydrocarbon leak was the JCB hitting the 'L' shaped 2" drain line (located at the proximity of road) of the 18" interconnection gas line in the slug catcher area during the scrapping of Road for cement surfacing work.
- The latent failure was absence of marking/ barricading around the protruding drain line as well as non-availability of crash barrier/ barricading on roadside to protect the pipelines.
- The systemic lapses included improper hazard identification, deviation in the work permit renewals, non-compliance with MOC procedures.

- Crash Barrier or physical barricading shall be provided along the slug catchers to prevent any impact on the hydrocarbon lines
- Any modification shall only be undertaken after following proper MOC procedures
- Permit should be issued/ renewed only after due diligence. Periodic audit of work permit system should be carried out
- Structured training of concerned personnel should be ensured. All potential hazards, associated with the job, should be comprehensively identified & addressed in Job Safety Analysis (JSA).
