OISD/CS/2021-22/LPG/05

Title: Fatal incident during degassing process of 150 MT capacity above ground LPG storage bullet

Location: LPG Bottling Plant

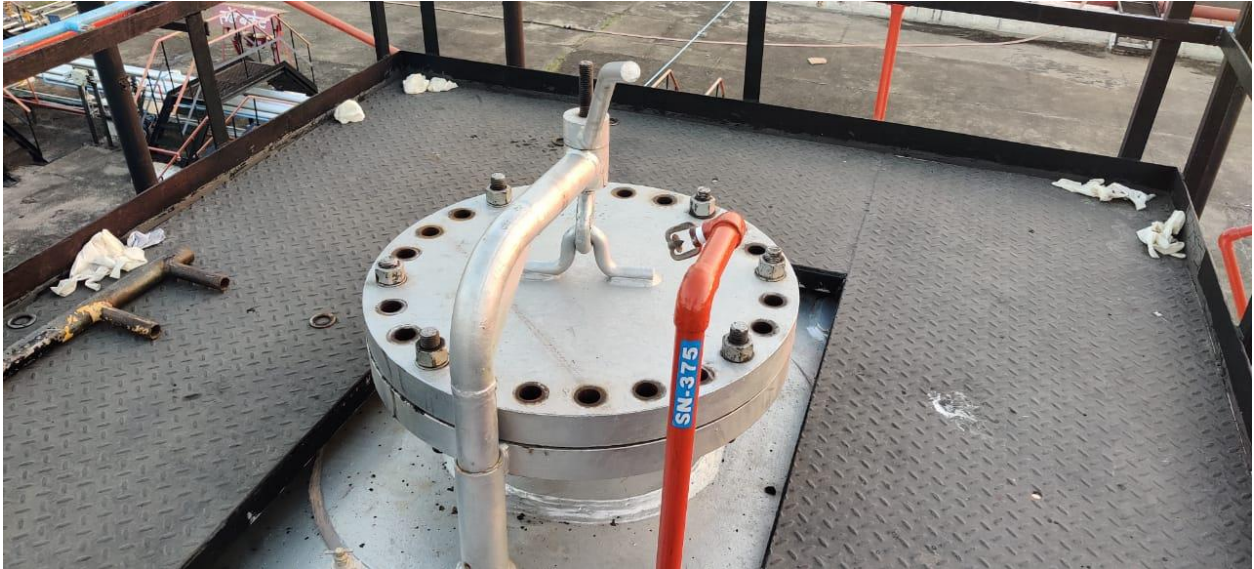
Plant personnel tried to rescue these two persons but due to lack of oxygen inside the bullet, small size of manhole (460 mm internal dia) and non-availability of appropriate equipment for rescue in such condition, no one could enter inside the bullet.

MANHOLE OF BULLET (460 MM INTERNAL DIA)

Rescue operation could not be done in time due to non-availability of equipment for safe vessel entry (having LPG vapour/ lack of oxygen) through manhole (460 mm internal dia). To provide suitable equipment such as hose mask with hand operated blower/ Supplied Airline Respirator system and full body safety harness with double lanyard, for safe vessel entry. Same to be used at the time of vessel entry even after degassing of vessels during periodic testing/ any other maintenance work.

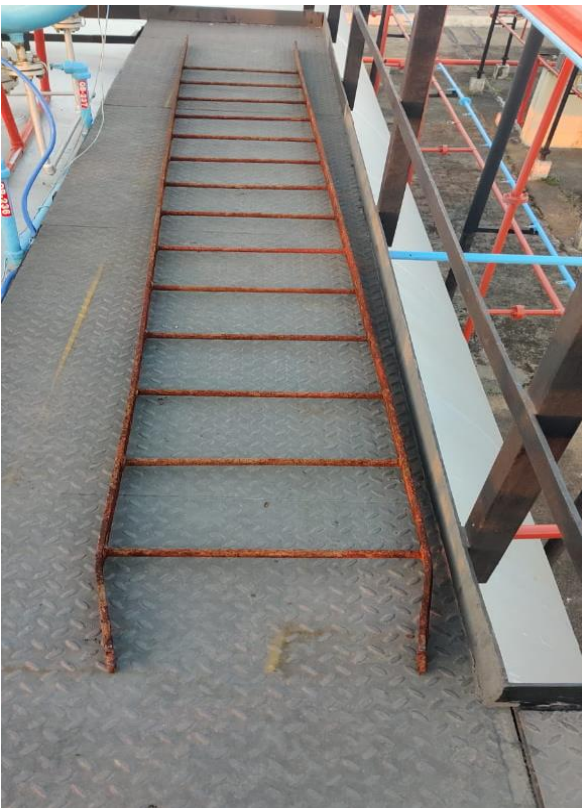
LADDER OF BULLET REMOVED FOR TAKING OUT THE BODIES

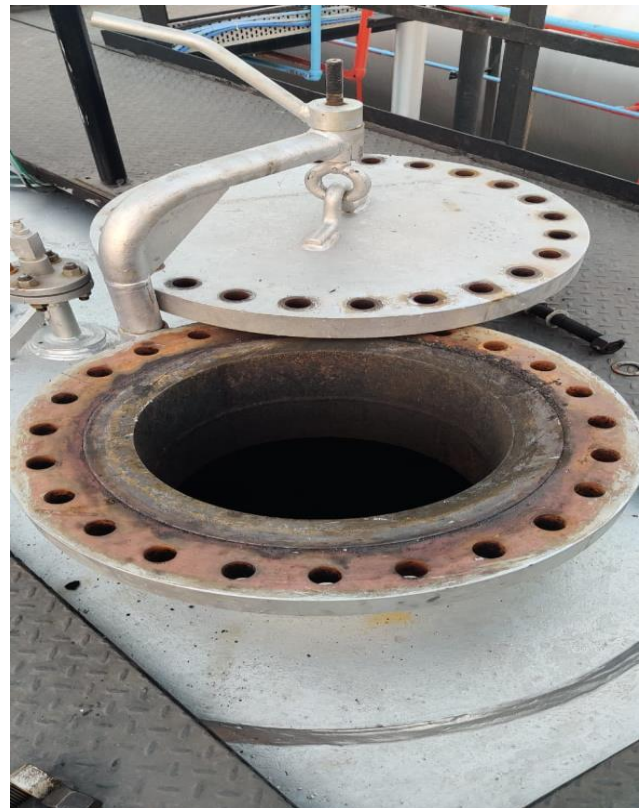
Rescue operation could not be done in time due to non-availability of proper equipment for safe entry in vessel (having LPG vapour or lack of oxygen) through manhole (460 mm internal dia). Location itself tried to rescue the deceased, but personnel were unable to enter the vessel through manhole carrying breathing apparatus, due to restriction faced by large size of BA to pass through the manhole. Call to mutual aid members for emergency/ rescue was made after a delay of more than one hour.

MANHOLE OF BULLET (460 MM INTERNAL DIA)

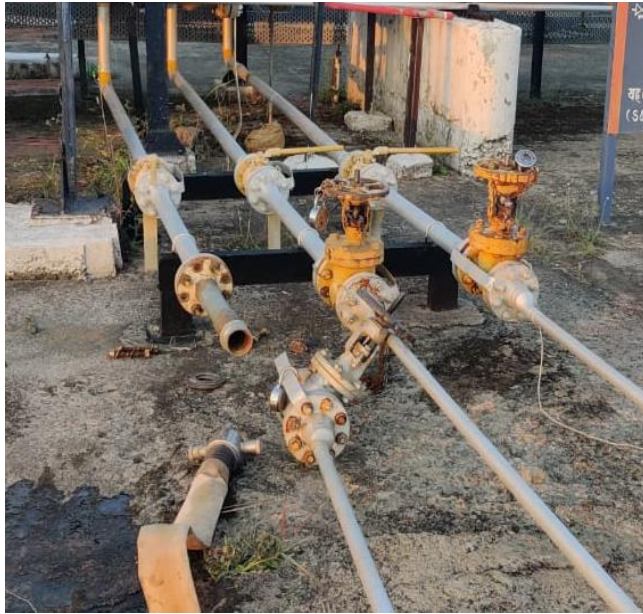
For degassing of bullet no. 3, fire hose was connected from one Double Hydrant at water drain point of bullet no. 3, through a spool piece having male part for hose connection. To speed up the water filling for degassing of bullet no. 3, another fire hose was connected from another Double Hydrant up to the top of bullet no. 3 for water filling through manhole. For this purpose, top manhole was opened and both the deceased person in presence of HSE officer tried to hold/ fix the fire hose in manhole and in this process one person fell inside the bullet and second person went inside the bullet to save first person.

**HOSE CONNECTION FOR WATER FILLING
IN BULLET THROUGH WATER DRAIN LINE**

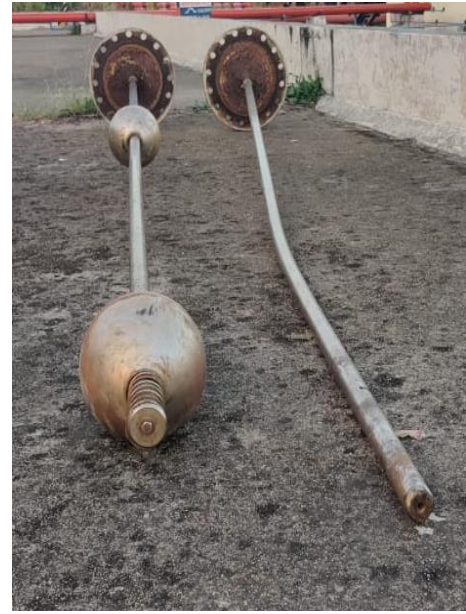
- a. Each bullet is having two level gauges i.e. Rochester gauge and Magnetic Level gauge, however reading of only Rochester gauge is being entered in the LPG Pump House dip book. Magnetic Level gauge of bullet no. 3 was not working and reading of the same was not being recorded in dip book. Plant is not aware since when this gauge was not working.

**LEFT (MAGNETIC LEVEL GAUGE)
RIGHT (DEFECTIVE MAGNETIC
LEVEL GAUGE)**

- a) To ensure logging/ entry of daily activities and sequence of operation performed in the log book of respective area where maintenance work is being carried out.
- b) Logbooks should be reviewed and countersigned by the role holder officer on daily basis.
- c) Reading of both the level gauges provided on LPG storage vessels should be recorded in log book/ dip book irrespective of which gauge reading is used for stock accounting purpose.
