CASE STUDY

OISD/CS/2023-24/P&E/08

Title: **Fatal accident during construction activity**

Location: **Refinery**

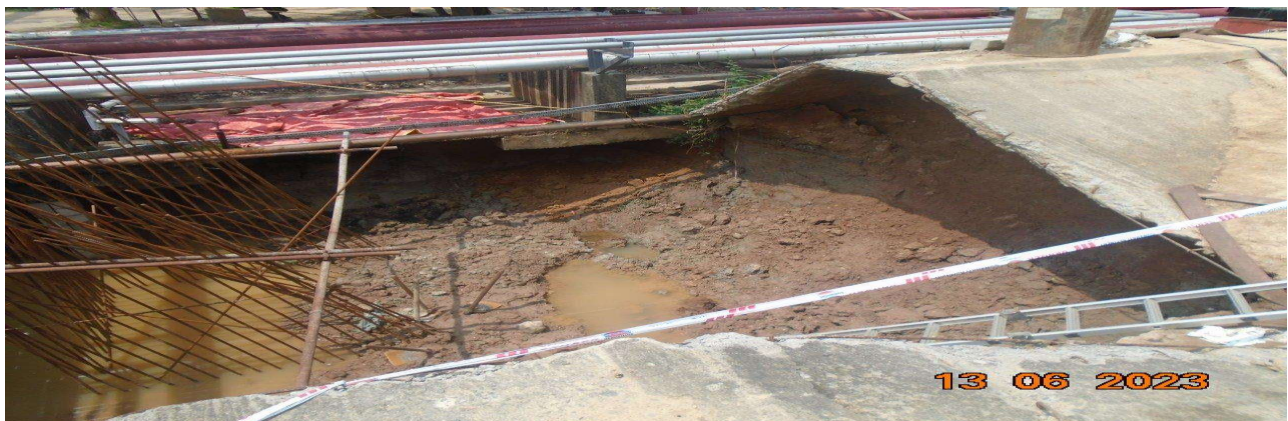
- It was observed that shoring was not there in the excavated pit, where accident took place. Shoring was absent even in the adjacent excavated pit. There was no proper approach to the excavated site and lot of iron rods and clamps were lying there.

Non-provision of sloping/shoring/strutting was the cause of soil collapse of one wall of the pit. The pit depth from ground level was 4 m. The mud dyke wall height was approximately 2 m. Accordingly, the effective depth of the pit bottom from top of the mud dyke was 6 m. Angle of repose was not maintained for excavation and steep vertical excavation was done. The unavailability of safeguard resulted in soil collapse of 6 m of the steep vertical mud wall instigated by the activities of the contract workers.

- All excavation should be done as per clause no 6.1 of OISD-GDN-192 by providing shoring and strutting and maintaining angle of repose for ensuring the structural stability of the pit. Other requirements as per clause 6.1 of OISD-GDN-192 and OISD-GDN-207 should be followed during excavation work.
- Compliance of work permit system as per OISD-STD-105 to be ensured. Actual situation in field is to be verified before mentioning the conformity of stipulated conditions in the permit. The recommendations and safeguards of JSA are to be followed. Recommendations of soil test report should be followed or appropriate/alternate mitigatory measures should be ensured.
