## CASE STUDY

OISD/CS/2023-24/P&E/09

Title: Major Fire Incident at HCU.  
 Location: Refinery  
 Loss/ Outcome: Production Loss & Property Damage

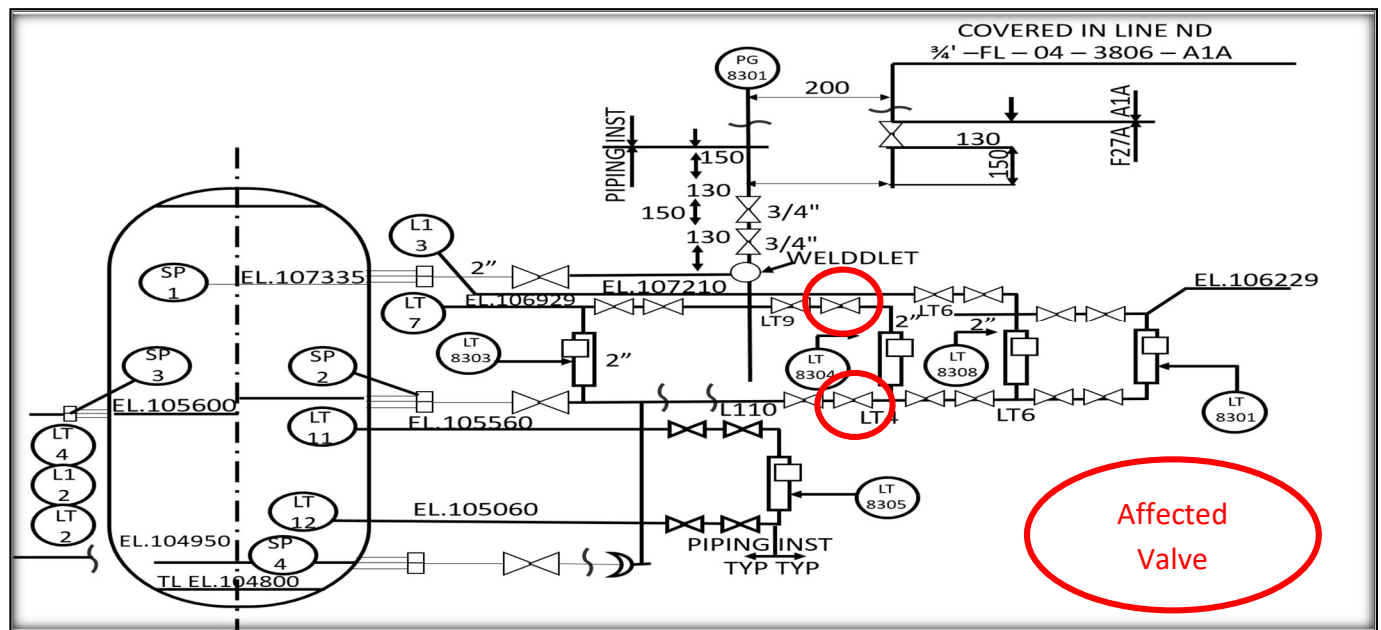
Explosion along-with major fire occurred in the vicinity of Cold High Pressure Separator (CHPS) in HCU unit. Operating personnel took emergency shutdown of the unit and depressurization activities were carried out by activating dump valve located at CHPS overhead line.

Firefighting activities were carried out by F&S personnel and fire was restricted to the source area within 20 min by continuous firefighting. N<sub>2</sub> de-blinding in the RGC suction line upstream of suction MOV was carried out and N<sub>2</sub> was pushed into the CHPS. However, the residual hydrocarbon of the system continued to burn. As there was no isolation valve in the High Pressure section upstream of CHPS to cut off the HC vapours coming into the separator, the hydrocarbon content of the system was allowed to burn. Finally, the fire got extinguished completely after 4 hours on the same day till the residual hydrocarbon from the separator got exhausted completely. Schematic representation of CHPS is given below:

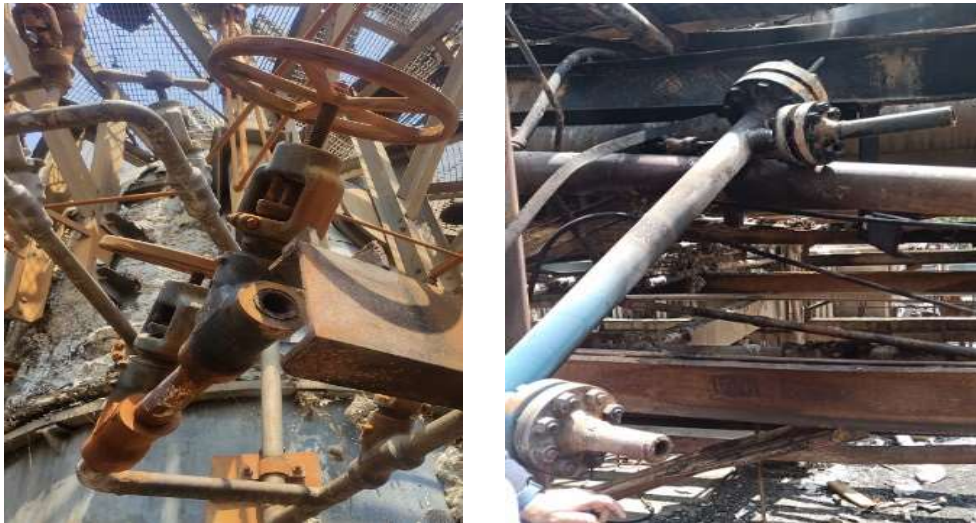
*Incident Site Photos*

2. One of the level troll standpipes meant for HC liquid level measurement was found sheared from the 2<sup>nd</sup> isolation valve, both on the LP as well as the HP side.

5. Pipe racks including pipes and supports, cable trays, within 15-20 meters from the leakage point were found damaged. Electrical and Instruments cable duct in the pipe rack were also found damaged.

7. Remaining troll standpipes were intact, and no damage was observed. No other valves had been replaced.
8. Failure of both the valves occurred in the valve body, just before the weld joint. Weld joints between troll standpipe piping to valve body was found intact.

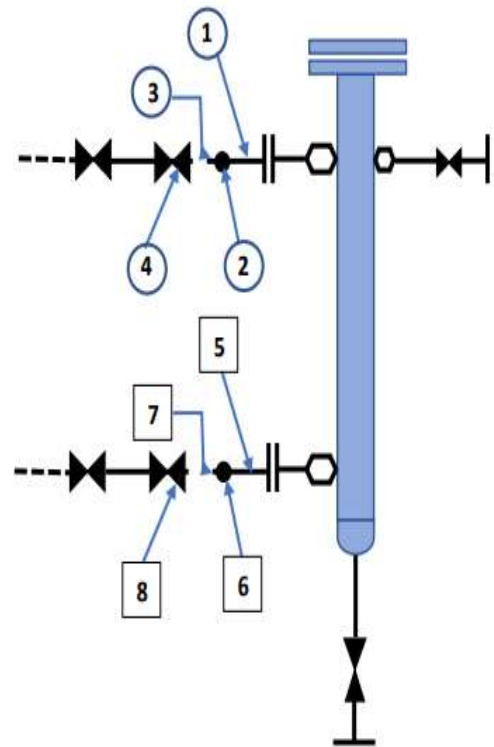
17. PMI of the relevant failed valve was carried out. It was observed that P-5 pipe was used in one side in deviation from the manufacturing guidelines.

S. no	Description	Chemical Composition					PMI Result
		Fe	Mn	Cr	Ni	Mo	
1.	LT Pipe Top	96.8	0.76	0.19	----	----	CS
2.	LT Pipe Weld Top	96.5	0.15	0.09	----	----	CS
3.	Break Point Top	93.2	0.76	5.78	----	0.5	P5
4.	Valve Body Top	98.5	0.92	0.42	----	----	CS
5.	LT Pipe Bottom	98.7	0.96	0.12	----	----	CS
6.	LT Pipe Weld Bottom	97.8	1.15	0.78	----	----	CS
7.	Break Point Bottom	94.9	0.71	3.94	----	0.5	P5
8.	Valve Body Bottom	96.4	0.80	----	----	----	CS

5. 100% Positive material identification (PMI) shall be ensured for all critical high rating valves (Criticality shall be defined by the industry and the same shall be authenticated) in high pressure section at site, including all carbon steel loop, in order to identify the dissimilar metals. PMI should be ensured for both the sides of the weld joints in such valve installations. Industry shall devise the criticality for the requirement of PMI.

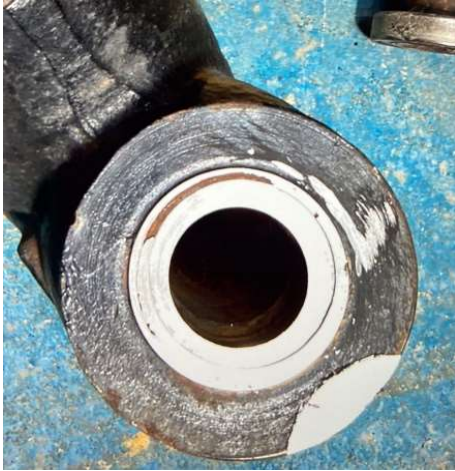
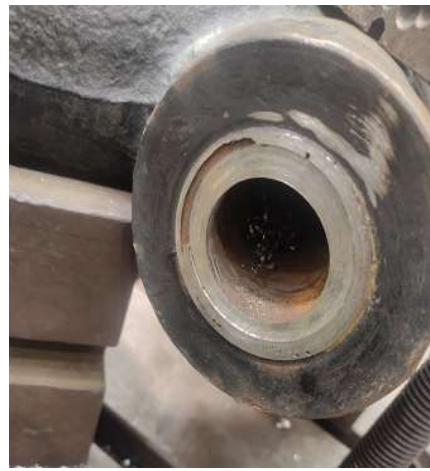
19. Bevelled end of the failed new valve was machined off in a boring machine in refinery workshop and the observations are as follows:

- ✓ Mark of the welding was observed at the end of valve body.
- ✓ An elongated circular discontinuity observed at its vertical to bevel end interface. The fillet welding also has discontinuity and other defects.
