## CASE STUDY

OISD/CS/2023-24/P&E/10

Title: **Accident during maintenance activity**

Location: **Refinery**

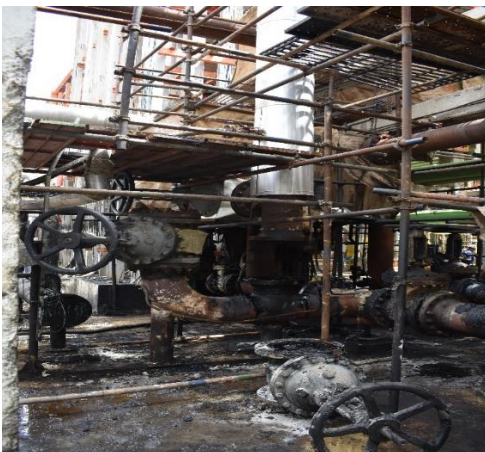
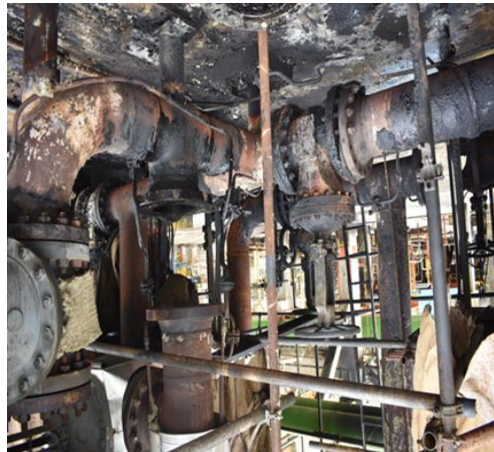
- Site was congested due to project job scaffolding all around the accident location. Reportedly, one of the injured had fallen while running away from the site and had maximum burns.

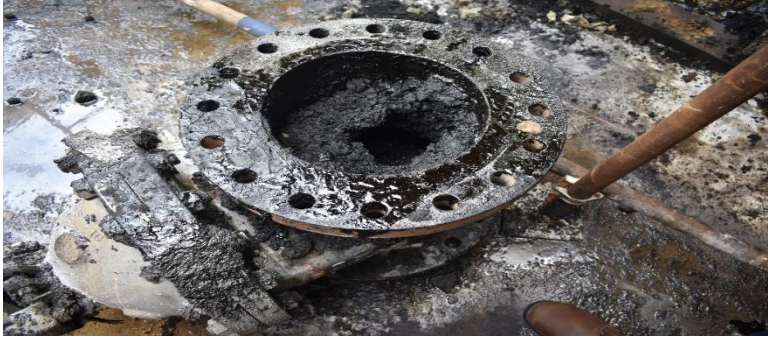
- Dropped 12" common outlet valve of VR exchanger was found chocked with tarry material/coke.

- The vertical loop of line was in tension and after removal of the valve, the line had shifted slightly towards battery limit.
- Provision for draining of steam condensate and fouling material had been made from the 2" horizontal stub of vertical header. The stub had a high possibility of being choked.

There was hot condensate trapped in the choked line. Due to blockage, the pressure buildup must have kept the condensate in liquid phase (saturation pressure at 150°C is 3.82 kg/cm<sup>2</sup>G). On release of pressure, caused by dislodging of the tarry material/coke, which was probably initiated because of the jerk of valve removal and the release of tension in the line, the condensate evaporated violently sending out a gush of steam/condensate from the open end of the line. The lowering of the temperature corroborates the phenomenon.

- Flushing job SOP may be reviewed like consideration of water flushing post steam flushing to ensure that temperatures are lowered before job is taken up. In case of suspected choking, all precautions shall be taken for line flushing as well as during opening of the line.
- Safe work practice shall be ensured as per Cl.7.3 of OISD-GDN-206(2023) like, Identification of anticipated or inherent/ specific hazard and risk involved should be done through:
  - ✓ Systematic evaluation of stepwise activities involved in the non-routine job or it's execution.
  - ✓ Identification of possible unsafe conditions in the surrounding
  - ✓ Identification of Hazard and risk from other job in the vicinity (if any).
