CASE STUDY

OISD/CS/2023-24/E&P/11

Title: Major fire incident at cluster location.

Location: On-land Workover Location.

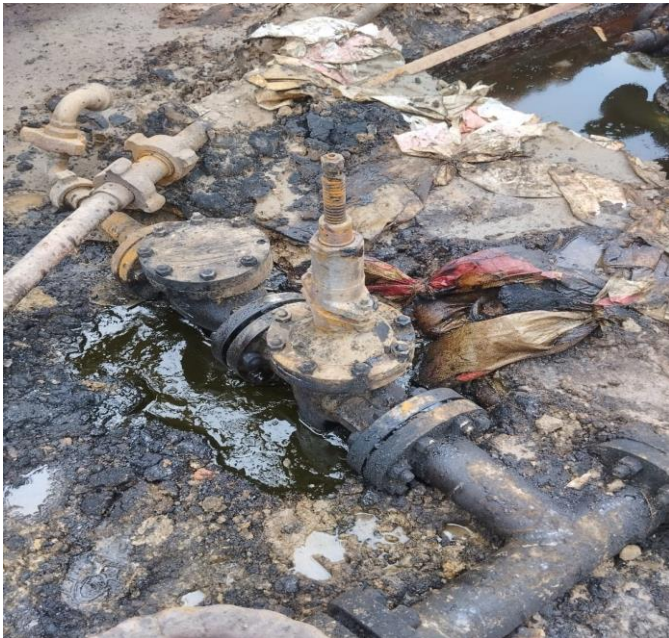
- The control wheels of valves on the X-mas tree of temporarily closed wells were not removed.
- Non-metallic compressed asbestos sheet was used as the gasket for flange of gate valve 4"X400#RF type instead of spiral bound metallic gasket.

Flange between NRV & Gate valve that leaked

- All rig crew members shall undergo comprehensive training on SIMOPS.
- The flange joint should be provided with either spiral wound metallic gaskets or metallic ring type gaskets, depending upon the piping class. Metallic gasket should be used for Raised Face flanges (RF) as per best industrial practice.

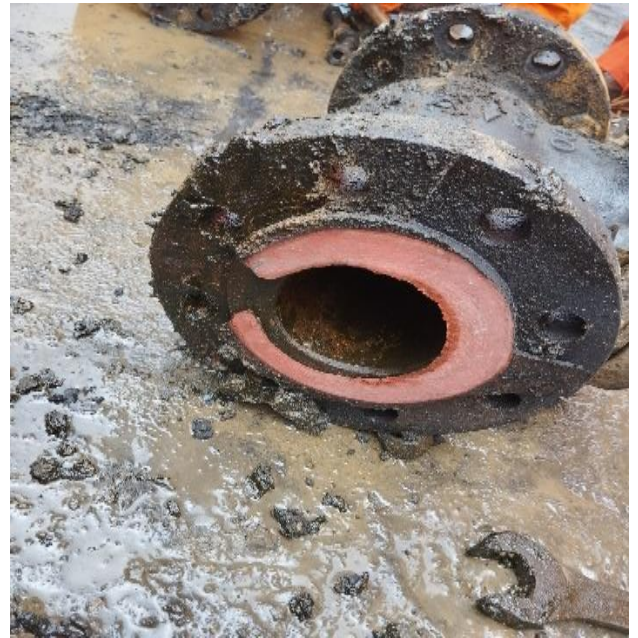
- Selection of non-metallic gasket for 4"X400#RF class gate valves instead of spiral wound metal gasket was not as per best industrial practice.
- There was absence of recorded pressure monitoring for the flow line of producing well at cluster location, following the flushing activities conducted at other well which was connected to the flow line of producing well. Due to this, constant building up of pressure in the flow line of producing well went unnoticed.

Questioned gasket which gave way.
