CASE STUDY

OISD/CS/2023-24/P&E/15

Dt.: 28/03/2024

Title: Fatal Incident due to fire in wet slop oil pump house.
Location: Refinery
Loss/ Outcome: Property Damage and One fatality

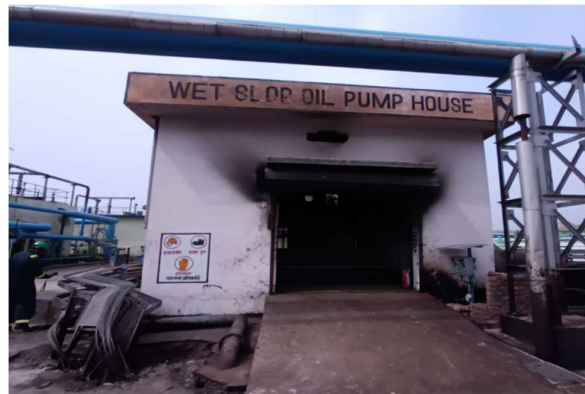
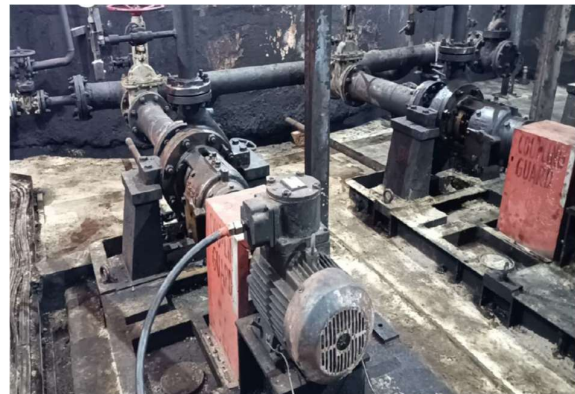
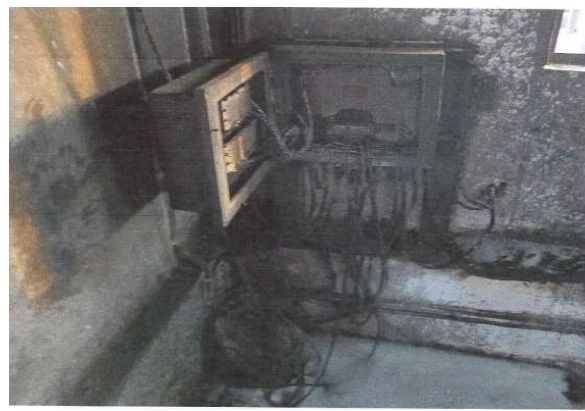
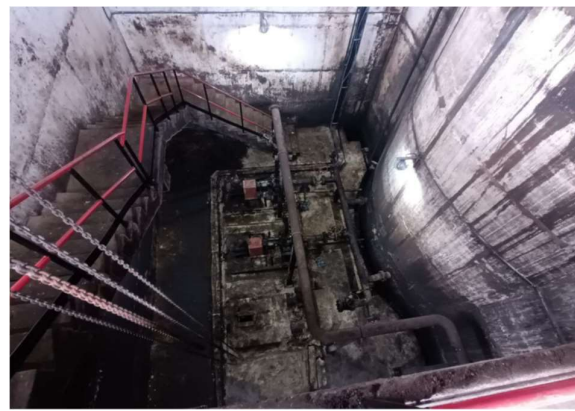
Site Photographs

Fire occurred in the wet slop pump house due to accumulation of hydrocarbon vapor. Electrical cables in the wet slop pump building were damaged and a contract employee suffered burn injuries in the fire. He was admitted in a Burn Hospital and succumbed to his injury after seven days.

12. Electrical technician had provided temporary electrical connection for portable exhaust fan in pump building. Temporary connection was taken from Flame proof distribution board located at the ground floor inside the building from where permanent exhaust fans were already connected. However, the distribution board cover was not closed after providing the connection, as evident from the site photographs taken just after the incident, compromising the flame proof integrity.

Source of Hydrocarbon: The pump and pipeline holdup material, being emptied on the pump floor for strainer cleaning job, may have created a pool of slop on the floor (aggravated by the suspected pump suction valve passing). The liquid pool on the pump floor must have created a vapour cloud well above the LEL level (corroborated by the smell that IP felt and for which he had requisitioned an exhaust fan).

Source of Ignition: Flameproof electrical distribution board was provided in wet slop oil pump building according to hazardous zone classification, but the integrity of electrical system was compromised when it was left open while providing the temporary electrical connection for the temporary exhaust-fan, which was also non-flameproof. Source of ignition was likely the electrical plugin for the temporary exhaust fan that may have generated spark while switching on, leading to ignition of the hydrocarbon/ air mixture.

1. **Facility Development:** Organization shall review and develop proper draining facility for pumps, through management of change procedure, to avoid spillage during preparation for strainer cleaning. Reason for requirement of frequent strainer cleaning shall be investigated and corrective actions shall be taken accordingly.

2. **Electrical Integrity:** Electrical equipment integrity shall be ensured as per hazardous area classification drawing approved by PESO. All electrical equipment and instruments shall conform to the hazardous area classification requirements and shall have appropriate PESO approval.

5. **Pump House Ventilation:** Building ventilation study shall be carried out w.r.t to IS:3103 :1975 (Code of Practice for Industrial Ventilation) requirement and necessary modification to ensure proper ventilation of basement area.
