CASE STUDY

OISD/CS/2025-26/E&P/05

Title: Fatal Accident at Workover Rig

Location: Onshore- Workover Rig

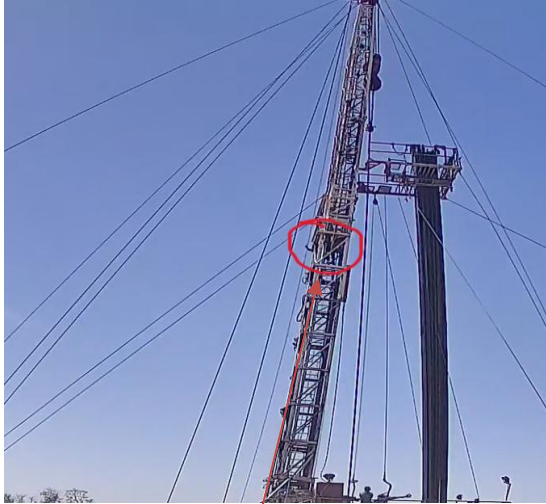
On 28th March 2025, the pull-out operation resumed. At 09:55 AM, a topman, after taking all required safety precautions—including cleaning his shoes, wearing a full-body harness, and properly securing the Fall Prevention Device (FPD)—began climbing to the monkey board. Tragically, as he neared the top, the FPD unexpectedly opened, causing him to fall from approximately 20 meters from ground. He was rushed to the hospital and declared dead.

Approximate position from where the deceased fell down

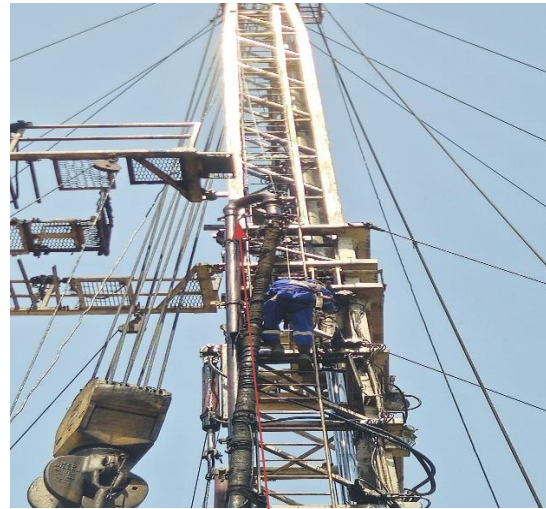
- e) The gooseneck with Kelly hose of the standpipe was positioned halfway across the monkey ladder, partially obstructing the monkey ladder and creating an additional climbing hazard. This seems to be something unusual. The ladder should always remain free of obstructions.

- a) The gooseneck with Kelly hose of the standpipe partially obstructed the ladder, forcing a sideward ascent. This likely caused the FPD wire rope to become entangled with the hammer union or similar obstruction. In attempting to manually free it, the device may have inadvertently disengaged, leading to a fatal fall.
- b) The victim had no training in working at heights and was not assigned a mentor or supervisor. This lack of competency and oversight contributed directly to unsafe practices and poor hazard recognition.
- c) Crude oil spillage resulting from a wet pull-out was observed on the derrick floor and monkey ladder. The presence of oil-contaminated surfaces likely created hazardous footing conditions, significantly increasing the risk of slipping or loss of stability during the victim's ascent. This environmental factor may have directly contributed to the fall.

Gooseneck with Kelly hose obstructing the monkey ladder.

- e) All safety gear like harnesses and FPDs must be checked before use. If anything looks damaged, it should not be used.
- f) Ladders and climbing areas must be free of anything that could block the way, like pipes or hoses etc. Before starting the job, workers must make sure the path is clear and safe.

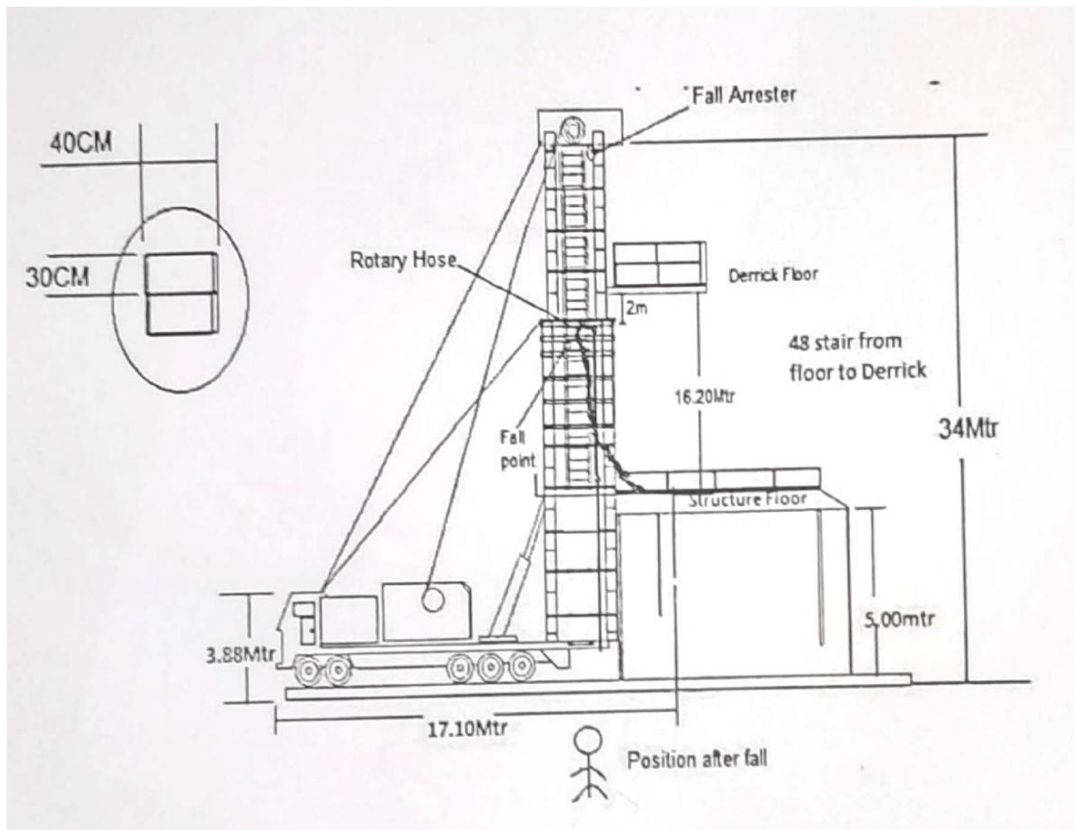
Schematic diagram with IP position after fall.
