## CASE STUDY

OISD/CS/2025-26/E&P/06

**Title:** Major Fire at Drilling Rig

**Location:** Onshore- Drilling Rig

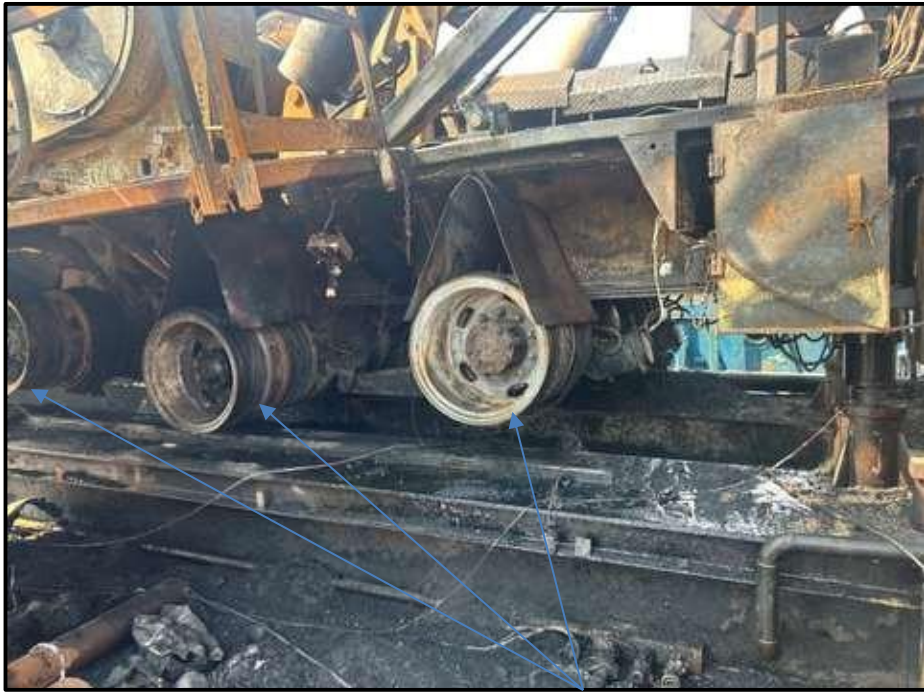
12 rear tyres (Including both side) completely burnt

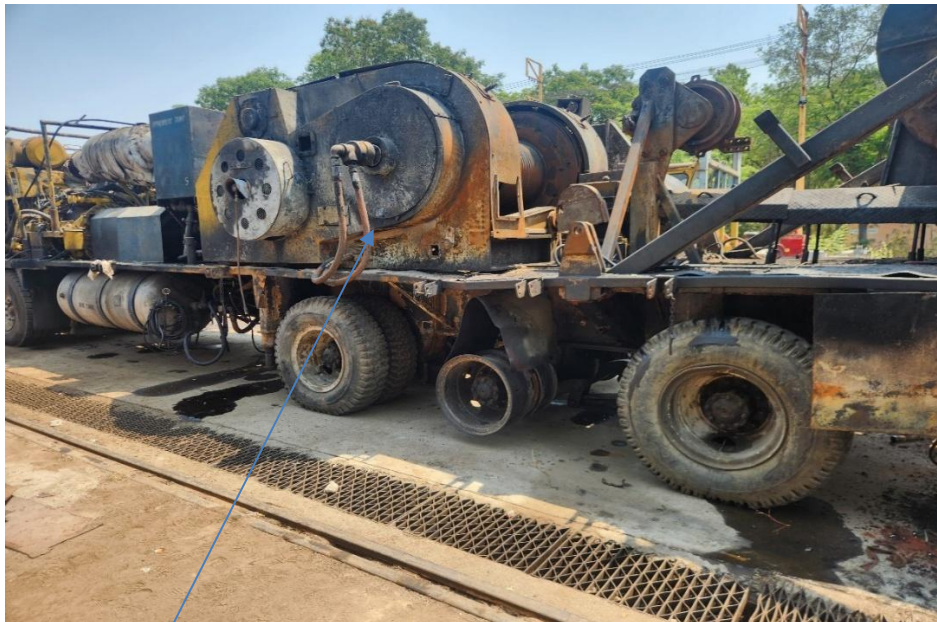
Draw works condition after fire
