CASE STUDY

OISD/CS/2025-26/P&E/07

Dt.:26.06.2025

Title: LNG leakage at LCNG Station.

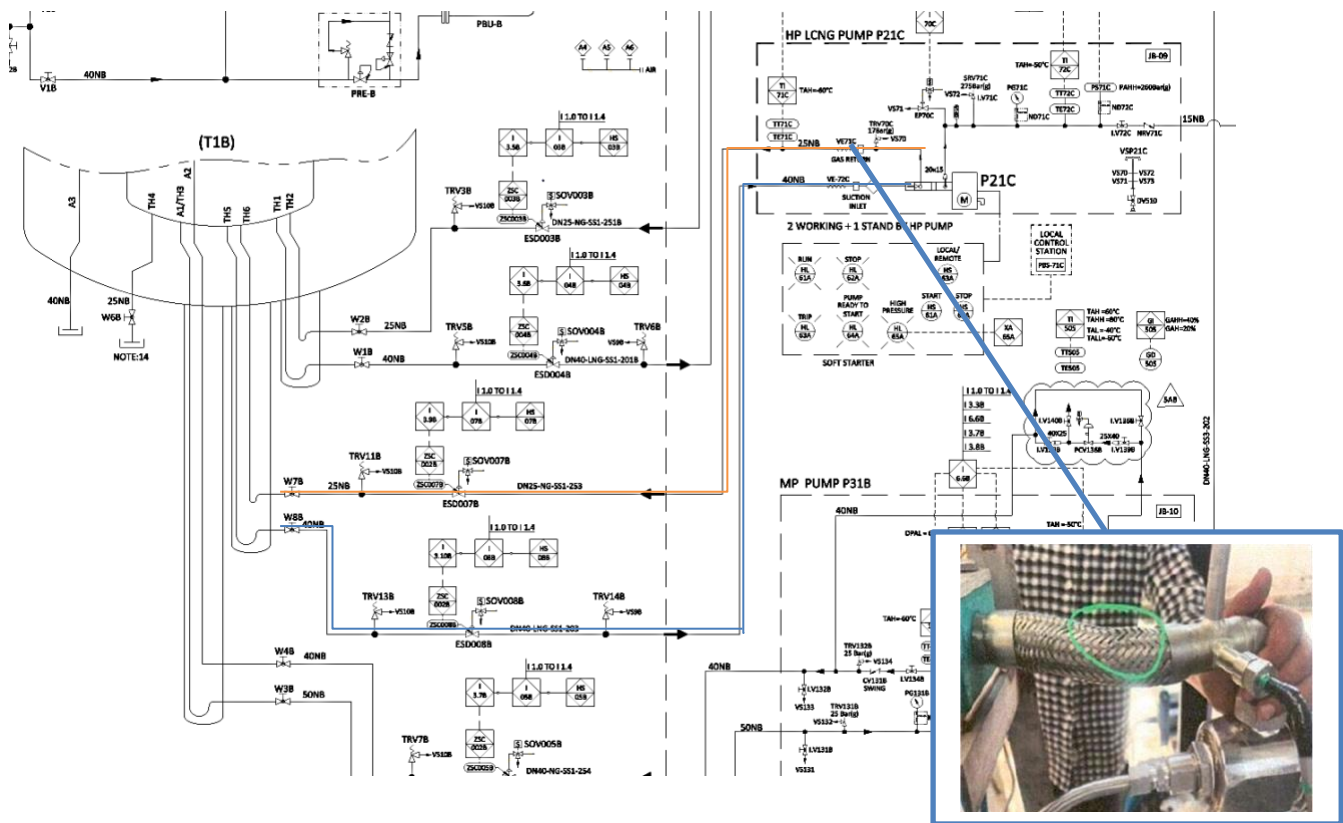
- a. The 2 high-pressure LNG transfer pumps' suction was from the LNG tanks of 114KL each through a 40 NB pipe. The pumps discharged to the high-pressure vaporisers through a 15 NB. The gas from the vaporizers were routed to the fixed cascade system.
- b. To manage vapor generated during start-up and normal operation, each pump was provided with a dedicated 25 NB return line to the storage tank.
- c. The suction and return lines had a manual isolation valve, a solenoid-operated valve (SOV), and a stainless-steel braided flexible connector (hose).

Sniped from P&ID showing Pump P-21 C suction, return and discharge line

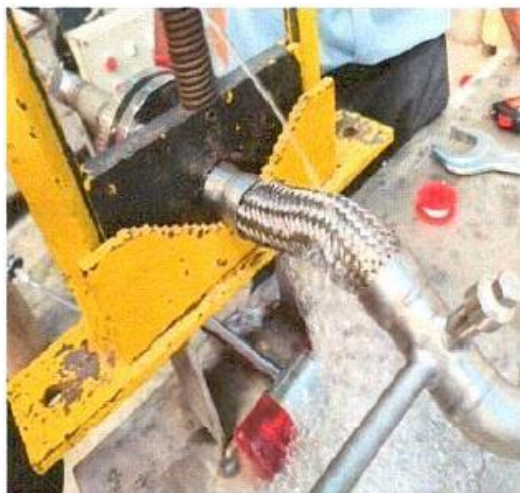
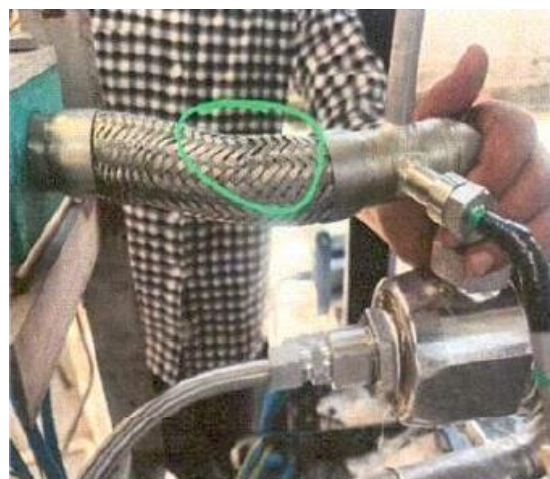
- h. The LNG leak occurred in the flexible connector (hose) on the pump return line (25 NB), which was a wire-braided, corrugated stainless-steel hose rated for the intended service. The rupture point was located at approximately the 10 o'clock position.

- i. Third-party failure analysis attributed the hose rupture to prolonged cryogenic exposure and continuous vibration from the reciprocating pump, resulting in fatigue and eventual failure.

The return line flexible connector (hose) of Pump P-21C, which leaked, failed due to cyclic exposure to cryogenic temperatures, intermittent operations, and continuous vibrations. No hydrotesting of the flexible connector (hose) was carried out in past 4 years.

- a. As per Annex-D of EN 12434:2000 (Cryogenic Vessels: Cryogenic Flexible Hoses), all cryogenic flexible connectors (hoses) must undergo routine visual inspections under operating conditions at defined intervals to identify early signs of deterioration. Further, a formal flexible connector (hose) replacement policy should be established for all flexible connectors (hoses) subjected to cryogenic temperatures and mechanical vibrations.

- b. A review of the requirement of hydrotesting the connecting flexible connectors may be carried out, preferably in consultation with OEM. The review may keep in view that for similar application of LNG transfer hoses, it is prescribed in clause 4.10.7(e) of OISD-STD-194 (2025 edition), that LNG transfer hoses shall be tested annually to the maximum pump pressure or relief valve setting.

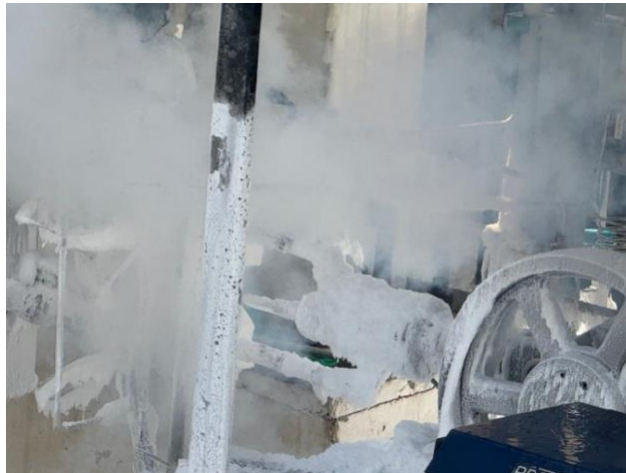
- k. The return line solenoid valve failed to close during emergency interlock activation due to complete icing. The failure was likely caused by sealing degradation or internal mechanical issues under cryogenic conditions

Delayed hydrocarbon detector response probably resulted in icing of the return ESD valve actuator—due to vapor impingement—and its failure to close.

- c. All ESD valves actuators and mounting kit, which is between actuator and cryogenic stem, should be fitted with protective thermal jackets. So that, in the event of an emergency or a failure of the normal control system, the valves and actuators cannot become inoperative due to icing, mechanical damage, or environmental exposure as per clause 8.3.5 of OISD-STD-194 (2025 edition).
