CASE STUDY

OISD/CS/2025-26/E&P/11

Title: Fall & damage of workover rig mast.
Location: Onshore workover rig.
Loss/ Outcome: Loss of rig mast-downtime/ Fatal Injury.

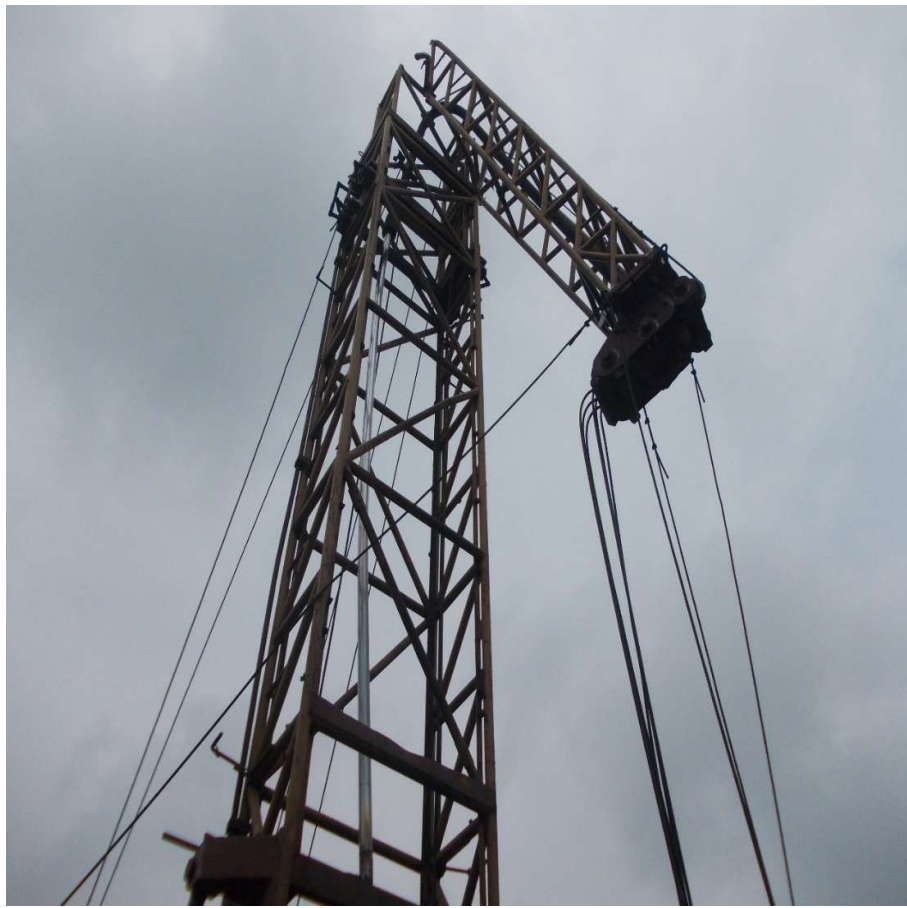
While attempting to free a stuck string, the telescopic mast broke, causing the traveling block to fall and a metallic piece to detach from the mast. A roustabout was struck by it, sustained injuries, lost consciousness, and was later declared dead at a nearby hospital. The detached metallic truss member of mast (13.3 kg -1.84 m) is suspected to have caused the fatal injury.

- Several truss members of both the upper and lower mast were found to be severely corroded. Some truss members were found bent at multiple points, with welded plates added at certain locations, which was not carried out in line with clause 4.4 of OISD-GDN-202.
- Visual inspection and magnetic particle test were carried out in Dec 2024 by a TPI. Two-page report was issued for four workover rigs. Locations of NDT measurements were not verifiable/traceable from the report. It does not look reliable for the purpose of inspection.
- Operator has 6 workover rigs and 2 drilling rigs. However, based on the frequency of workover jobs, usually only two to three rigs are deployed at a time, and that too infrequently. As a result, most rigs remain idle for long periods and are not subjected to audits.

- Lack of inspection and maintenance of mast & substructure: Level I, Level II, Level III and Level IV inspections of the mast and substructure were not carried out since the commissioning of this Workover Rig on 13.11.2009. The condition of the mast was observed to be very poor. Several truss members of the mast were found bent or welded at multiple locations with additional plates to strengthen without any analysis.
- Lack of competency of manpower for work over operation: The rig crew, including the Tool Pusher, Driller, and Assistant Driller, were found to be neither competent nor trained in well control. Additionally, they had not undergone mandatory Mines Vocational Training, Firefighting, or First Aid training.

Photograph of broken telescopic mast

- Level I, Level II, Level III & Level IV inspections of the mast & substructure shall be carried out as per desired frequency in line with OISD-GDN-202.

- The level III & Level IV inspections shall be conducted by a competent third-party agency having adequate experience and knowledge in the specific field.

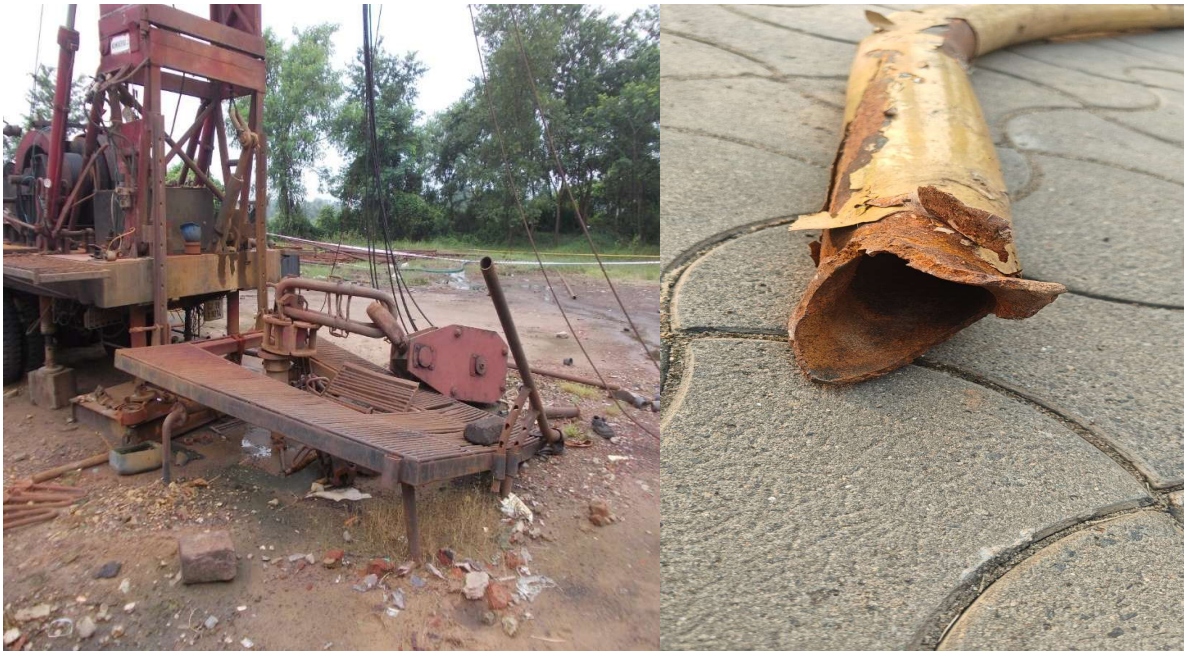
Photograph of fallen travelling block & broken metallic piece of Rig mast

- Rig equipment like Travelling block, draw works, crown block etc shall be periodically inspected as per OISD-GDN-203.
- Mandatory and essential trainings shall be imparted to all the personnel in line with OISD-STD-176. Maintain proper training records and ensure refresher courses are conducted before the expiry of training validity.

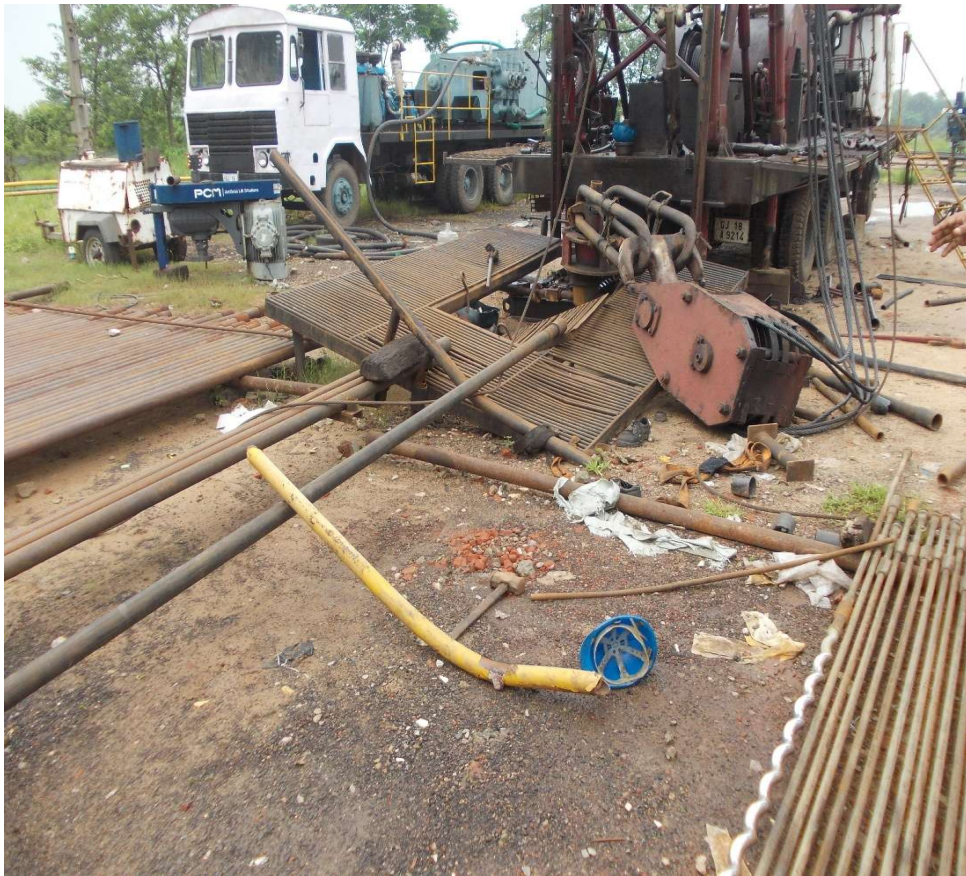
Photograph of Incident location
