केस स्टडी / CASE STUDY

OISD/CS/2025-26/LPG/12

Title: Fatal accident due to electrical shock

Location: LPG Bottling Plant

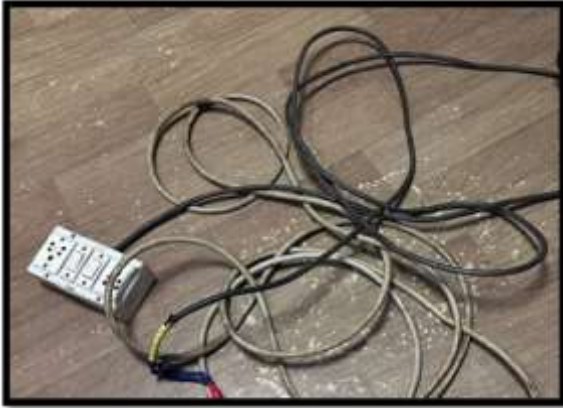
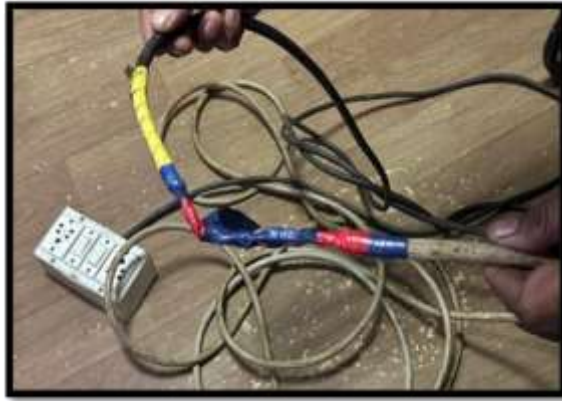
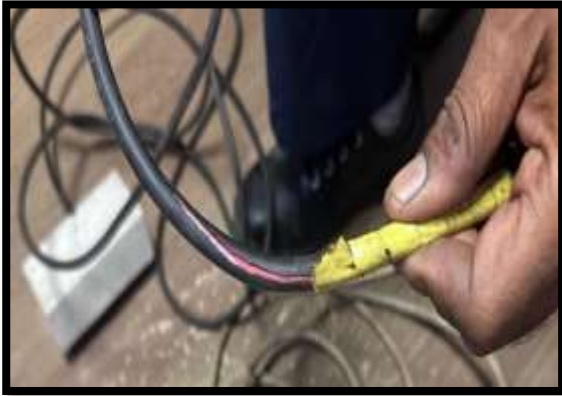
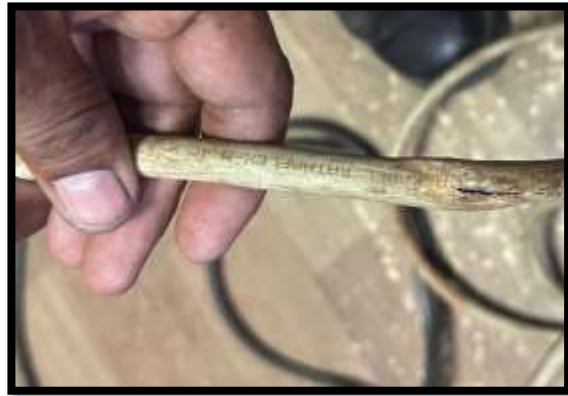
- 1.1** The electrician used a non-standard extension box with damaged cable and connected it to an incorrect and unauthorized power source (PTDU: Motor push button station) inspite of having dedicated single-phase and three-phase connection sockets located at distance of 24 meters approx.
- 1.2** The temporary extension box was not fit for use. It was a makeshift arrangement where two different cables were joined together using insulation tape, and the cable was found damaged at multiple places. Sockets were not of industrial type (metal clad) and did not have any human protection like ELCB, RCCB.
- 1.3** Though plant was having industrial type of plug and junction box suitable for temporary power connection; however, it was not kept ready connected to an armoured cable. Non availability of this arrangement would have prompted electrician to use nonstandard extension board.

Temporary extension Box and cable

- 1.1. Ensure that the dedicated single-phase and three-phase sockets are used for temporary electrical connection.
- 1.2. Temporary electric power connection with Human body protection devices such as ELCB, RCCB etc shall only be used.
- 1.3. The correct plugs and suitable armoured cables must be kept readily available at all times.
- 1.4. Entity to review the current provision of sockets in the LPG shed and install additional connections wherever necessary to eliminate the need for temporary or unsafe wiring.
- 1.5. Defective cables/ equipment should be identified and removed from the system.
