CASE STUDY

OISD/ CS/ 2025-26/ P&E/ 10

Title: H₂S exposure & fatality on external floating roof tank deck

Location: Oil Movement & Storage area of Refinery

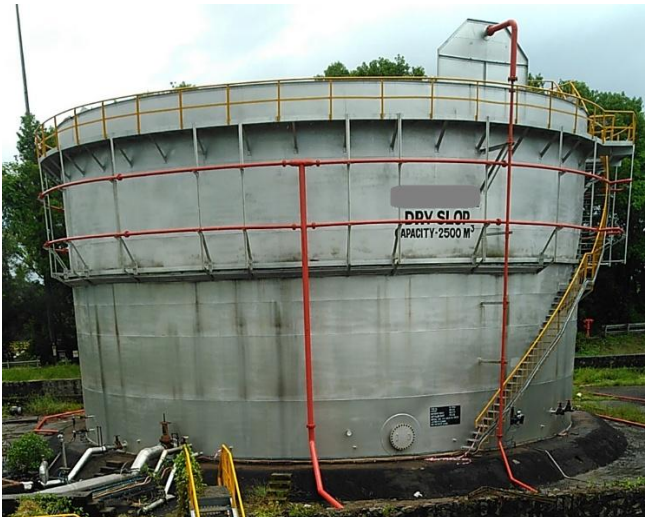
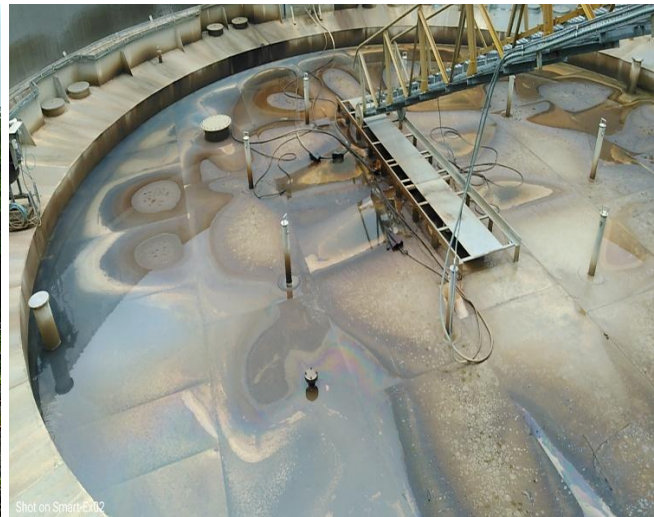
In the morning shift, an OM&S area operator was sent to inspect the slop tank roof to check for rainwater accumulation on the floating roof deck. As there was no contact from him for quite some time, another operator was sent to find him. 2nd operator informed on walkie-talkie that 1st operator has fallen on roof deck of the slop tank. He attempted to evacuate the first operator by going onto the floating roof deck. 3rd Operator, who was in near-by area, rushed to top of slop tank and saw both operators lying on the floating roof deck. He communicated the same on walkie-talkie and asked for emergency assistance.

1. The concentration of H₂S on slop tank was observed to be quite high (in the range of 40 ppm at the top platform of the tank) even 48 hours post-incident.
2. Presence of oil was observed on the tank floating roof deck, indicating slippage/ escape of tank contents onto the roof floating deck upper side.
