CASE STUDY

OISD/CS/2025-26/E&P/13

Title: Blowout after well perforation.
Location: Onshore workover rig.
Loss/ Outcome: Blowout.

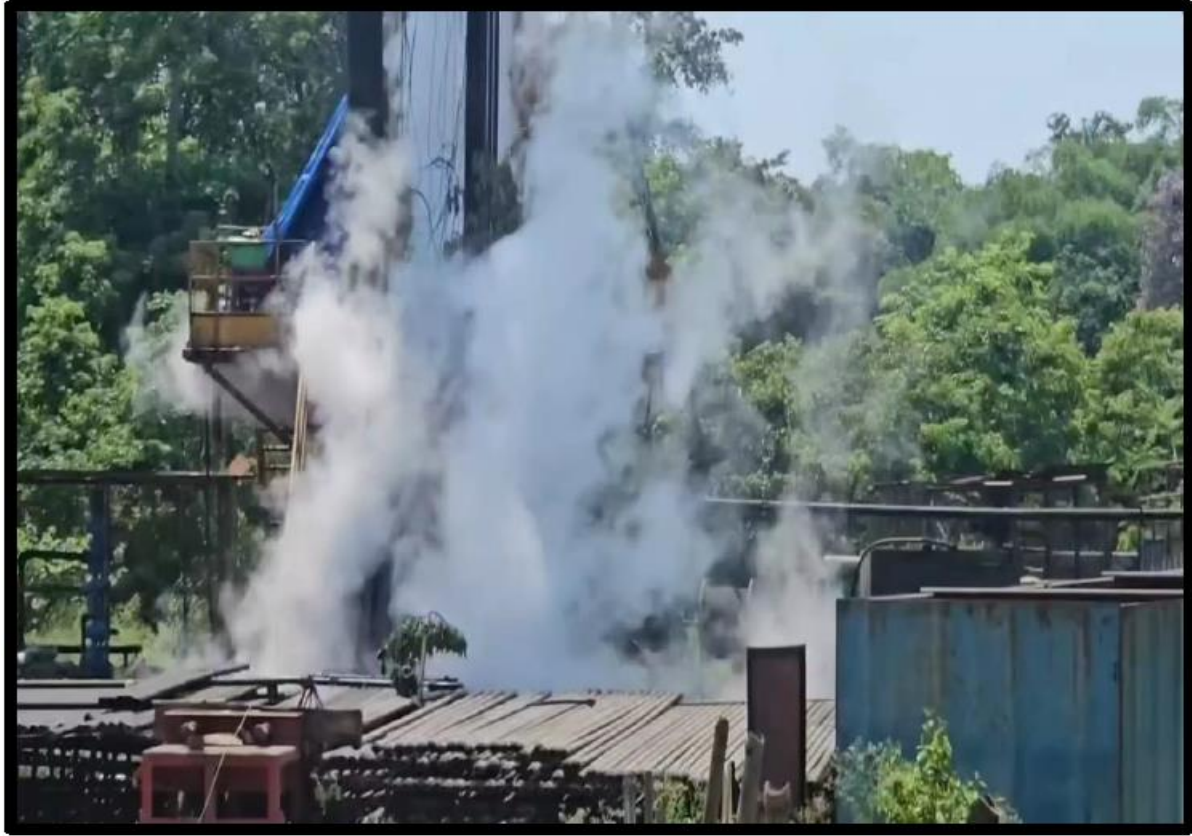
PICTURES POST-INCIDENT

A major incident of gas blowout was observed at a charter hired workover rig working in a workover well. The incident occurred during the pulling out of conventional perforation gun after perforating a new zone in the well. There was no fire or injury reported due to the incident. During blowout, no oil flow was reported from the well.

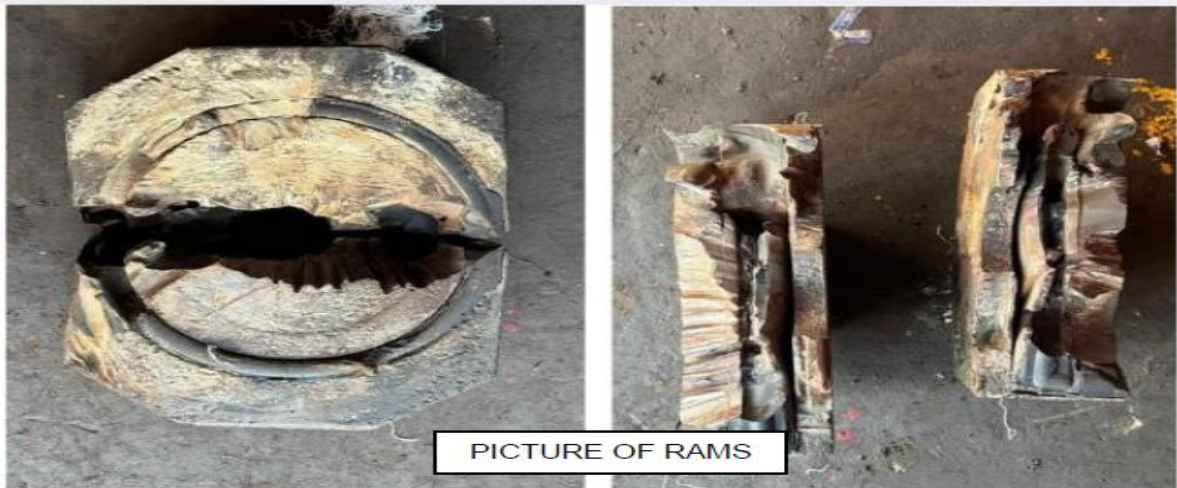
PICTURE OF RAMS

- It seems that the blind ram was closed on wireline, which is against the condition for application of blind ram, resulting in damage to the rams.

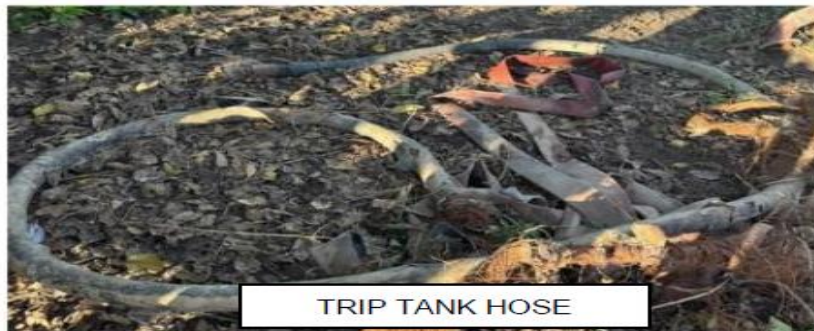
TRIP TANK HOSE

- The trip tank was not in use during the incident, and the level alarm system of the trip tank was also defunct at the time of incident. This is violation of clause 6.8 (V) of OISD-STD-174.

- Trip tank should be always connected and used for well monitoring to check gain/ loss in the well as per Clause 6.8(V) of OISD-STD-174.
- All perforation gun RIH and P/O operations must strictly adhere to the SOP-specified speeds to minimize the risk of swabbing and well influx.
