## CASE STUDY

OISD/CS/2025-26/E&P/14

**Title:** Fatal accident caused by tubing drop after the elevator was unlatched at the monkey board

**Location:** Onshore Workover Rig

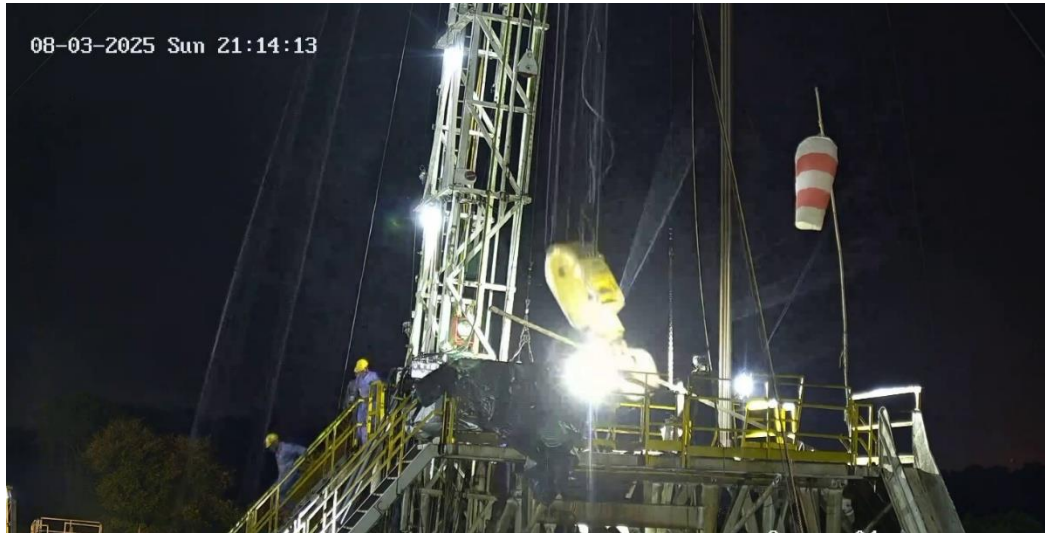
4. Twin stop device failed to function during the incident. The daily checklist indicated that the device was checked at the beginning of the shift. Rigor of the checking might not have been adequate.

**Picture 1: Uncontrolled Fall of Travelling Block**

- A. The topman unlatched the tubing double from the elevator while the pin end was on the incline ramp due to communication gap.
- B. The travelling block descended uncontrollably and hit the rig floor as the twin stop device did not engage. This non-functionality of the twin stop device occurred presumably due to bypassing or not setting of the device.

3. **Twin stop Device:** As per regulation 42 (f) of Oil Mines Regulations-2017, the draw-works shall be provided with an automatic device which shall effectively prevent the travelling block from coming closer than two metres of the crown block on one end and crashing on the rotary table at the other end. The twin stop device should be physically verified before being marked 'checked' in the daily checklist.

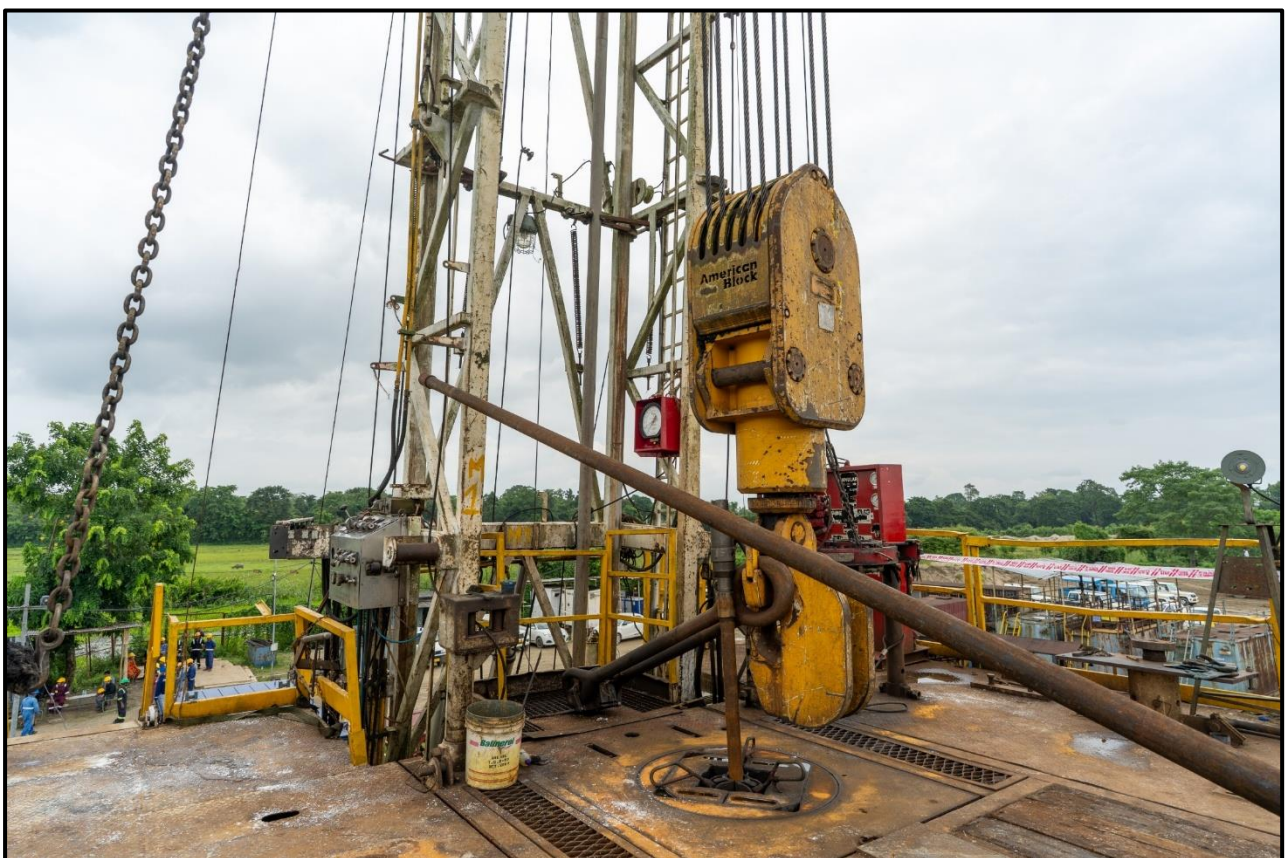
## POSITION OF TUBING DOUBLE AND TRAVELLING BLOCK POST INCIDENT

The topman pulled the tubing-double toward the racking fingers with the rope and unlatched it from the elevator. The tubing-double then slid down suddenly and uncontrollably. Its box end struck Night Tool Pusher near the driller console, causing a severe head injury. The tubing also hit a rig-man, who was descending the stairs, causing a serious injury by crushing him against the stair handrail, resulting in multiple rib fractures and broken left hand. The travelling block then descended uncontrollably, struck the box end of the tubing held on the slips, and its elevator and links hit the rig floor. Another rig-man engaged the brake. Fortunately, the travelling block's fall caused no further injury or damage.

5. The catwalk showed multiple impact marks and was misaligned with the substructure. Tubing-double, which had slid down the ramp, bounced over the V-door handrail and box end hit the tool pusher.

4. **Catwalk orientation:** The catwalk should be correctly aligned with the substructure and fitted with a functional end stopper to prevent tubulars from jumping out. Damaged stoppers must be repaired or replaced immediately.
