## CASE STUDY

OISD/CS/2025-26/P&E/17

Title: Fire in 2" hydrocarbon drain line.

Location: Slug Catcher Area in Gas Processing Plant.

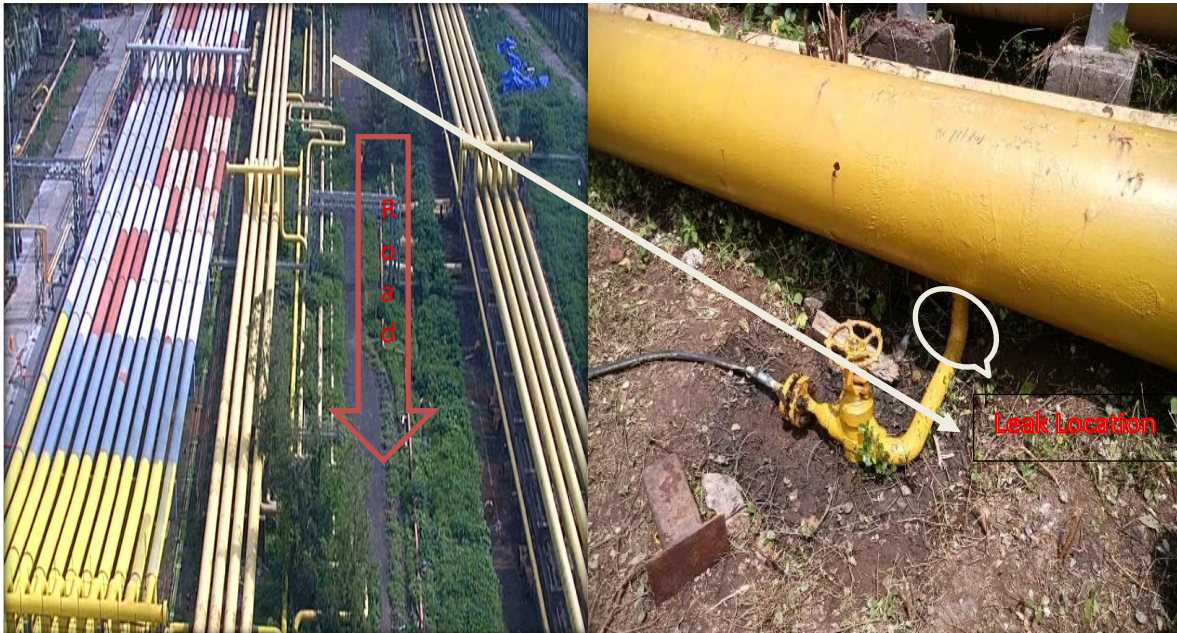
A hydrocarbon leakage occurred from elbow in a 2" drain line in a 18" gas interconnection pipeline adjacent to slug catcher area followed by a major fire. Firefighting operations were immediately initiated. The affected pipeline was isolated and adjoining sections were shutdown. Depressurisation and cooling measures were undertaken simultaneously. The fire was contained locally within 30 minutes and extinguished in around 2 hrs 40 mins. No casualties were reported in connection with the incident. Normal operations at the GPP were restored on the next day.

The cause of hydrocarbon leak was the JCB hitting the 'L' shaped 2" drain line (located at the proximity of road) of the 18" interconnection gas line in the slug catcher area during the scrapping of Road for cement surfacing work. The latent failure was absence of marking/ barricading around the protruding drain line as well as non-availability of crash barrier/ barricading on roadside to protect the pipelines.
