CASE STUDY

OISD/CS/2025-26/E&P/18

Dt.: 11.11.2025

Title: Man Overboard (MOB).

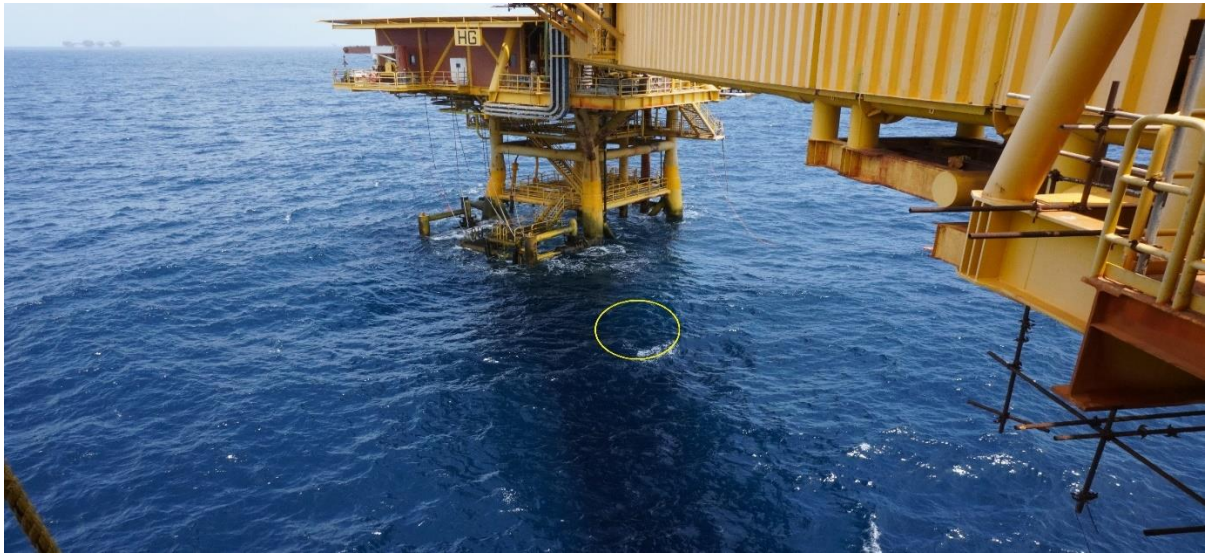
- It was observed that personnel did not use work vests during their stay at the unmanned platform.
- The railing at the southeast (SE) location was missing and was later barricaded using pipes.

Photograph of Incident location

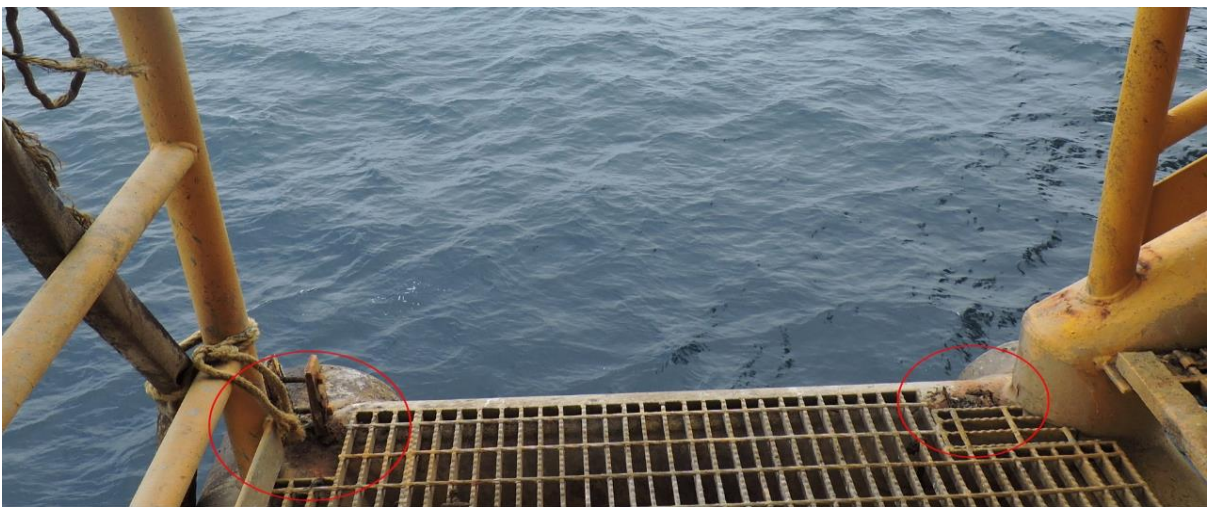
- The base of the missing railing of the southeast corner had a weld joint on one side and a composite material (FRP/GRP) with a nut-bolt fitting on the other side.

- The southeast corner mezzanine deck railing was likely rusted or cracked and may have failed if the IP used it for support; nearby composite railings also showed cracks, indicating material weakness, and the residual portion of the railing suggested a non-standard method of attachment.
- Failure to use work vests or lifejackets was a contributing factor to the incident.
- A designated washroom was not available at the unmanned platform.
- The quality of the BOSIET training could not be ascertained, which may have been a contributing factor.
- Monsoon weather conditions probably affected recovery of IP.

Photograph of broken railing

- All personnel visiting unmanned platforms must wear work vests throughout their stay.
- An SOP for the inspection and repair of railings/handrails should be prepared, along with a system for periodic verification of their integrity.

- A study should be carried out to identify suitable materials and fixation methodologies for railings that can withstand offshore conditions, and a policy should be framed to standardize their selection, installation, and maintenance across all offshore locations. Cracked composite handrails or railings should be repaired or replaced immediately.

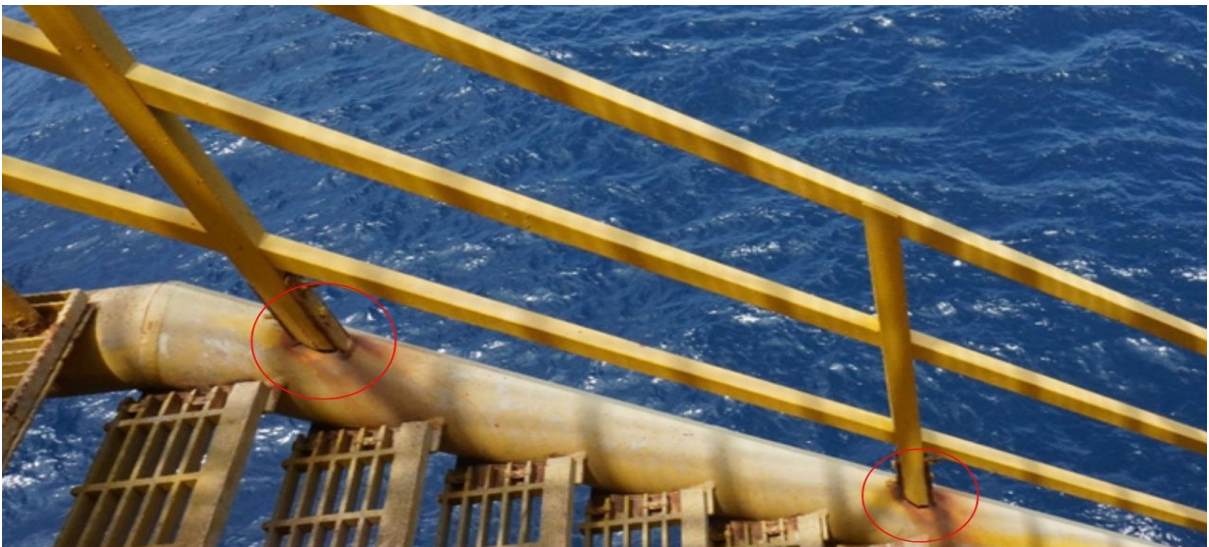
- Some deck handrails/railings were made using a combination of hollow composite materials and hollow square-shaped iron pipes.
- It was observed that the north side stair railing, made of composite material, had developed cracks at the bottom where it was fixed with bolts and studs...

Photograph of cracks developed at the base of railing
